**GEOTECHNICAL ENGINEERING REPORT  
MULTI-FAMILY  
RESIDENTIAL DEVELOPMENT  
SOUTH OF VIA CANON AND  
CAMINO CAPISTRANO  
DANA POINT, CALIFORNIA**

Project: **Multi-Family Residential Development**  
South of Via Canon and Camino Capistrano  
Dana Point, California

Subject: **Geotechnical Engineering Report**

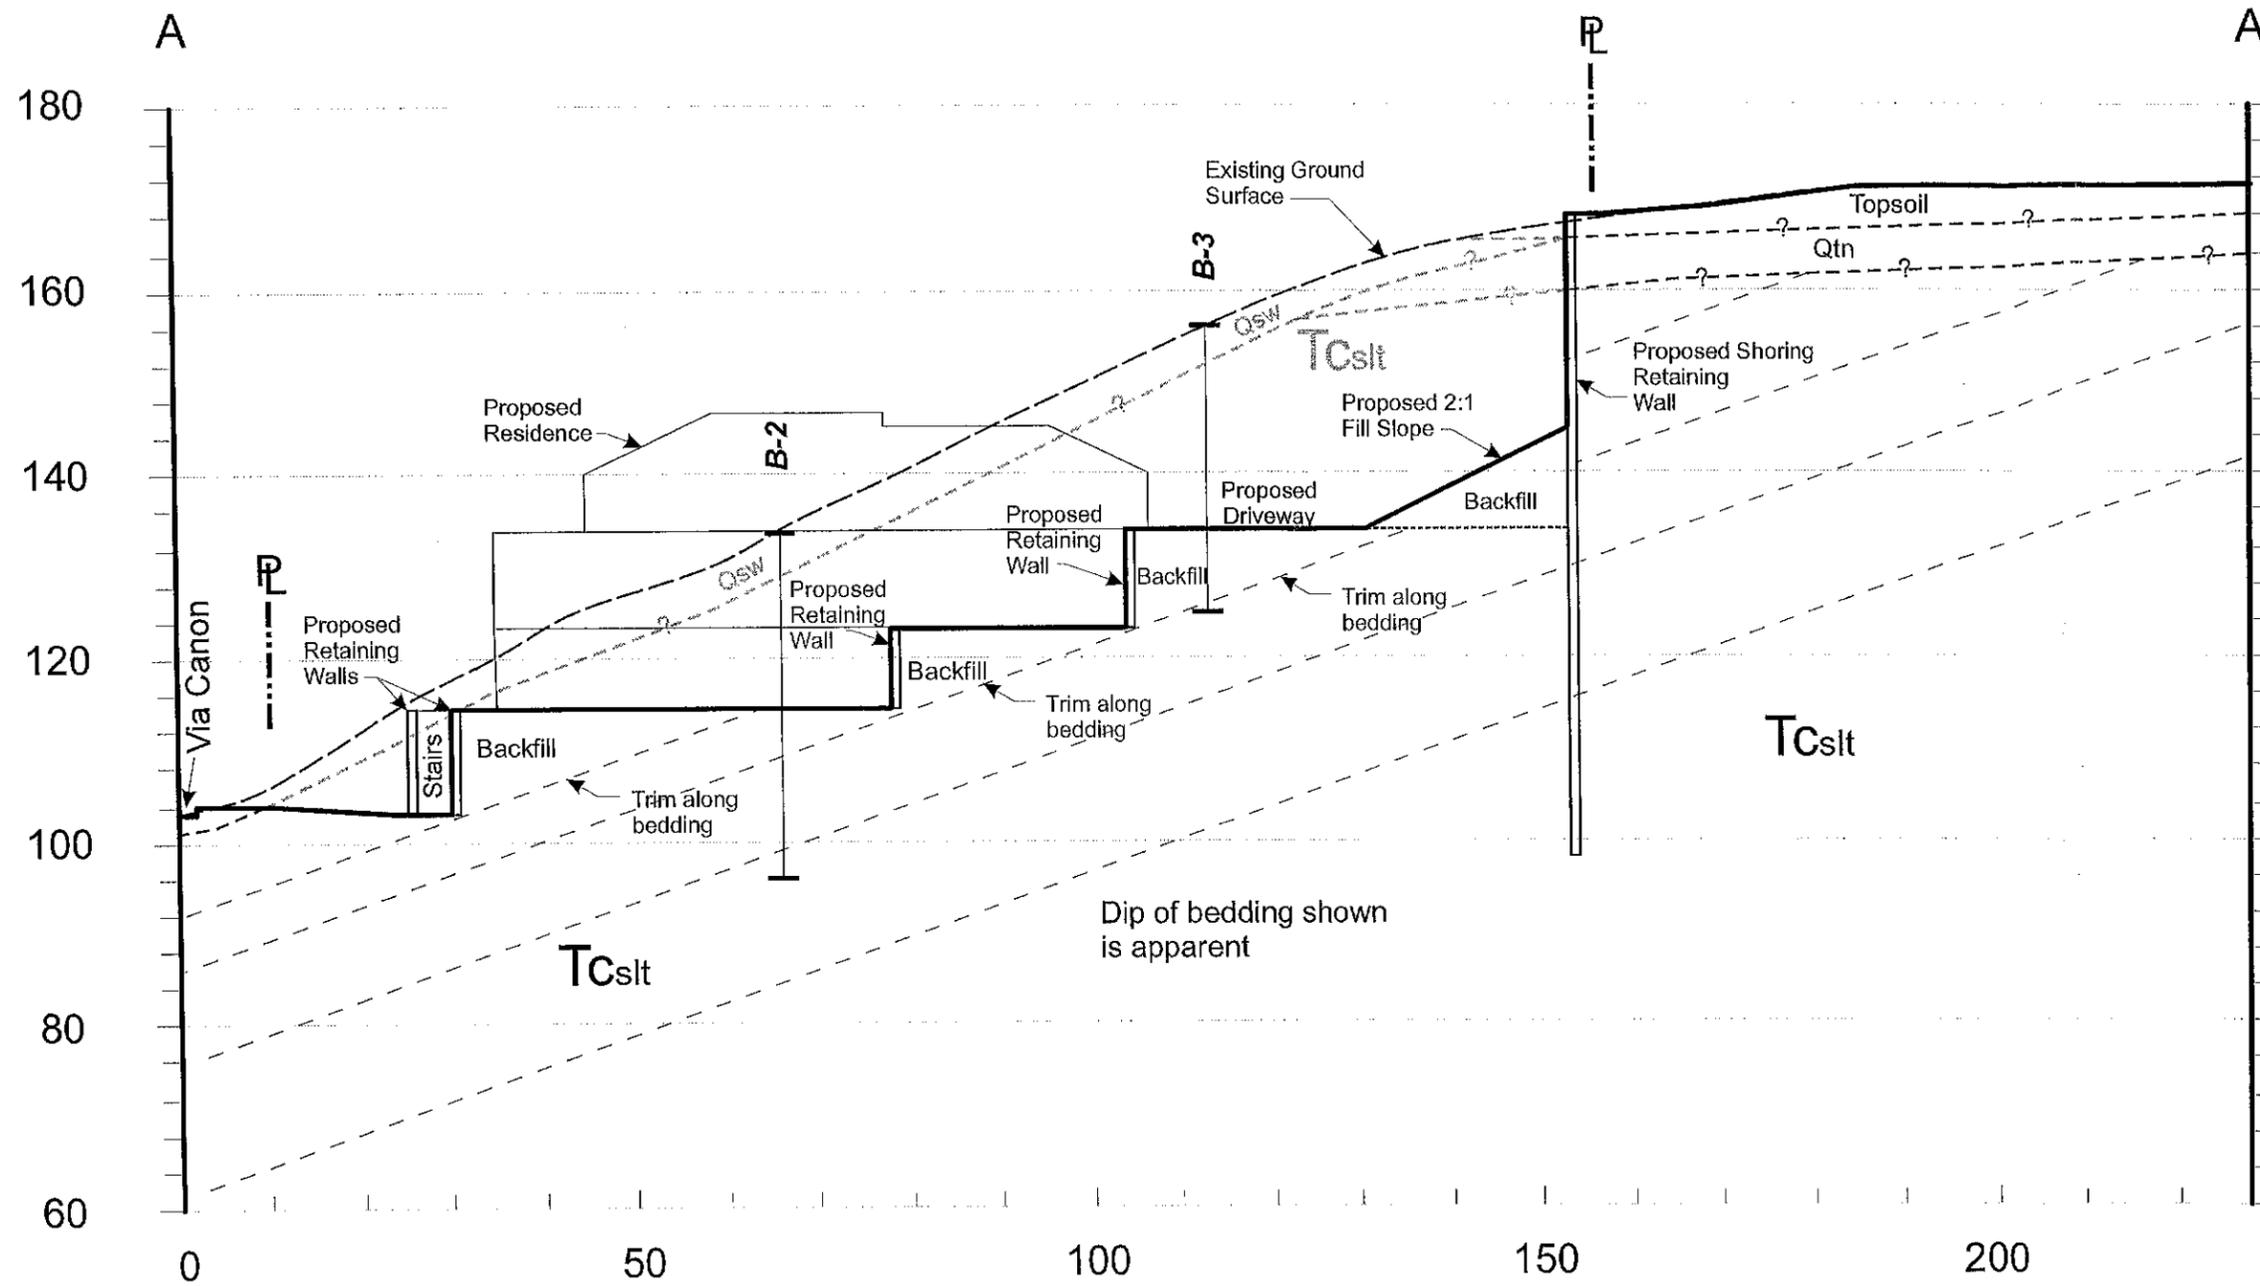
**Figure 3A**  
**Geologic Section A-A'**

# SECTION A-A'

South of Via Canon & Camino Capistrano  
Dana Point, California

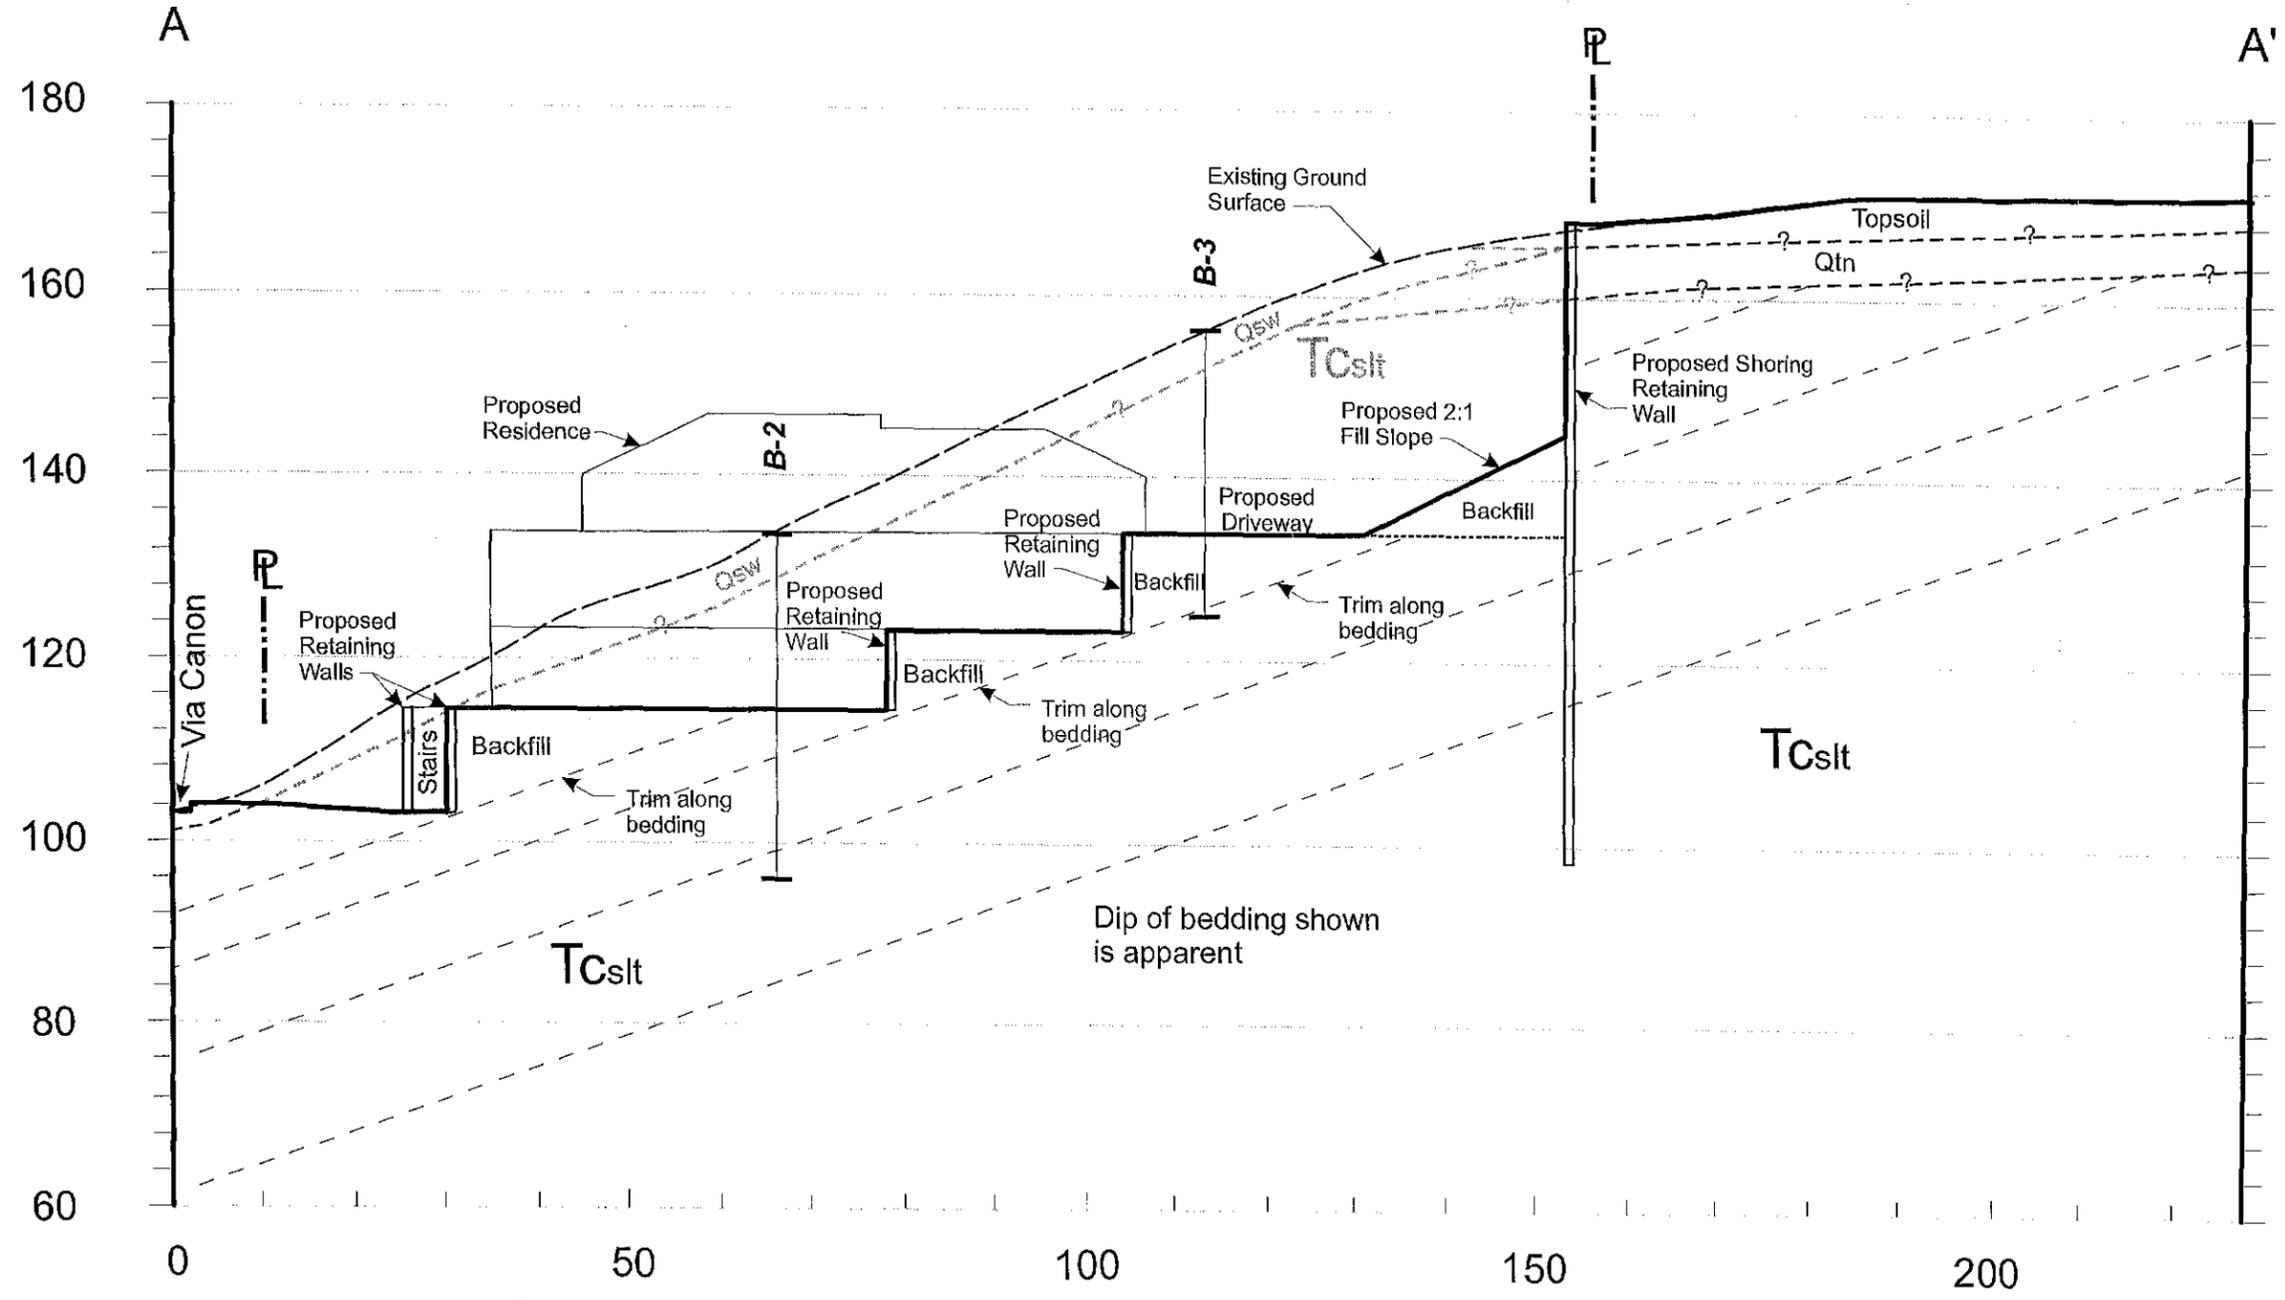
**Figure 3A**  
**Geologic Section A-A'**

# SECTION A-A'

South of Via Canon & Camino Capistrano  
Dana Point, California

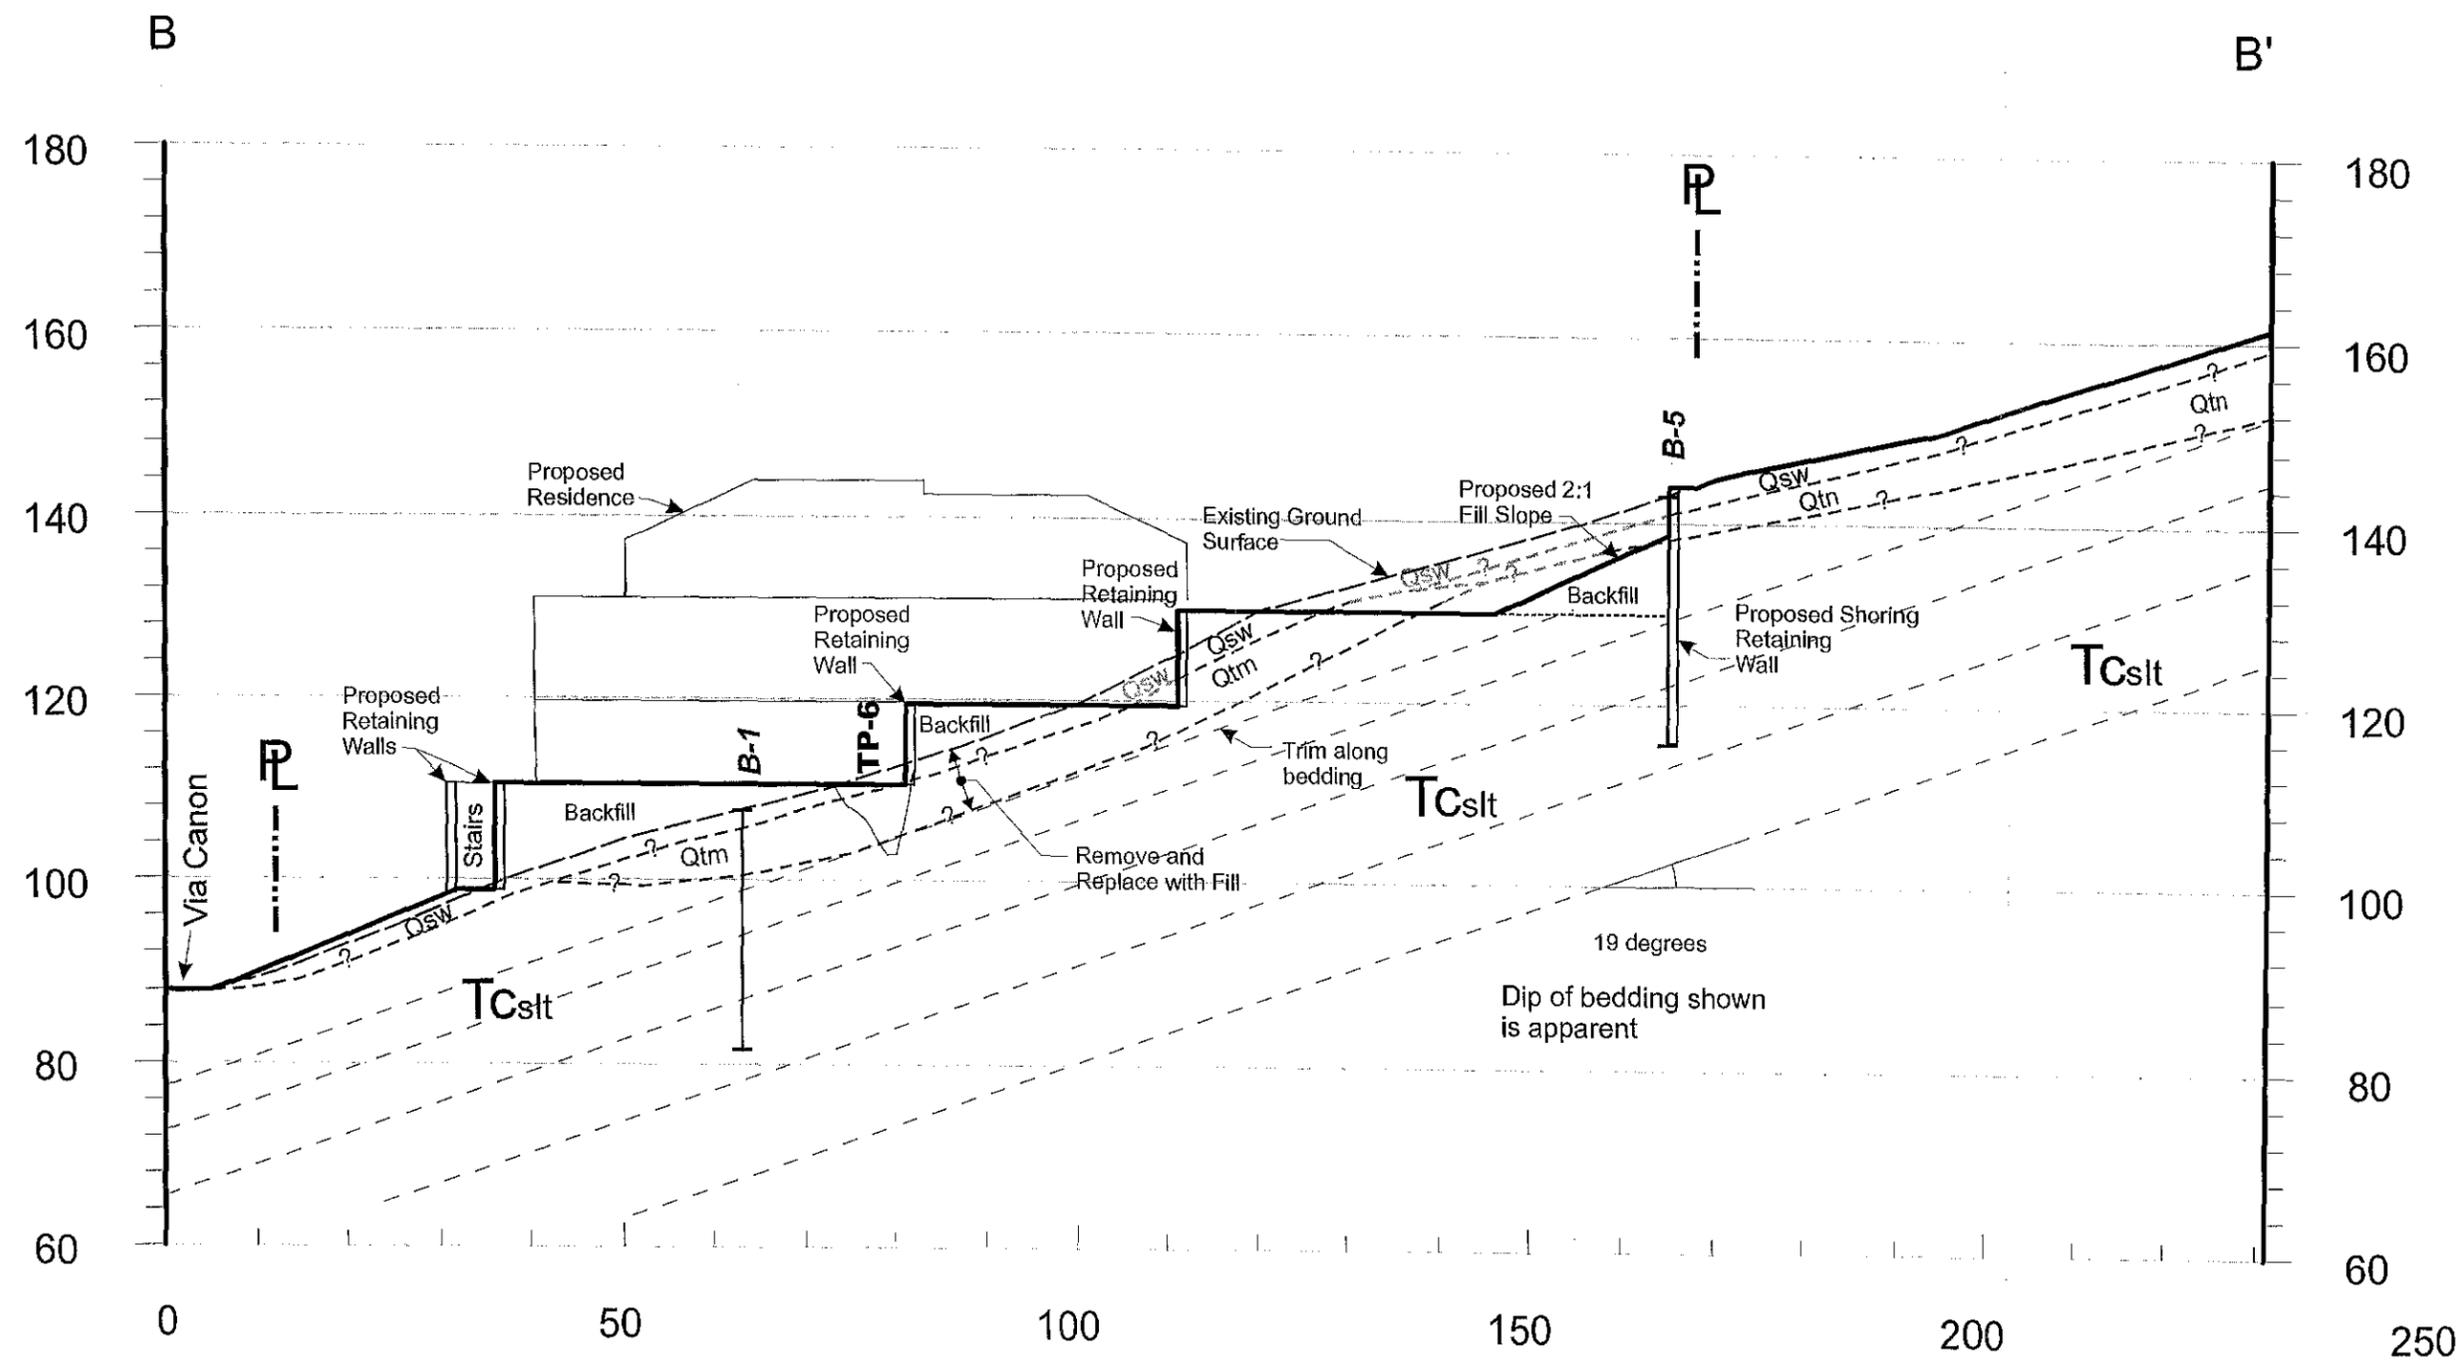
**Figure 3B  
Geologic Section B-B'**

# SECTION B-B'

South of Via Canon & Camino Capistrano  
Dana Point, California

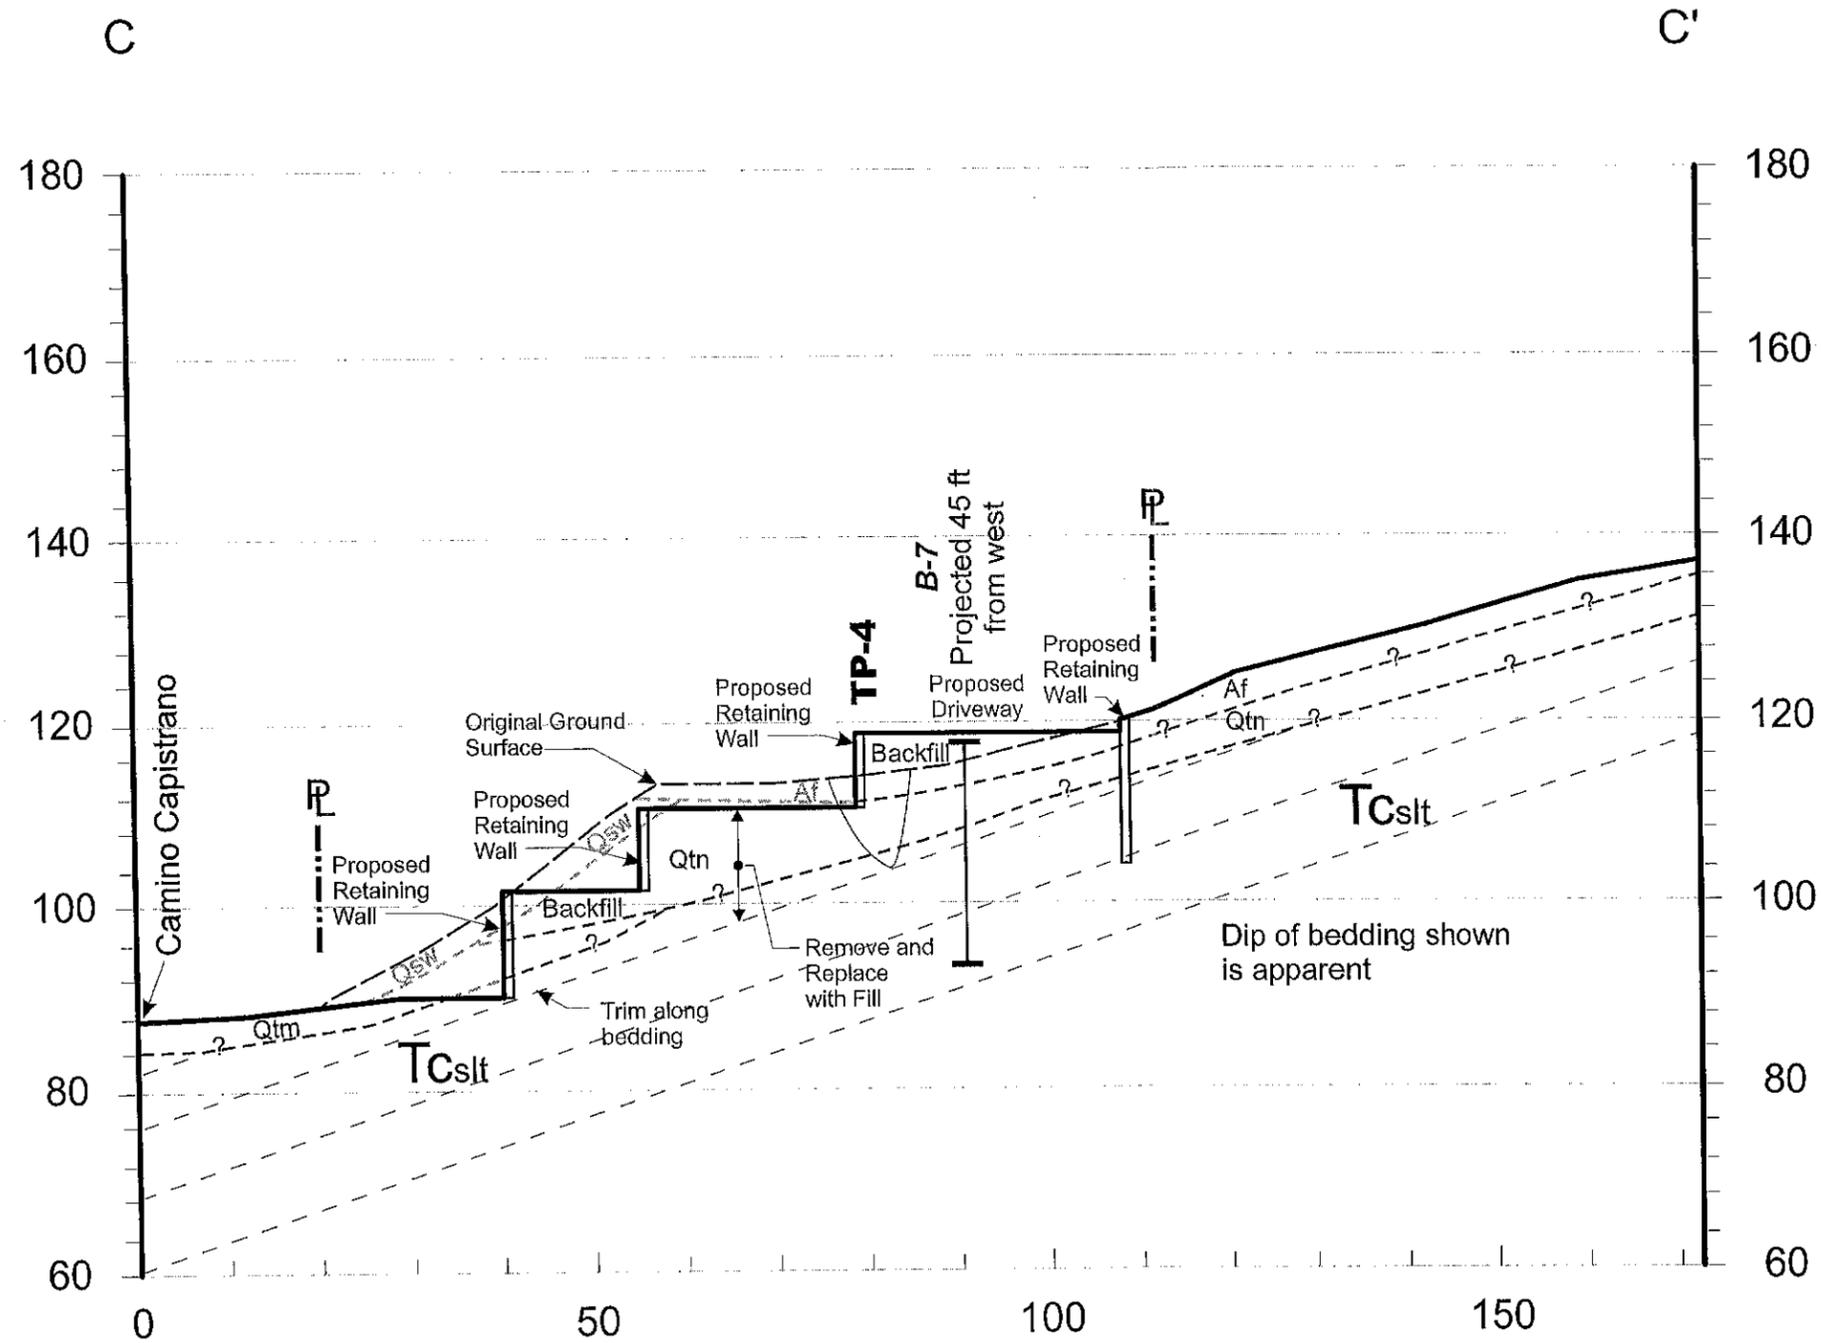
**Figure 3C**  
**Geologic Section C-C'**

# SECTION C-C'

South of Via Canon & Camino Capistrano  
Dana Point, California

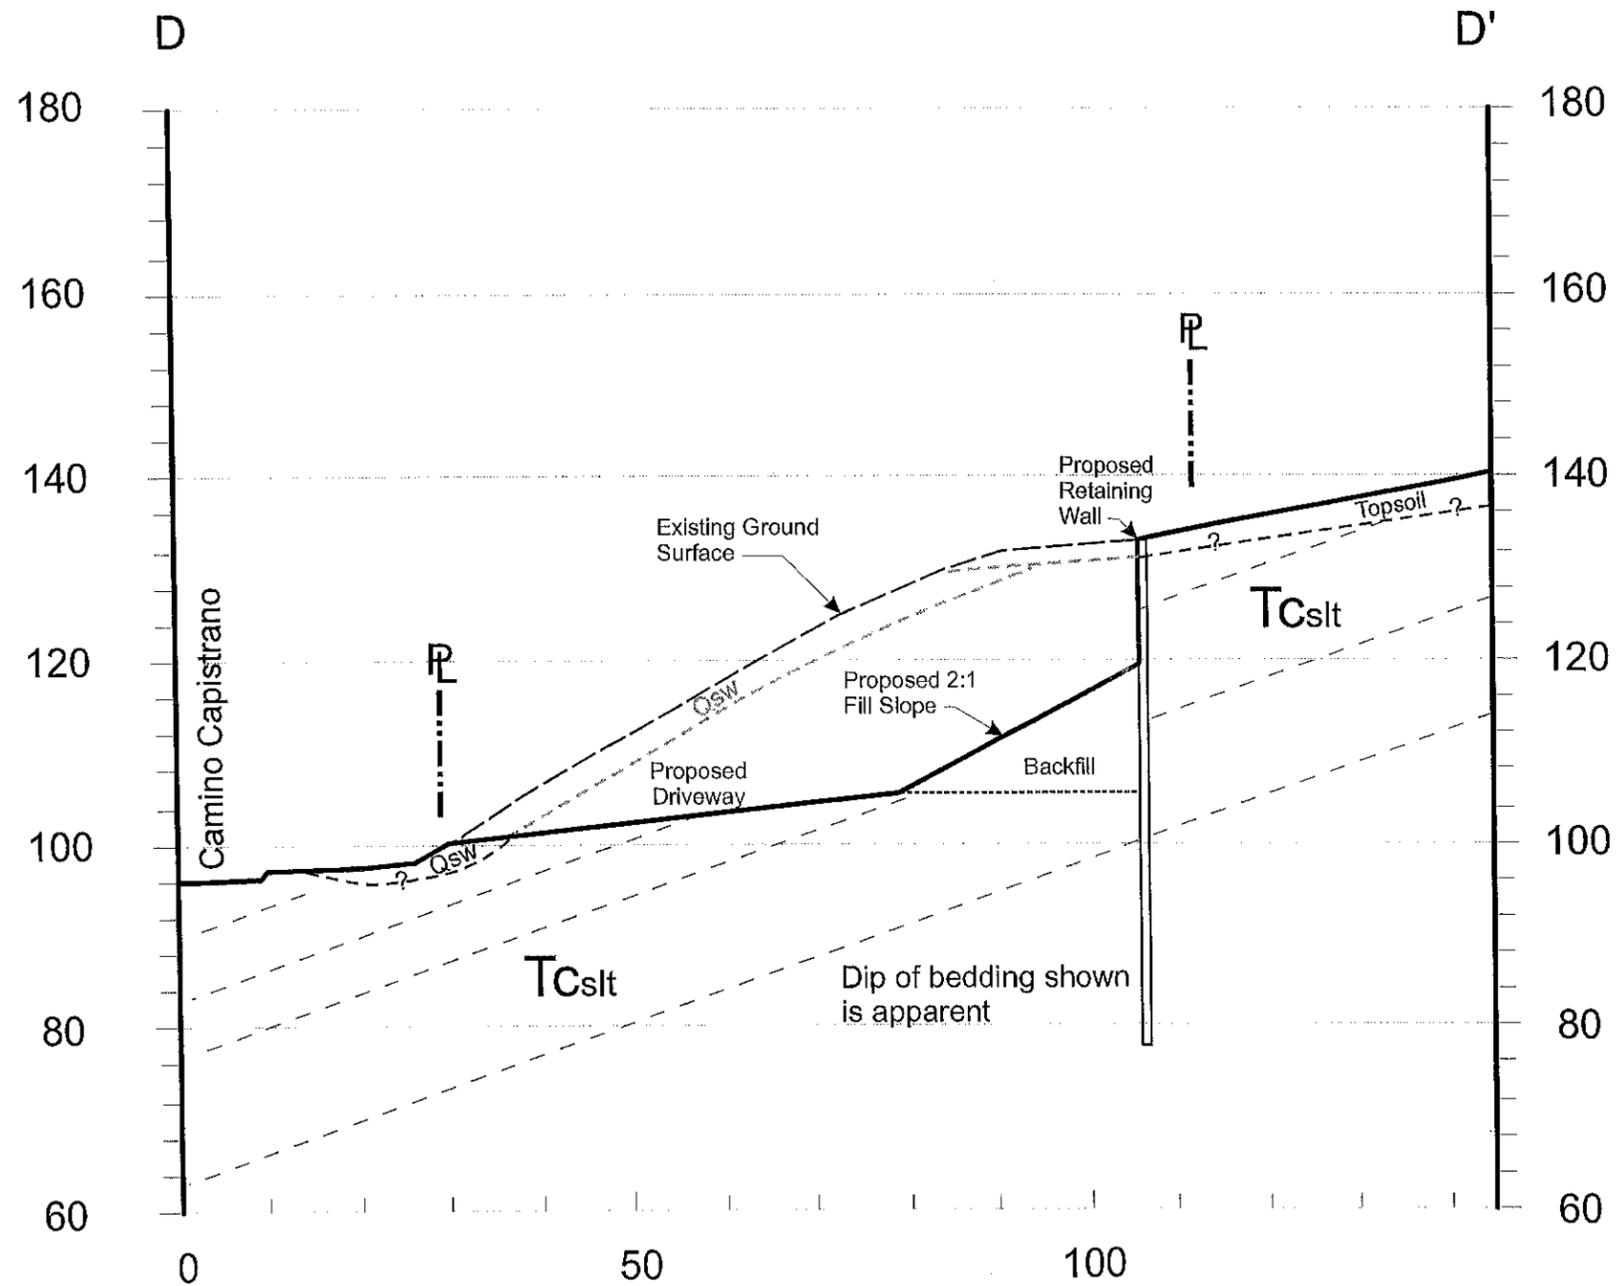
**Figure 3D  
Geologic Section D-D'**

# SECTION D-D'

South of Via Canon & Camino Capistrano  
Dana Point, California

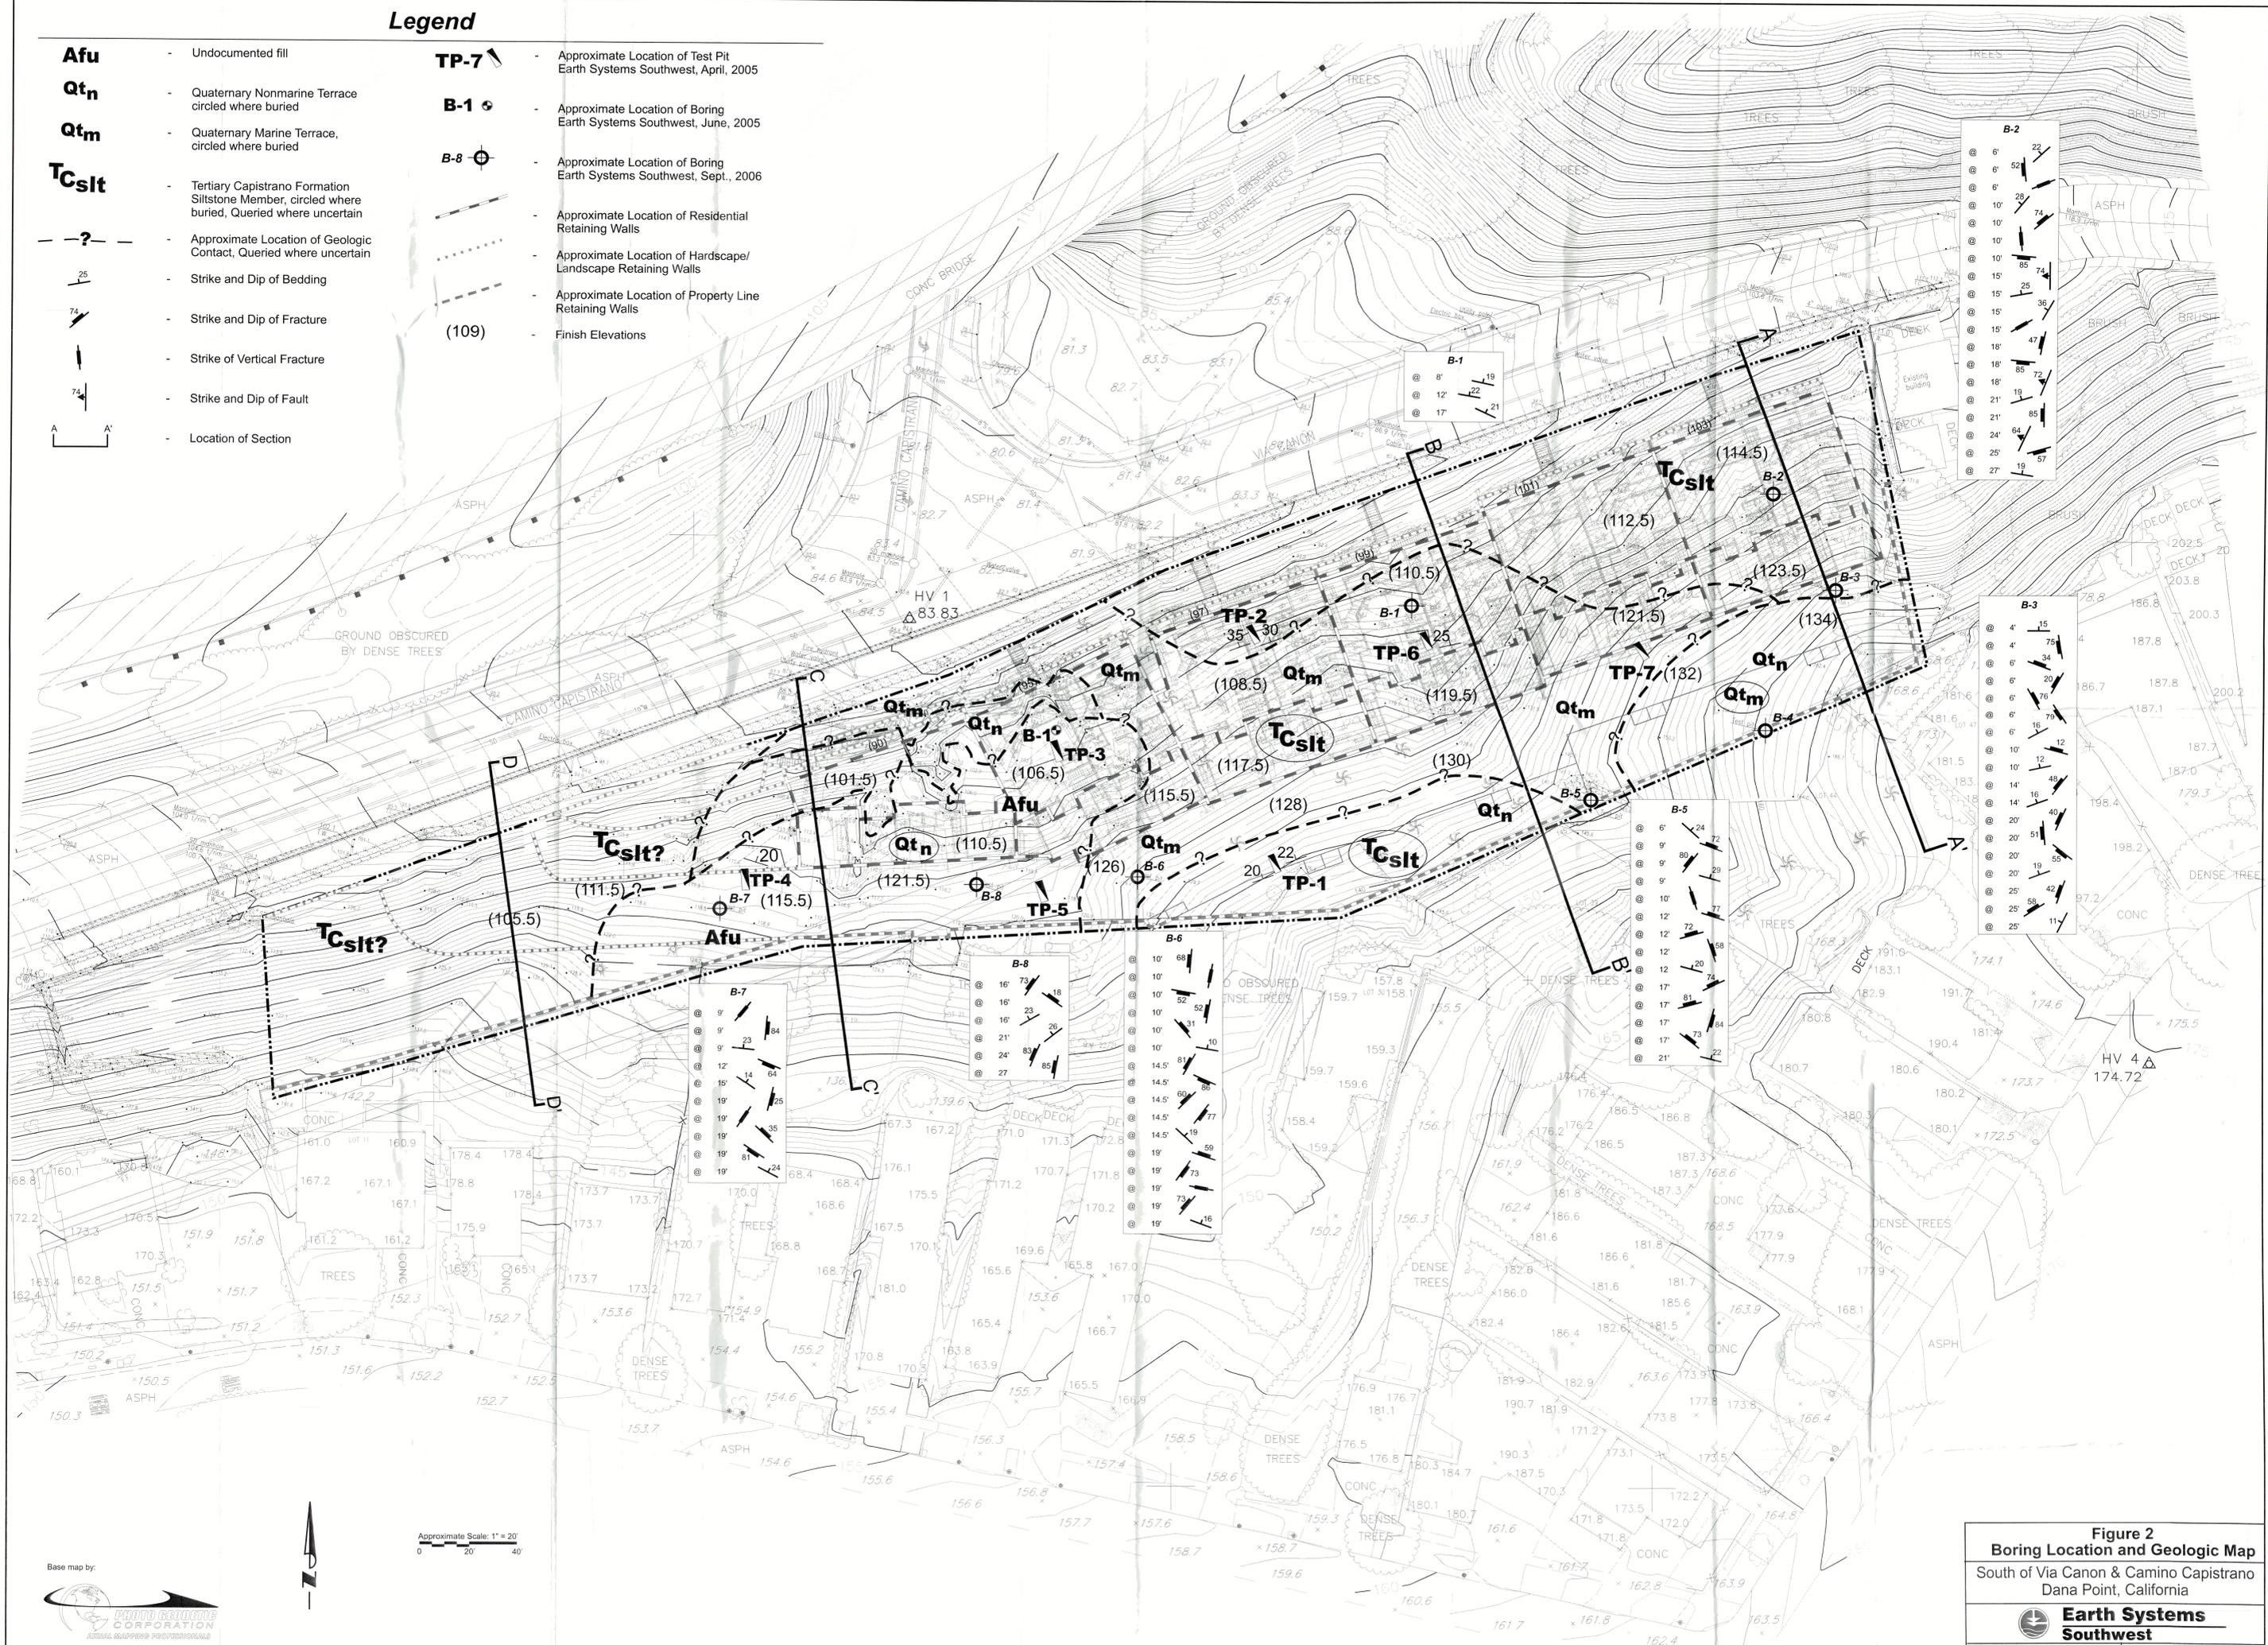
**Figure 2**  
**Boring Location and Geologic Map**  
 South of Via Canon & Camino Capistrano  
 Dana Point, California

- - Approximate Location of Residential Retaining Walls
- - Approximate Location of Hardscape/Landscape Retaining Walls
- - Approximate Location of Property Line Retaining Walls

- (109)** - Finish Elevations

Site Geology: Review of the California Division of Mines and Geology Special Report 109, Geology of the Dana Point Quadrangle, 1974, reveals a portion of the central area mapped Qtn on Figure 2 as a landslide. However, based upon our exploration and past development of this "landslide" area no evidence of any landslide or other landslide related instability was noted during our exploration.

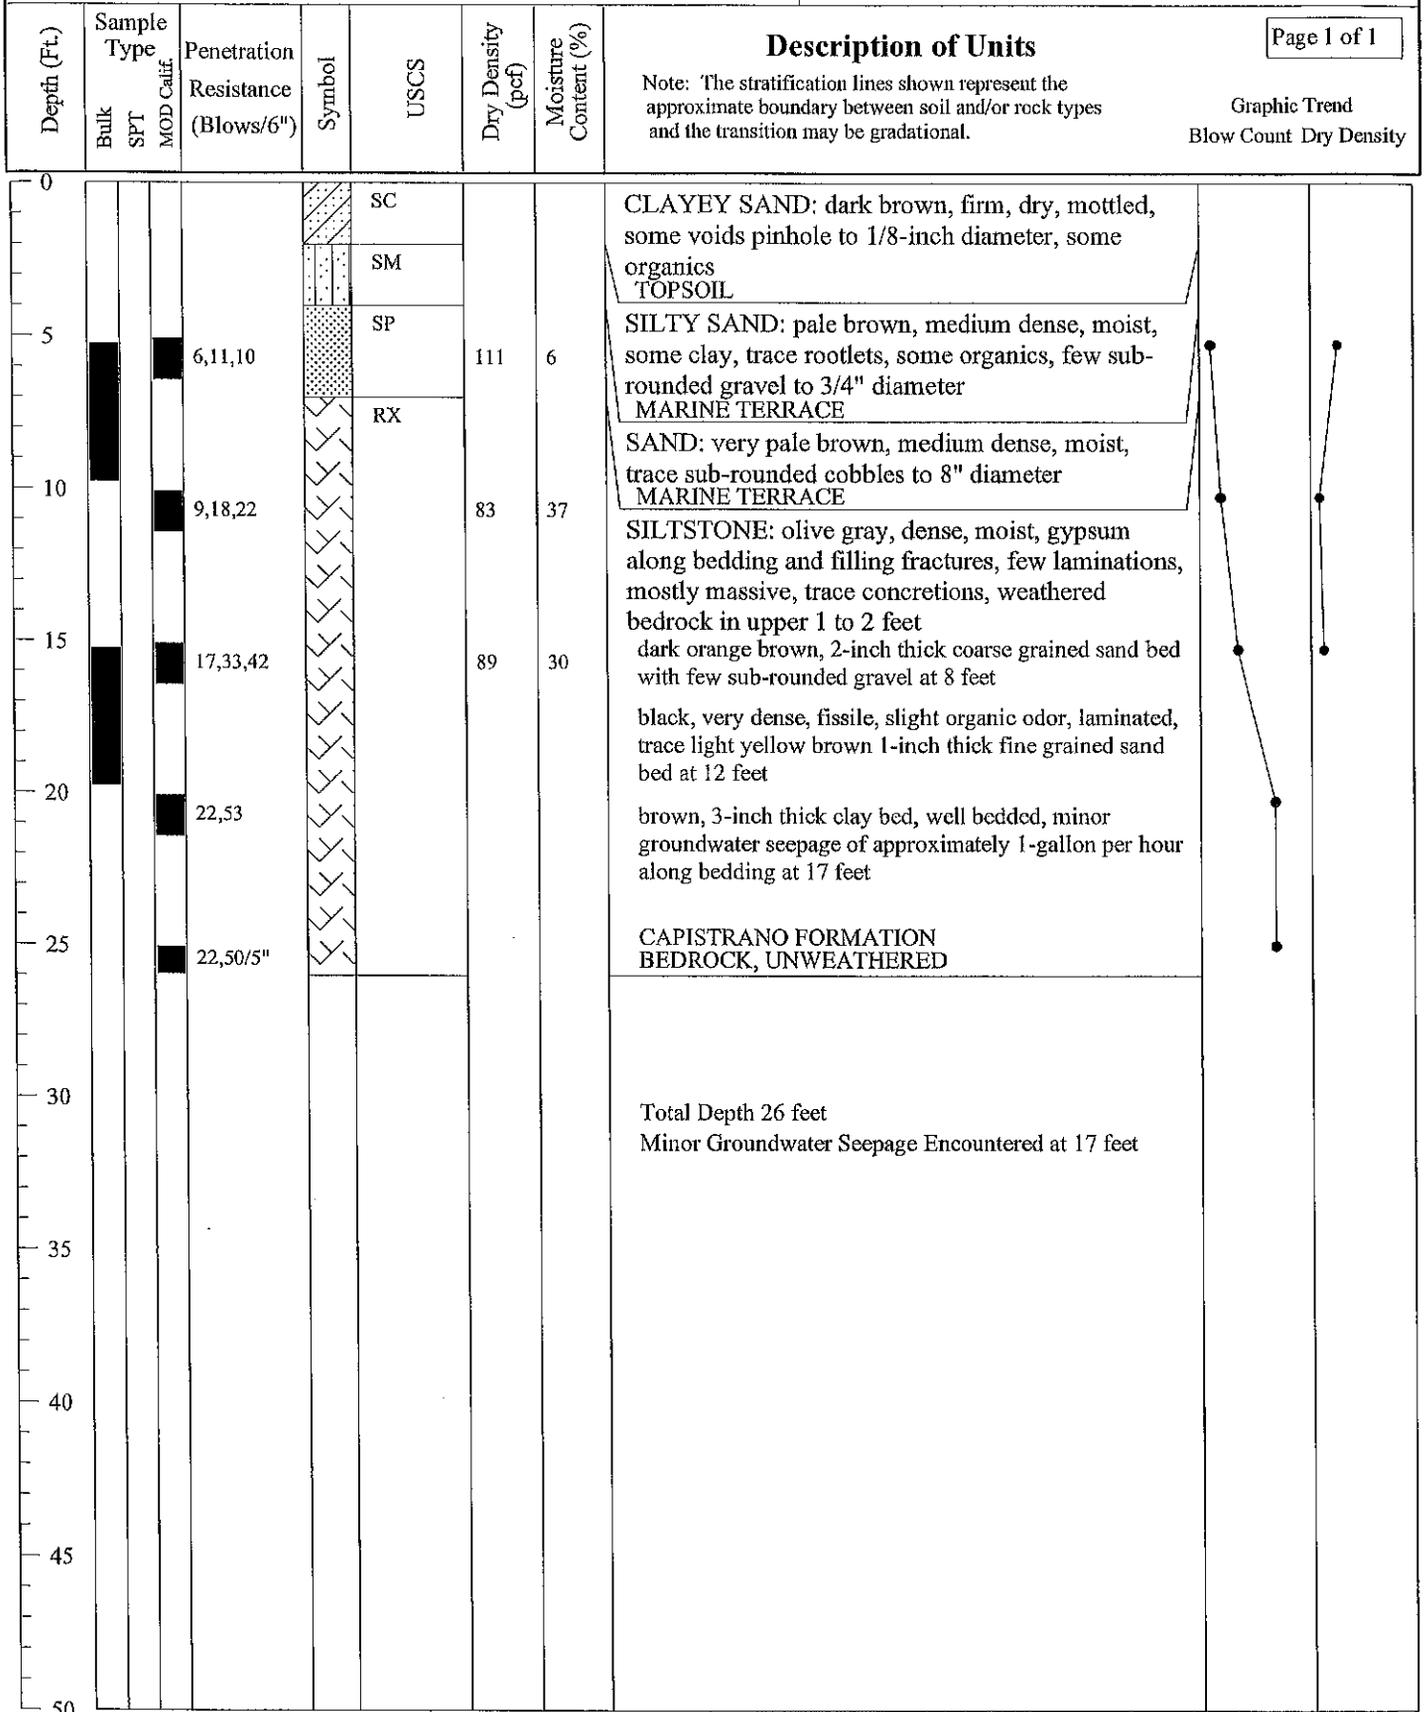
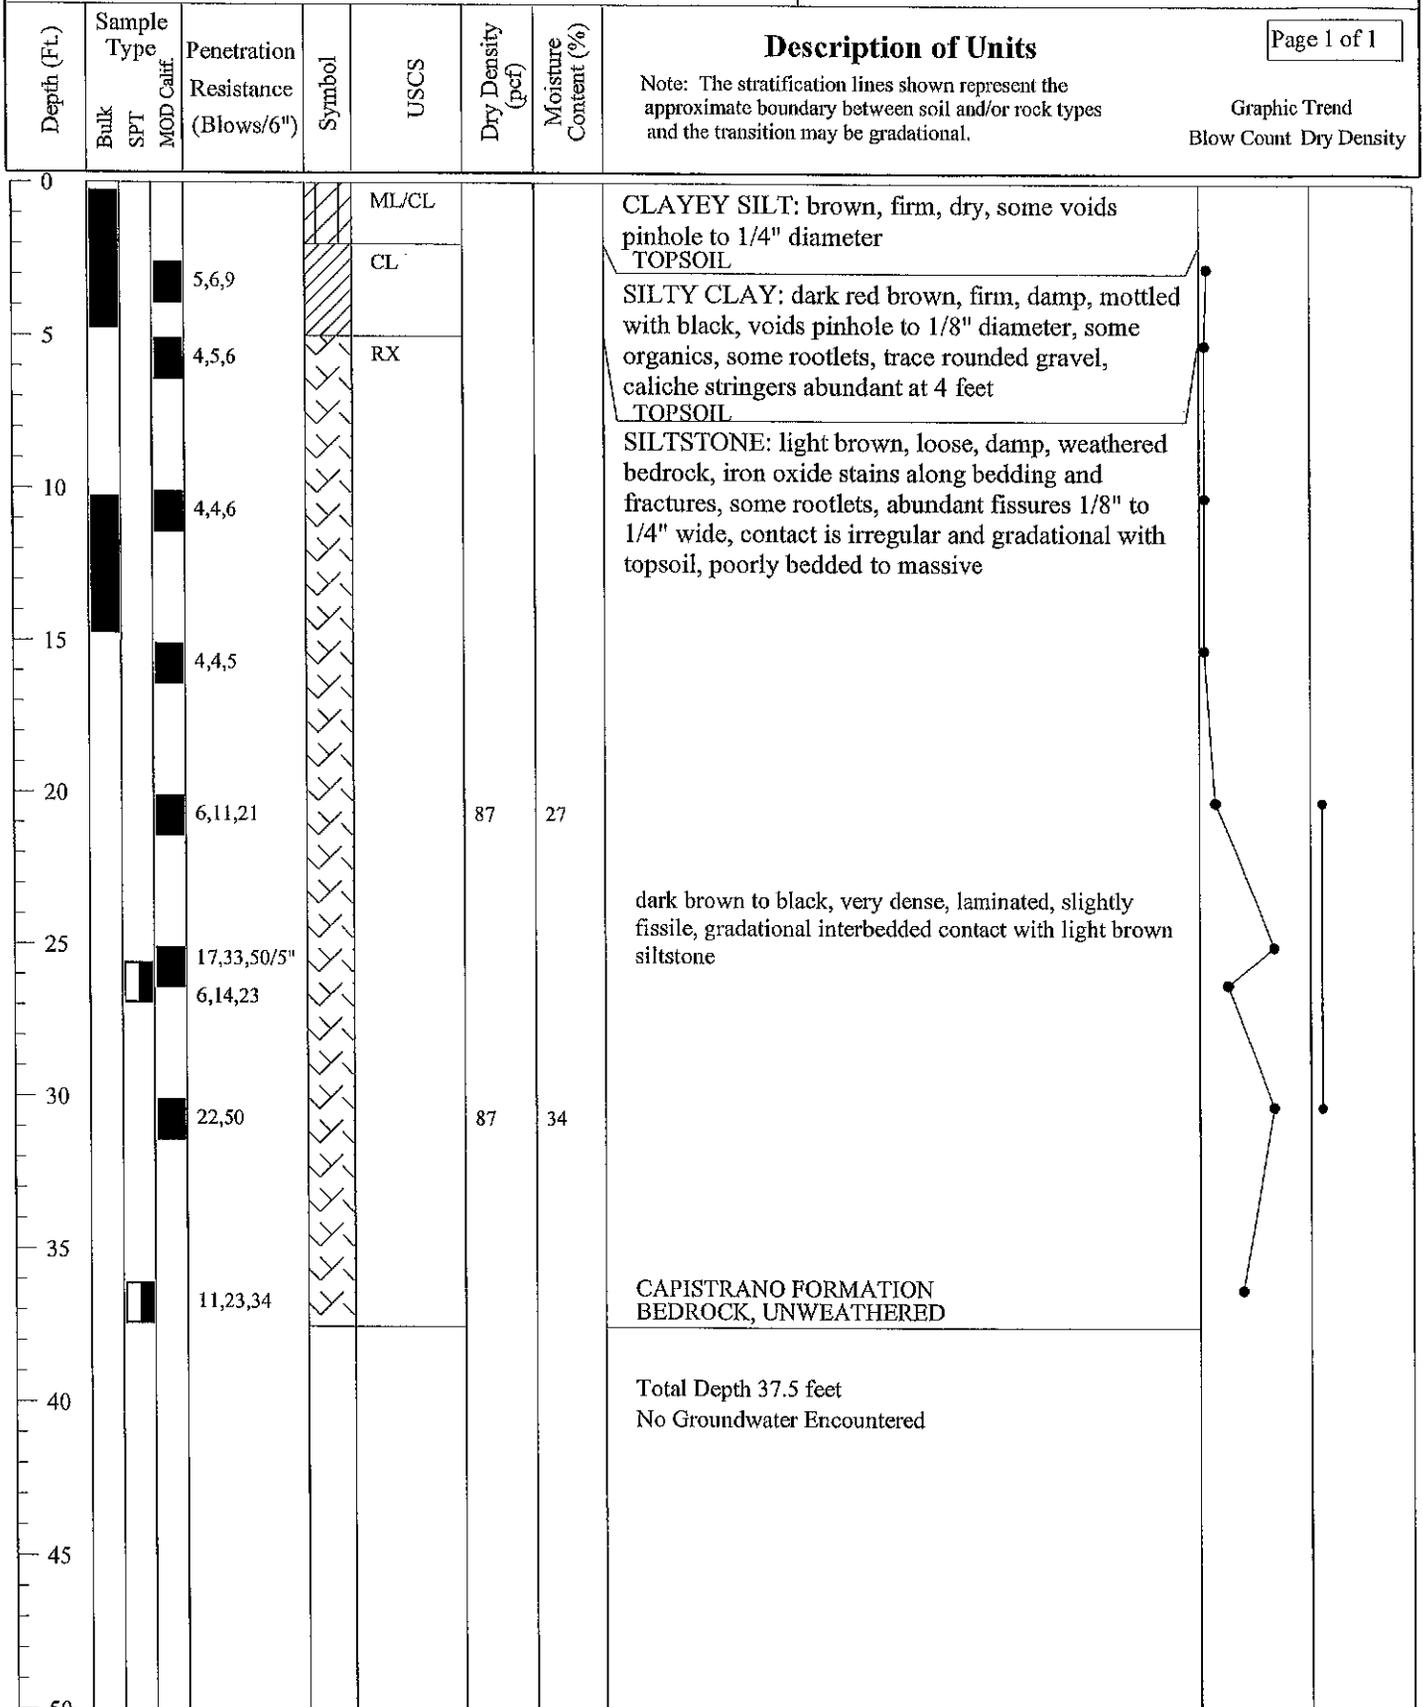
**Boring No: B-2**

Project Name: South of Via Canon & Camino Capistrano, Dana Point, CA  
File Number: 10123-02  
Boring Location: See Figure 2

Drilling Date: August 22, 2006  
Drilling Method: 24" Bucket Auger  
Drill Type: Limited Access Rope & Cathead  
Logged By: Clay Stevens

Total Depth 37.5 feet  
No Groundwater Encountered
