**GEOTECHNICAL ENGINEERING REPORT  
MULTI-FAMILY  
RESIDENTIAL DEVELOPMENT  
SOUTH OF VIA CANON AND  
CAMINO CAPISTRANO  
DANA POINT, CALIFORNIA**

Project: **Multi-Family Residential Development**  
South of Via Canon and Camino Capistrano  
Dana Point, California

Subject: **Geotechnical Engineering Report**

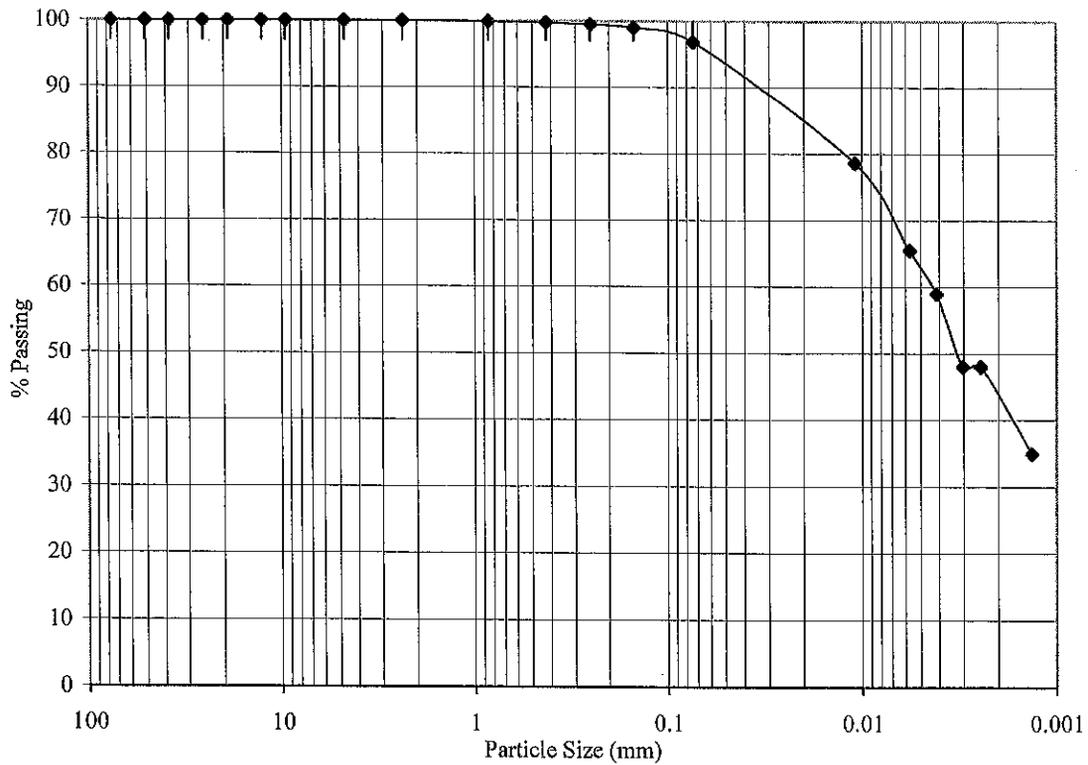
Description: Black Siltstone

Sieve Size	% Passing	By Hydrometer Method:	
		Particle Size	% Passing
3"	100	47 Micron	104
2"	100	18 Micron	87
1-1/2"	100	11 Micron	79
1"	100	6 Micron	65
3/4"	100	4 Micron	59
1/2"	100	3.0 Micron	48
3/8"	100	2.5 Micron	48
#4	100	1.3 Micron	35
#8	100		
#20	100		
#40	100		
#60	99	<b>% Gravel:</b>	<b>0</b>
#100	99	<b>% Sand:</b>	<b>3</b>
#200	97	<b>% Silt:</b>	<b>49</b>
		<b>% Clay (2 micron):</b>	<b>48</b>

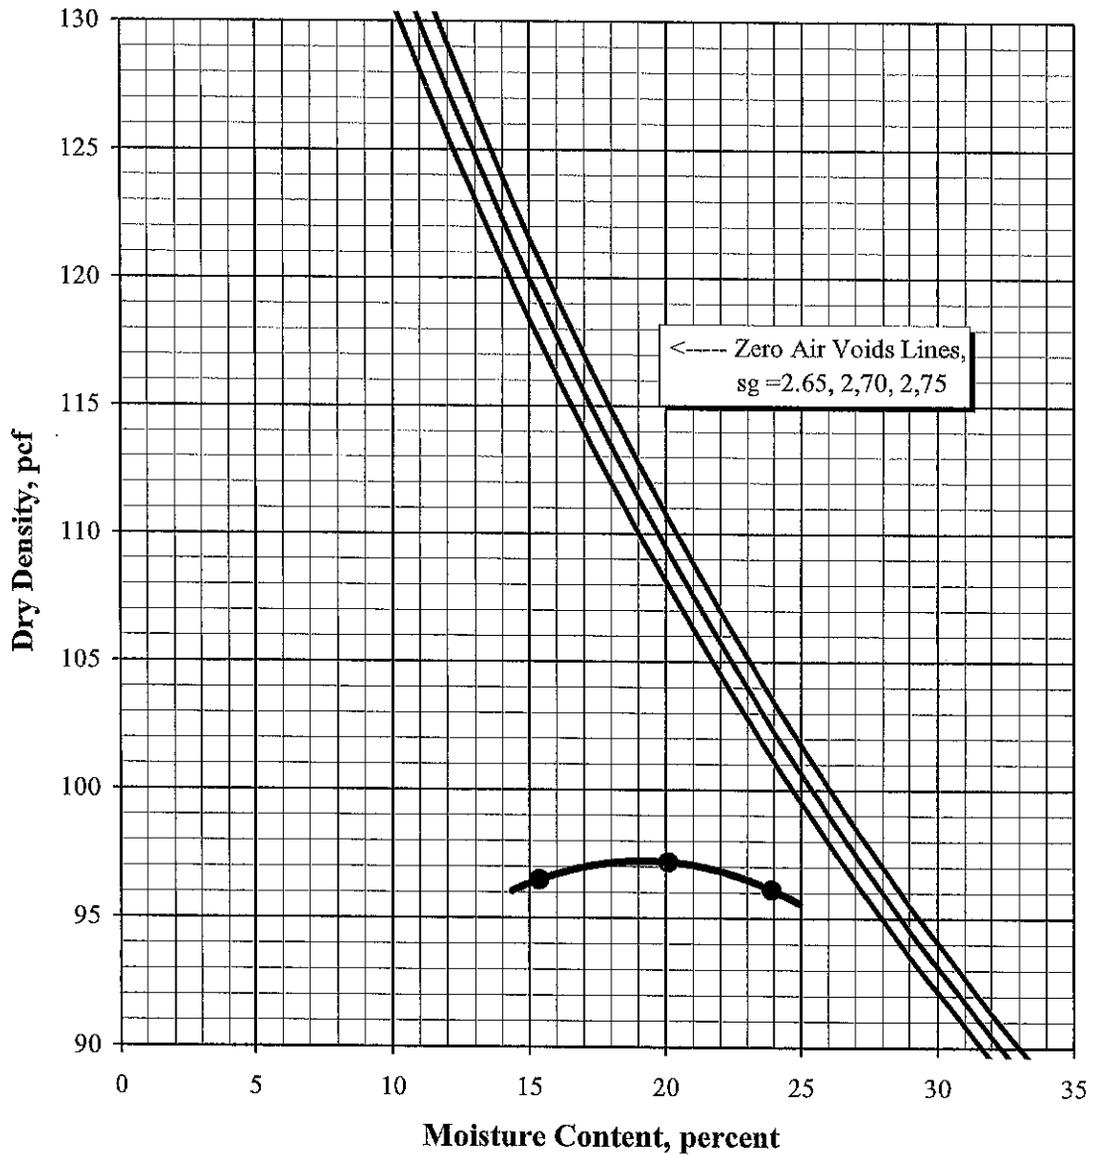
**MAXIMUM DENSITY / OPTIMUM MOISTURE**

Procedure Used: A  
 Preparation Method: Moist  
 Rammer Type: Hand

<b>Maximum Density:</b>	<b>97.5 pcf</b>	<u>Sieve Size</u>	<u>% Retained</u>
<b>Optimum Moisture:</b>	<b>18%</b>	3/4"	0.0
		3/8"	0.0
		#4	0.0

ASTM D 1557-91 (Modified)

- Maximum density tests to evaluate the moisture-density relationship of typical soils encountered.

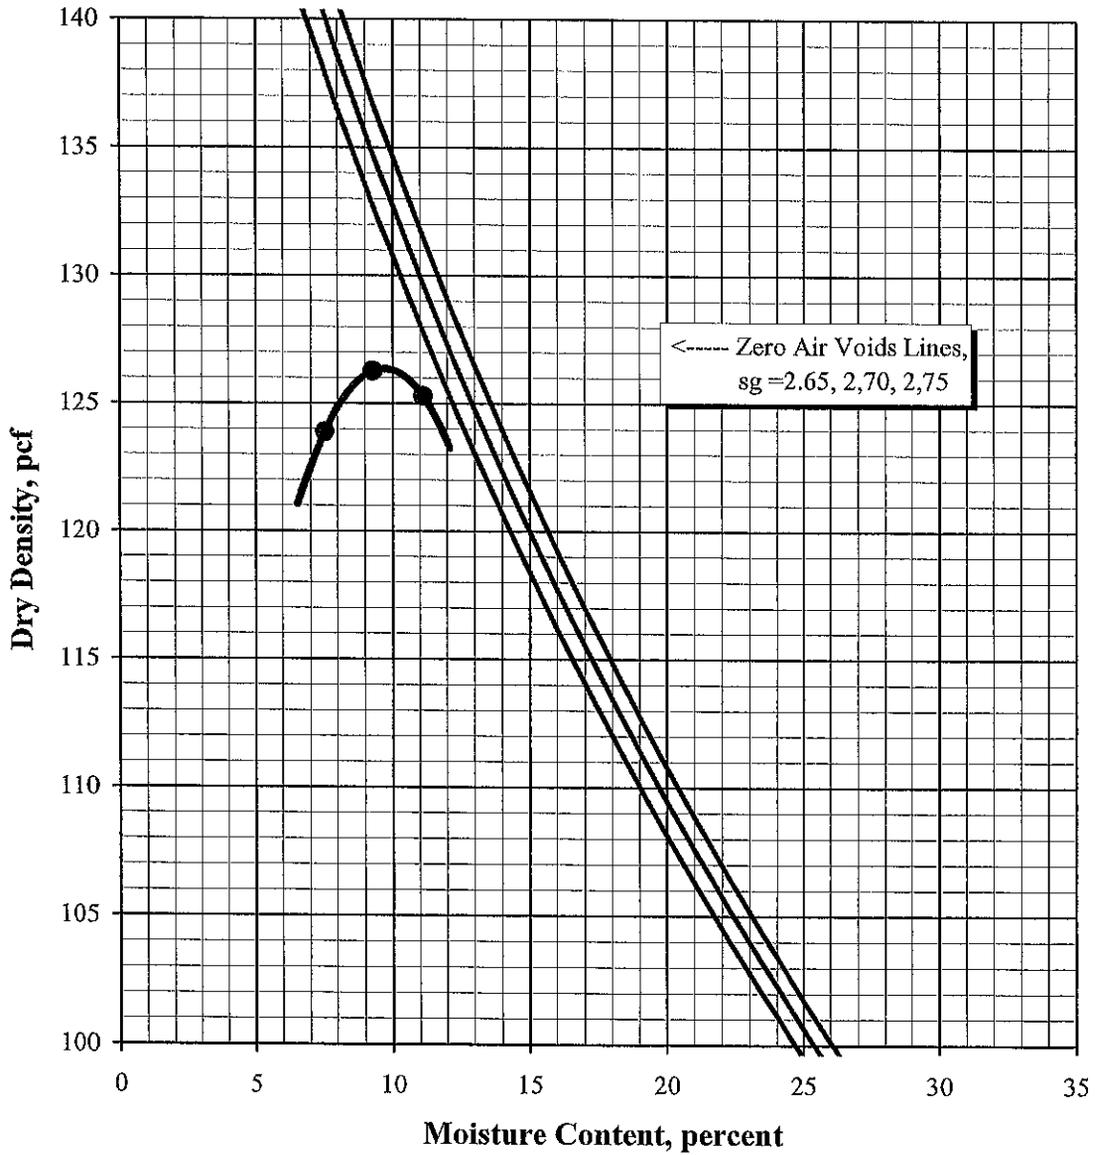
Procedure Used: A  
Preparation Method: Moist  
Rammer Type: Hand

<b>Maximum Density:</b>	<b>126 pcf</b>	<u>Sieve Size</u>	<u>% Retained</u>
<b>Optimum Moisture:</b>	<b>9%</b>	3/4"	0.0
		3/8"	0.0
		#4	0.0

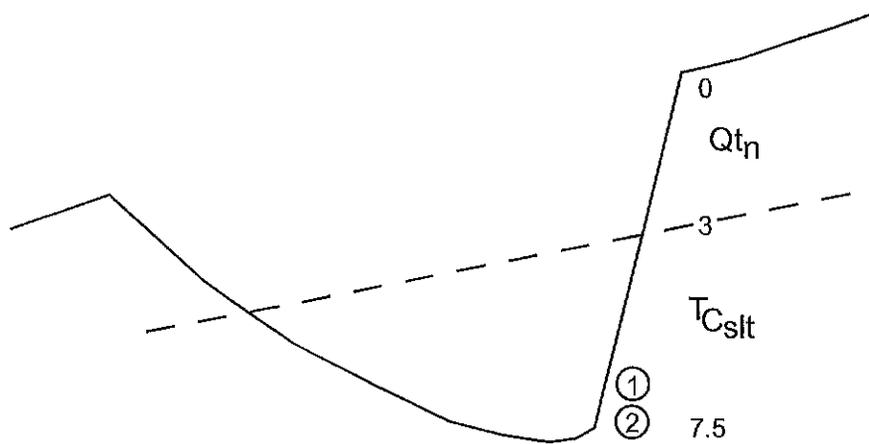
### Test Pit 1

- 0 Cobbly clayey Sand, brown to red brown, loose, moist, occasional roots
- 3 Non Marine Terrace  
Siltstone, dark gray with reddish brown parting surfaces, very dense, moist, upper 3' highly weathered (silty clay), below massive to poorly bedded
- 7.5 Capistrano Formation  
No Caving  
No Free Water
- ① N80E 20NW bedding @ 7'
- ② N78E 22NW bedding @ 7.5'

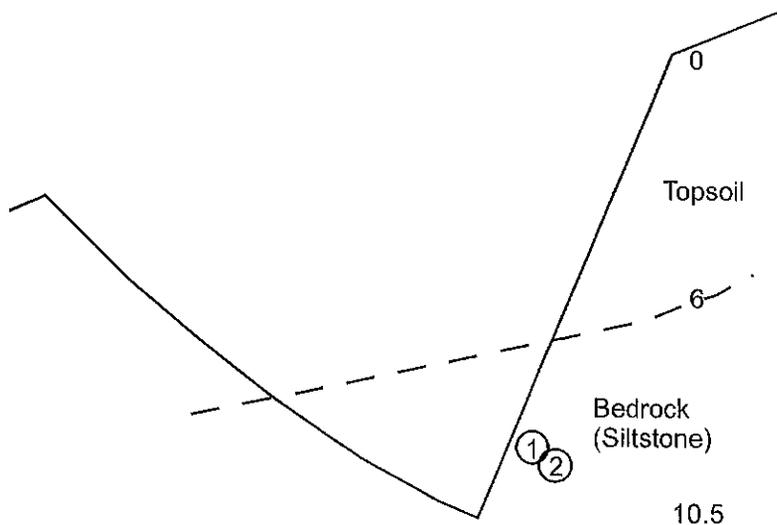
### Test Pit 2

- 0 Silty Clay, dark brown to gray brown, soft, very moist, rodent holes, creep prone
- 6 CREEP PRONE TOPSOIL  
Siltstone, dark gray, dense to very dense, moist to damp, upper 2 feet weathered below unweathered and well bedded, thin sandstone interbeds
- 10.5 Capistrano Formation  
No Caving  
No Free Water
- ① N63E 30NW bedding @ 9.5'
- ② N65E 35NW bedding @ 9.7'

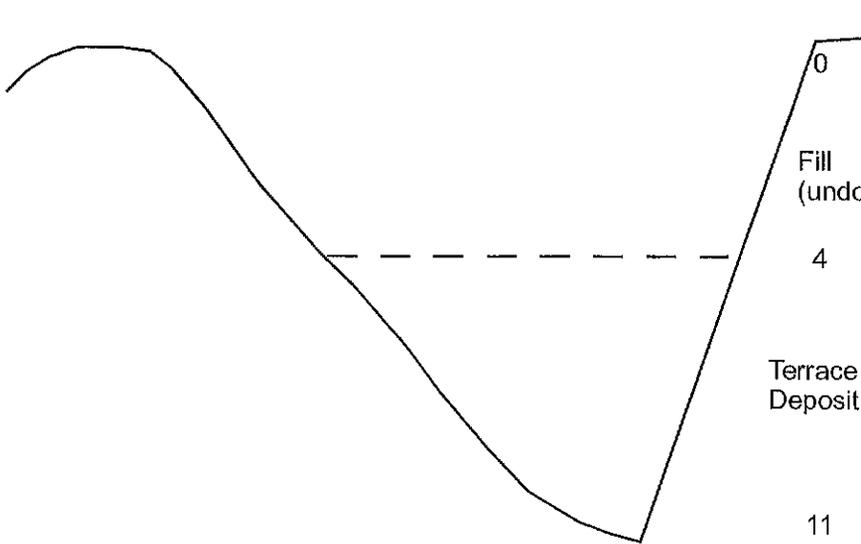
### Test Pit 3

- 0 Silty fine Sand to fine sandy Silt, loose, moist, clasts of clay, scattered asphalt and concrete
- 4 Fill (undocumented) Silty fine Sand, brown, medium dense, moist, uniform
- 11 Terrace

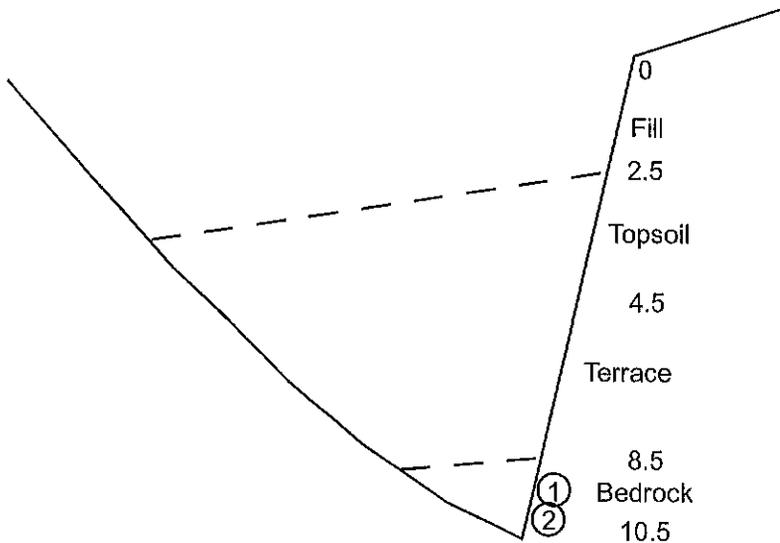
### Test Pit 4

- 0 Silty Clay, mottled brown to red brown, soft, very moist
- 2.5 Silty Clay grading to Clayey Sand with depth, dark, black grading to light brown, loose, moist, abundant rodent holes
- 8.5 Topsoil/Terrace Undifferentiated Siltstone (clayey), dark gray to red brown along bedding surfaces, very dense, moist, unweathered
- 10.5 Capistrano Formation
  - ① N83W 20NE bedding @ 9.5'
  - ② E-W 25N bedding @ 10'

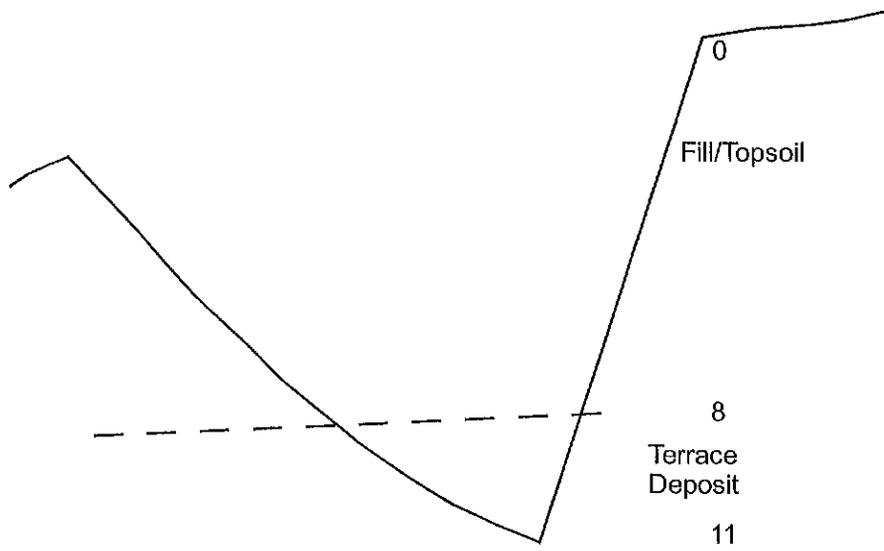
**Test Pit 5**

- 0 Fill/Topsoil, Sandy Clay to Silty Clay, mottled brown to light brown, soft, very moist, abundant rodent holes
- 8 Fill/Topsoil (undifferentiated) Silty fine Sand to fine Sandy Silt, light brown, medium dense, moist, uniform
- 11 Terrace

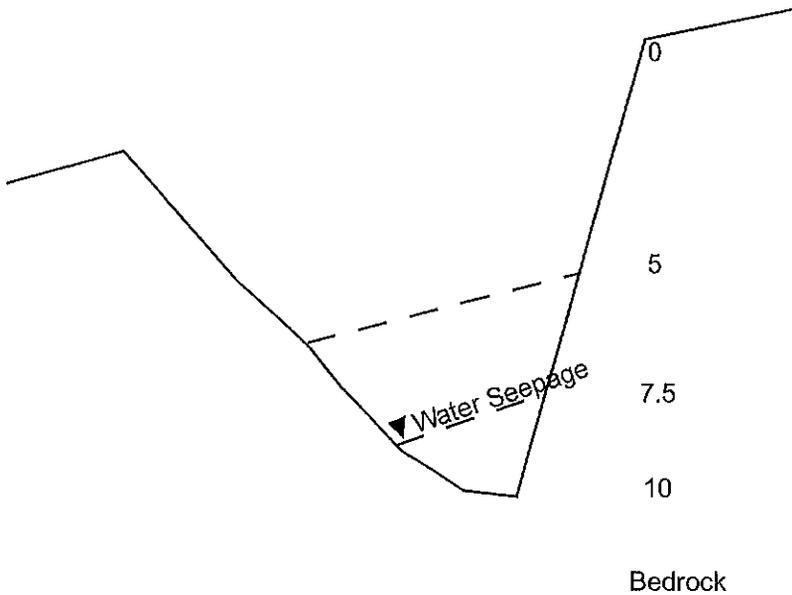
**Test Pit 6**

- 0 Sandy Clay, black, soft, moist, scattered roots
- 5 Topsoil Sand, medium dense, wet, fine to medium grained, scattered well-rounded gravel to cobble size clasts, caving
- 7.5 Terrace Siltstone, dark gray to red brown along bedding and joint surfaces, very dense, moist, poorly bedded
- 10 Capistrano Formation

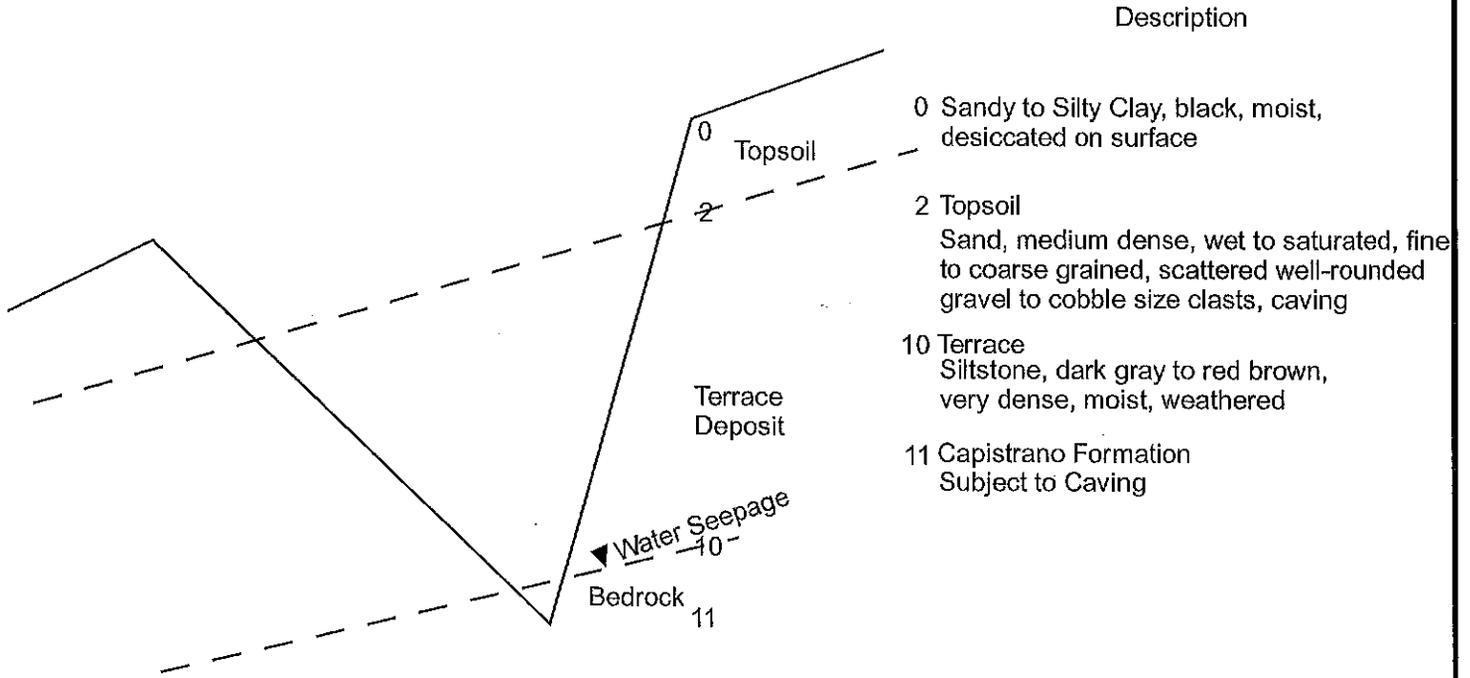
# Test Pit 7

- 0 Sandy to Silty Clay, black, moist, desiccated on surface
- 2 Topsoil  
Sand, medium dense, wet to saturated, fine to coarse grained, scattered well-rounded gravel to cobble size clasts, caving
- 10 Terrace  
Siltstone, dark gray to red brown, very dense, moist, weathered
- 11 Capistrano Formation  
Subject to Caving

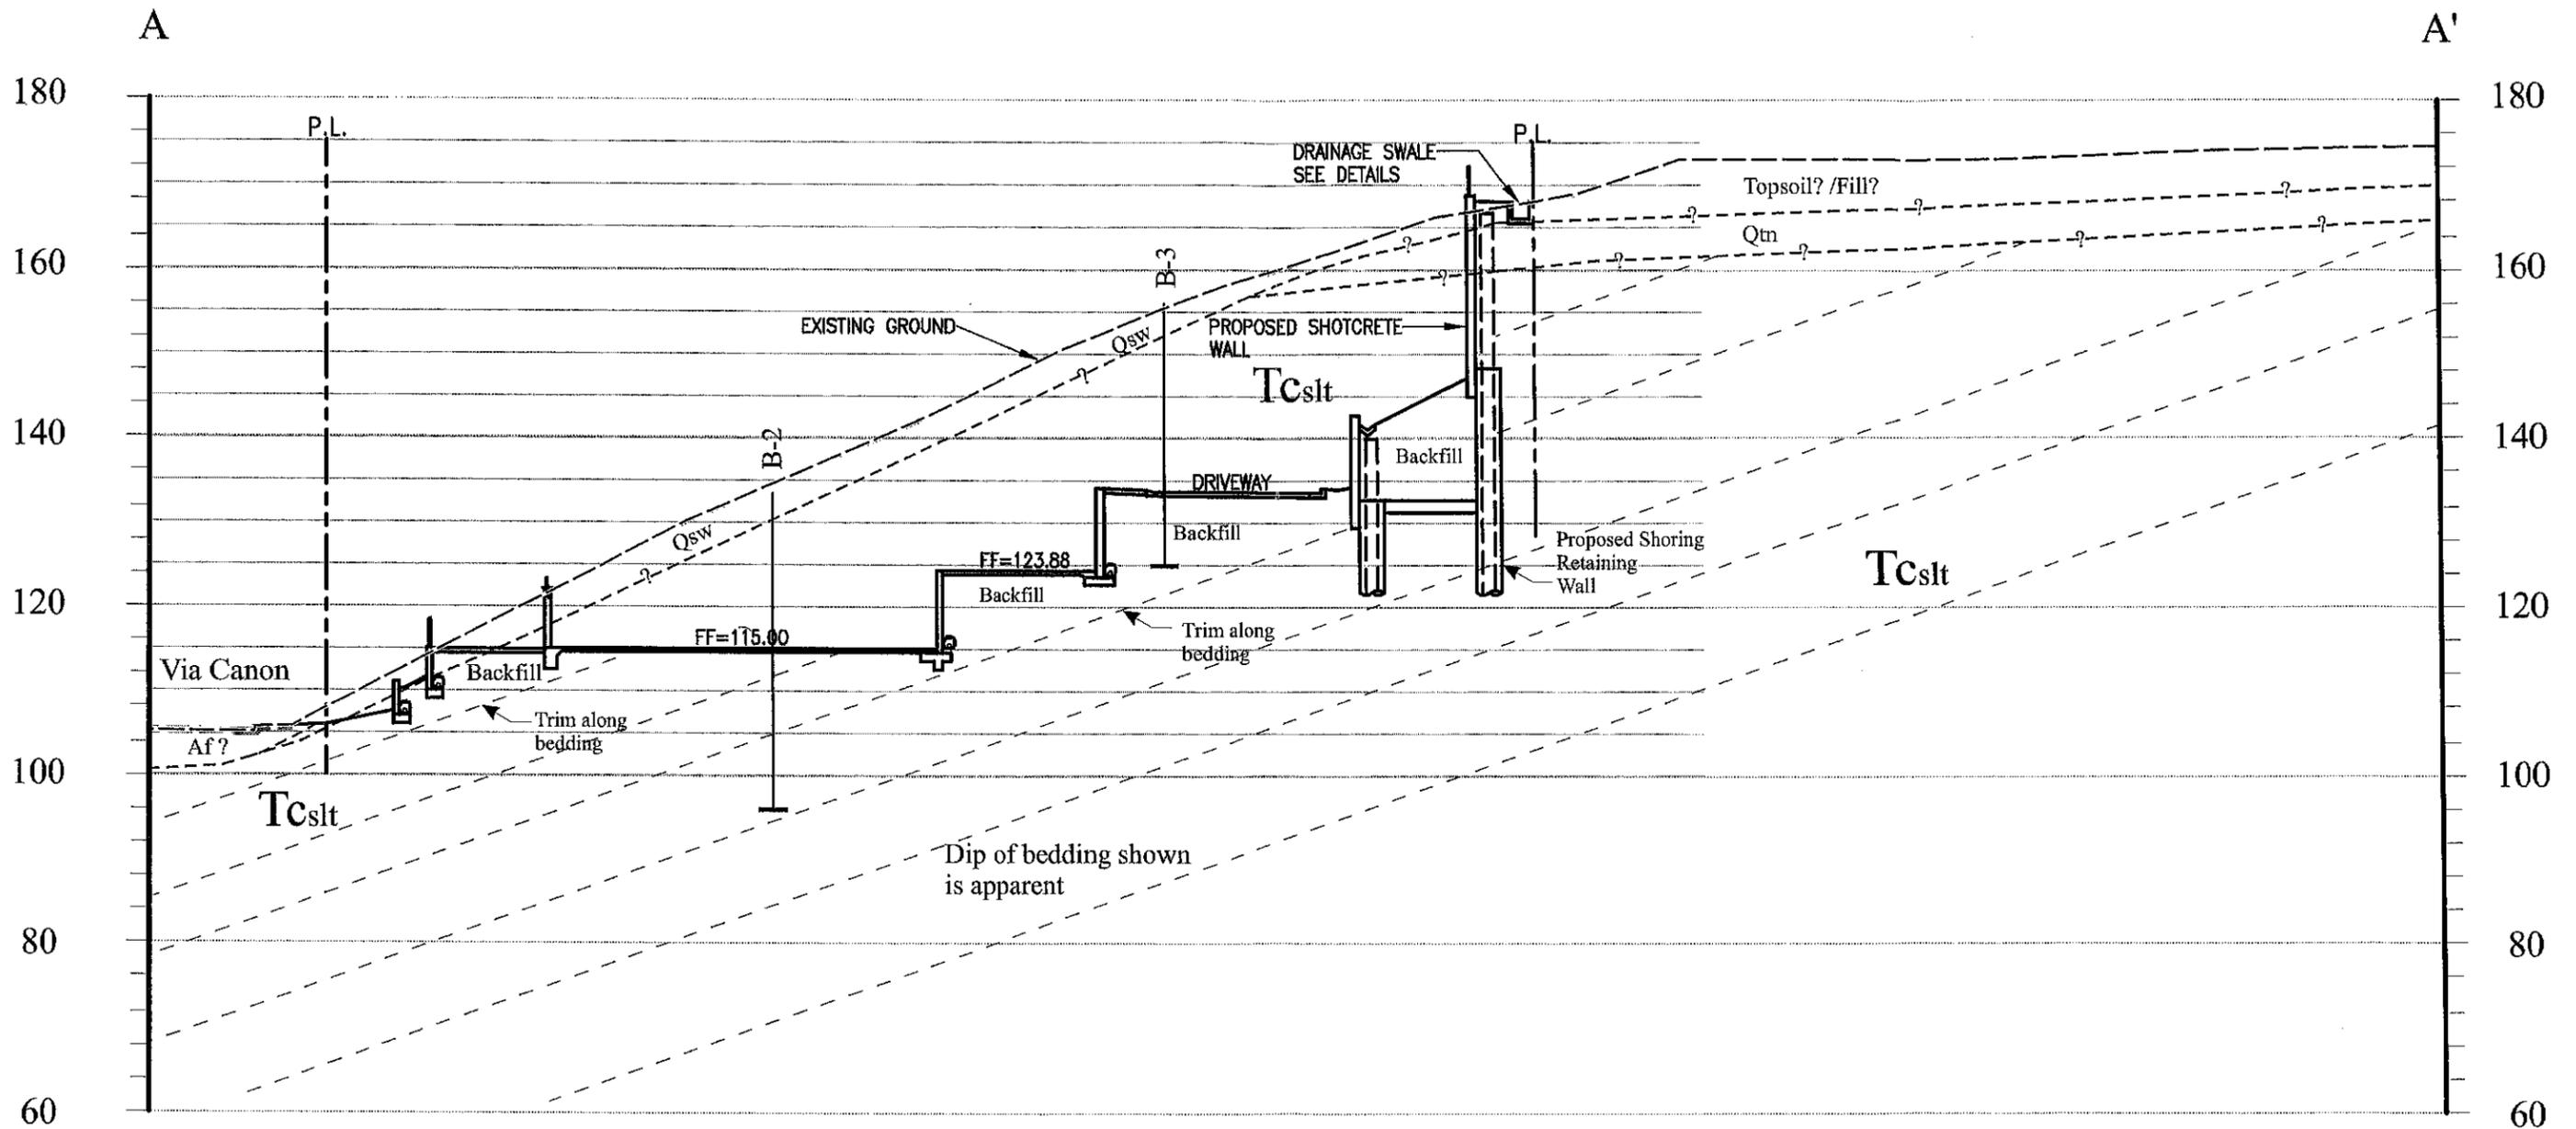
Revised Figure 3A Geologic Section A-A'	
South of Via Canon and Camino Capistrano Dana Point, California	
05/23/08	10123-02

HORIZONTAL = VERTICAL  
 Approximate Scale: 1" = 20'

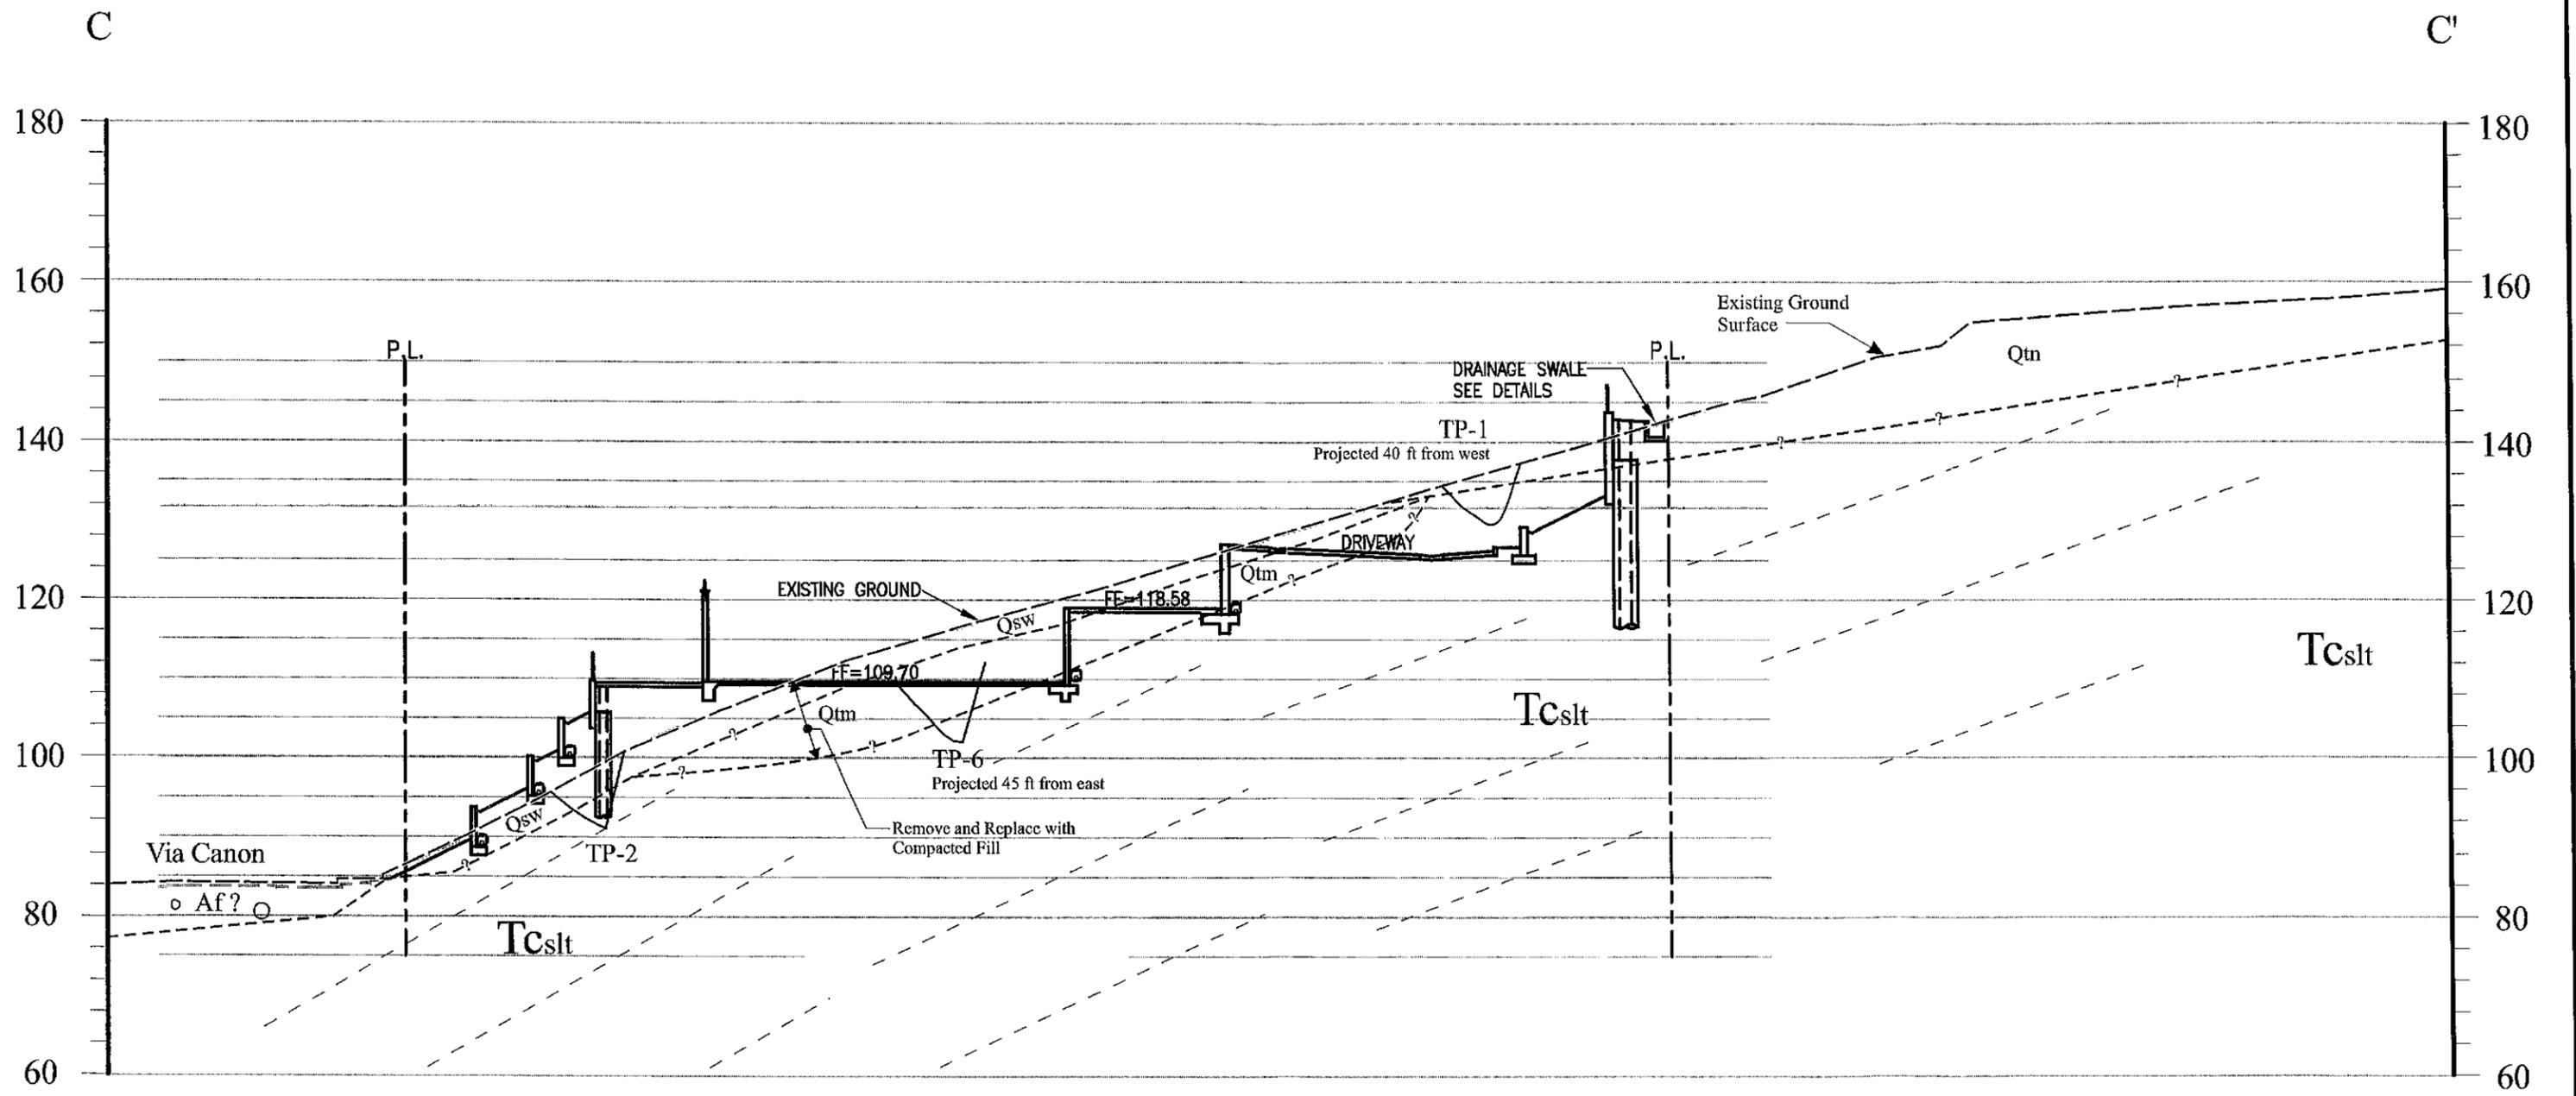
Revised Figure 3C Geologic Section C-C'	
South of Via Canon and Camino Capistrano Dana Point, California	
05/23/08	10123-02

HORIZONTAL = VERTICAL  
 Approximate Scale: 1" = 20'

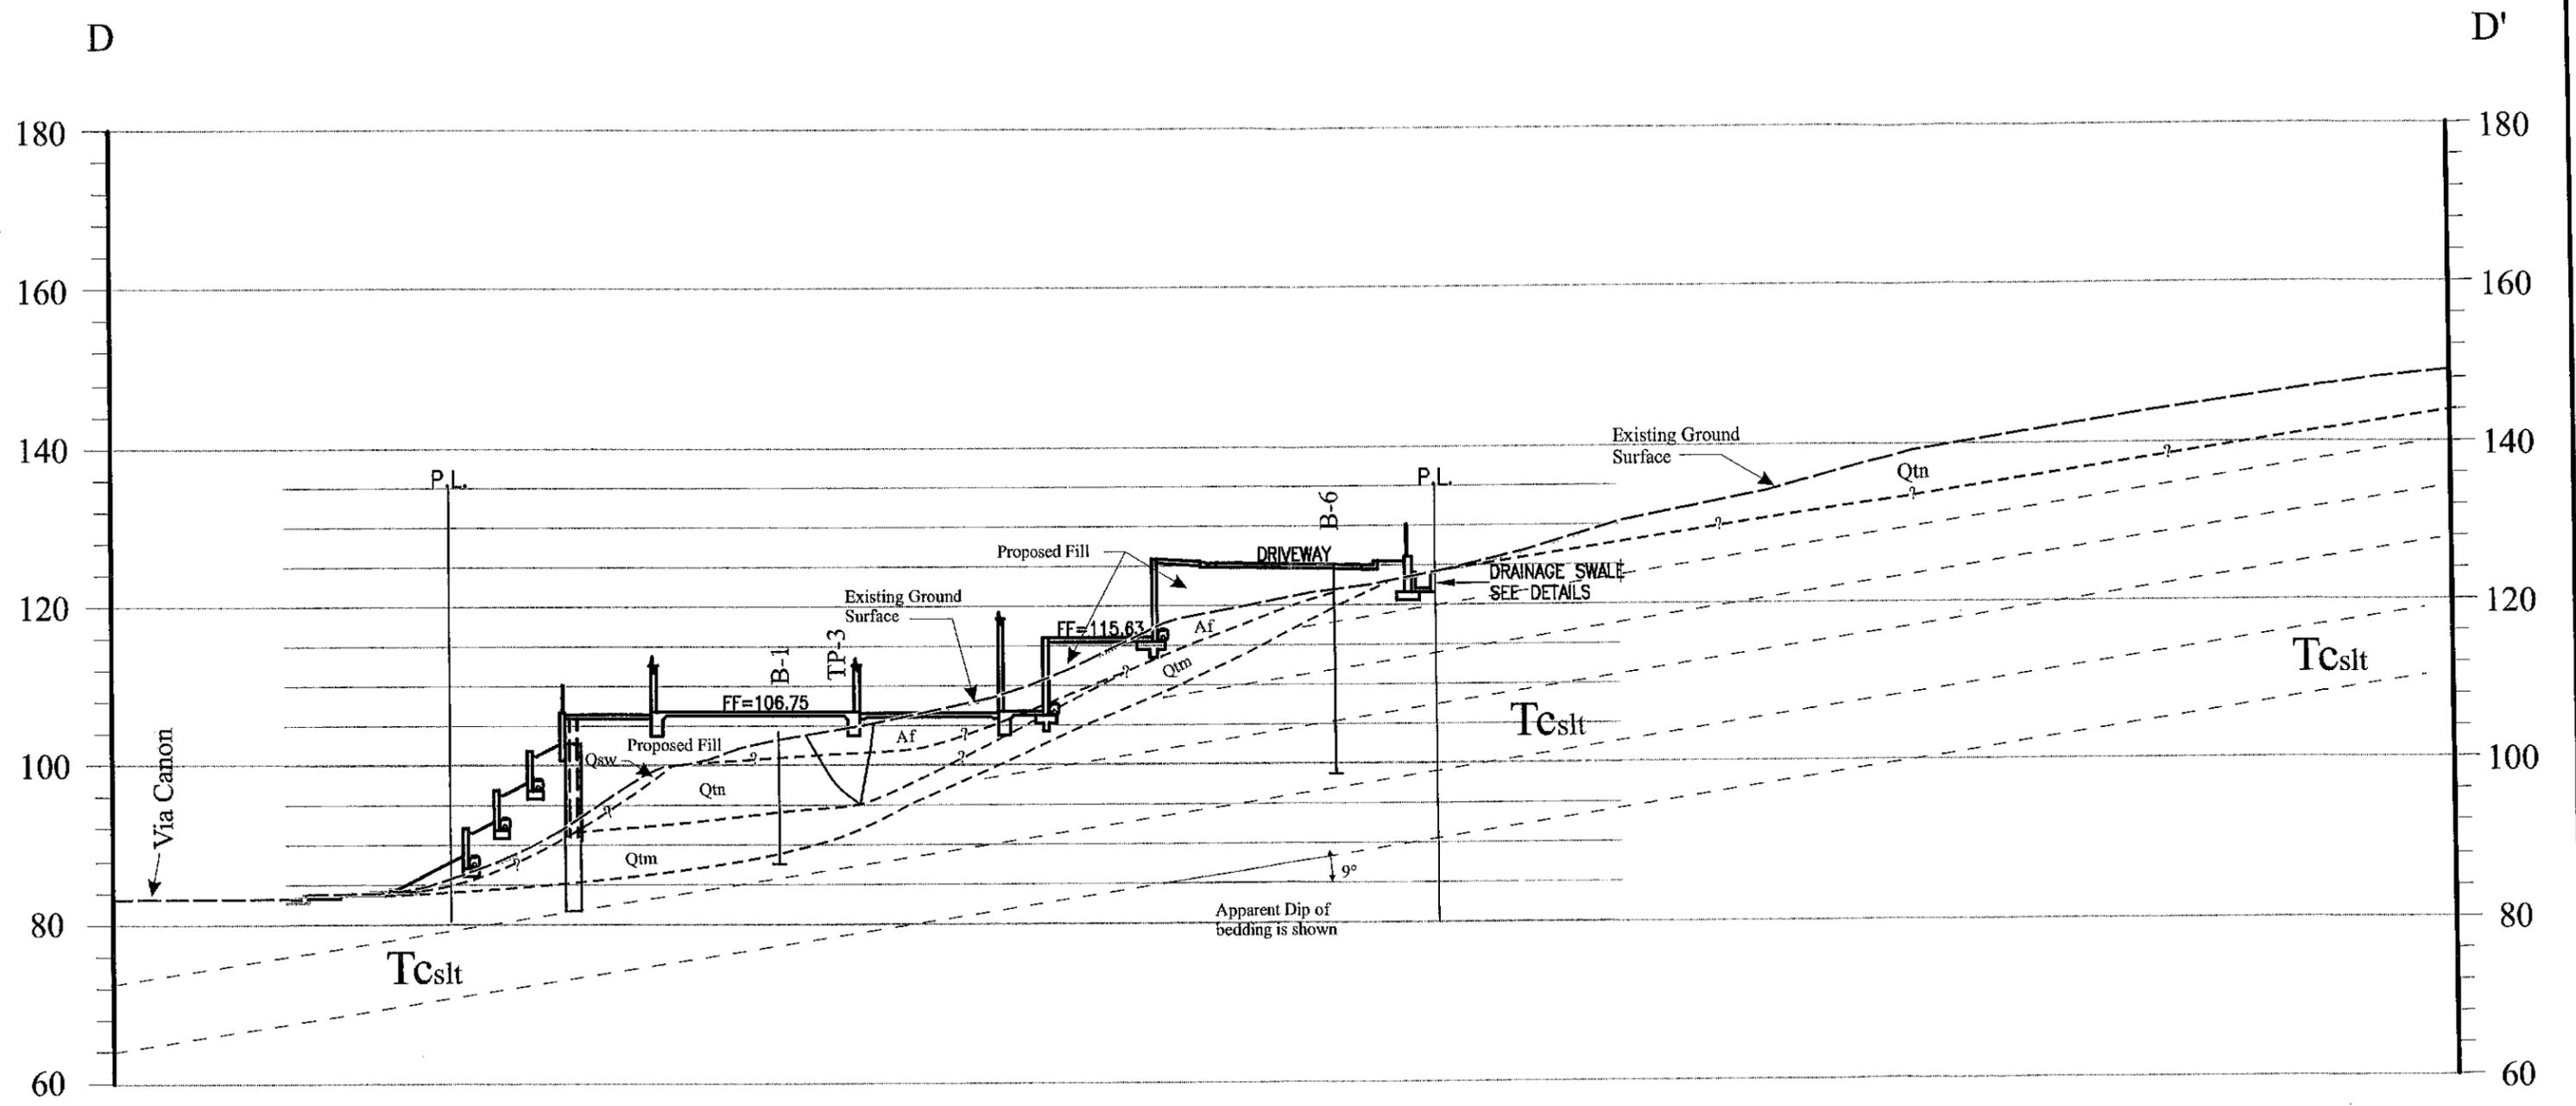
Revised Figure 3D Geologic Section D-D'	
South of Via Canon and Camino Capistrano Dana Point, California	
	<b>Earth Systems Southwest</b>
05/23/08	10123-02

HORIZONTAL = VERTICAL  
 Approximate Scale: 1" = 20'  
 0 20' 40'

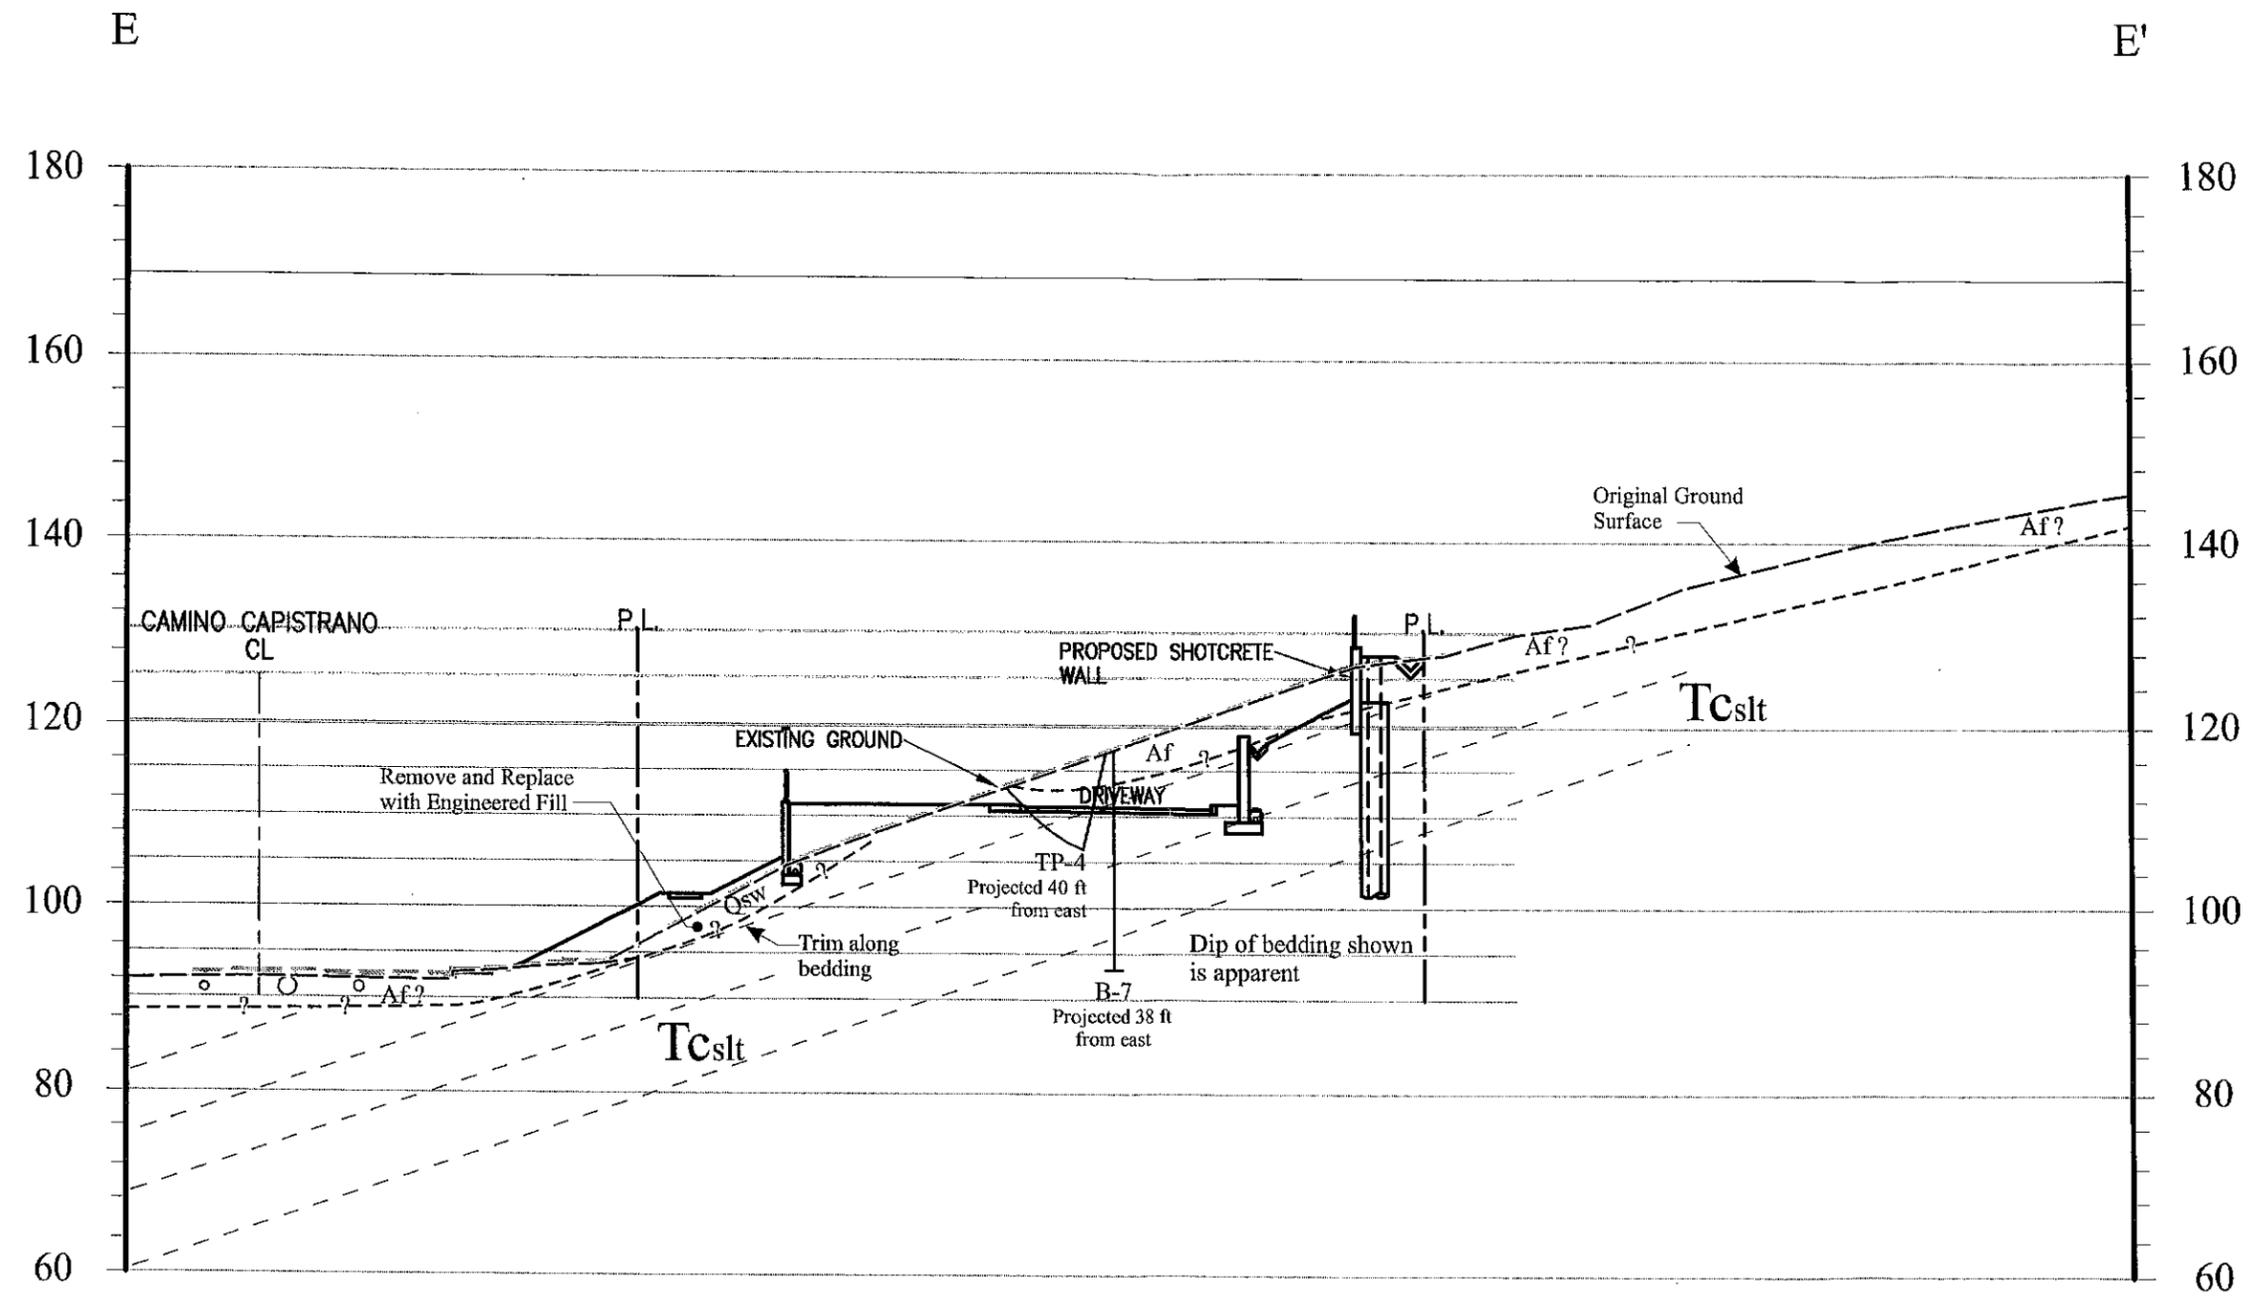
Revised Figure 3E Geologic Section E-E'	
South of Via Canon and Camino Capistrano Dana Point, California	
05/23/08	10123-02

HORIZONTAL = VERTICAL  
 Approximate Scale: 1" = 20'

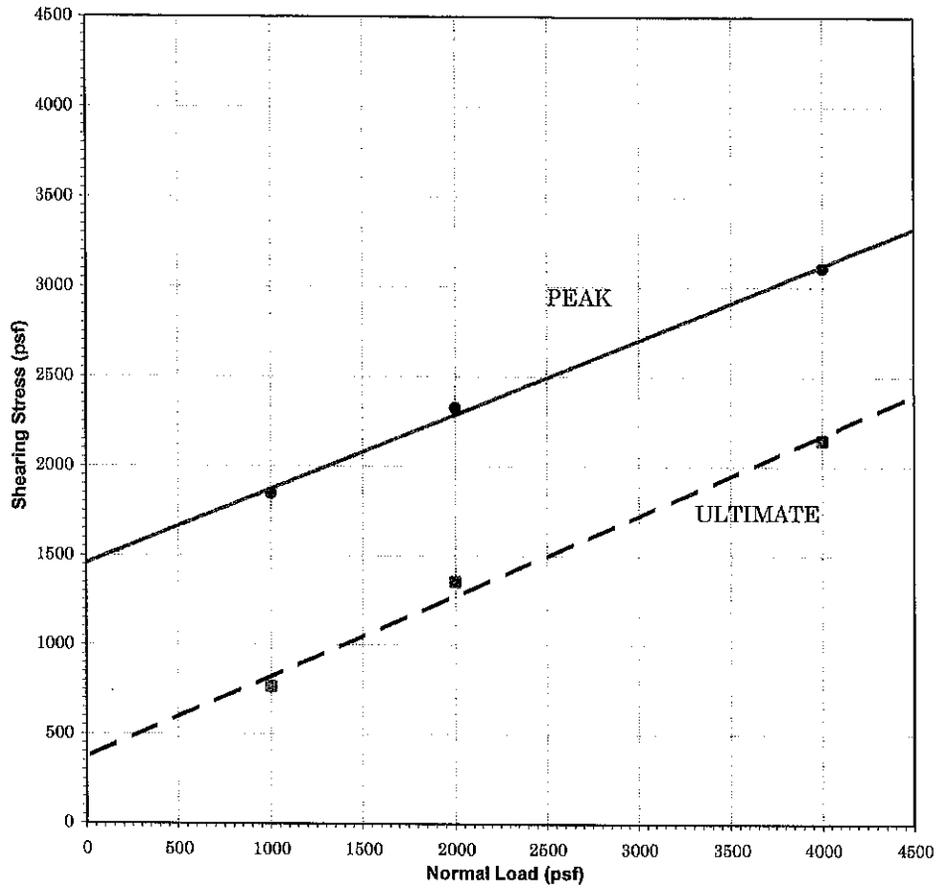
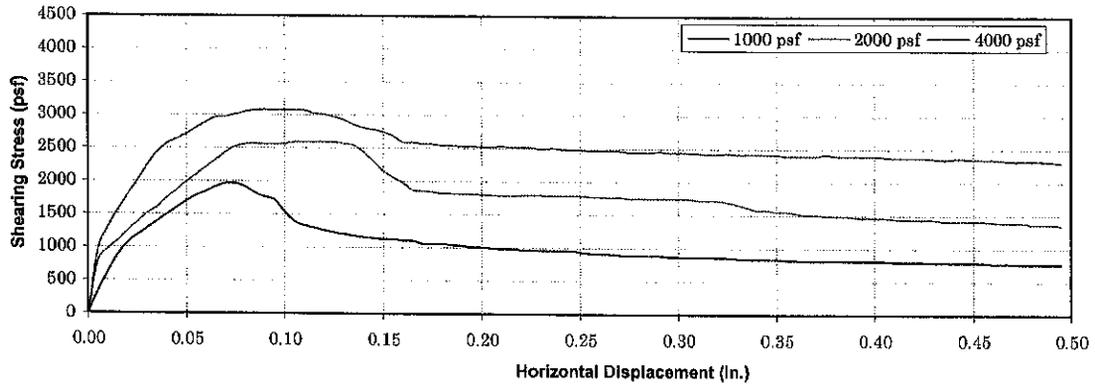
**DIRECT SHEAR DATA\***

Sample Location: B2 at 20 feet  
 Material: Claystone Bedrock  
 Dry Density (pcf): 81.8

- Direct Shear to evaluate the relative frictional strength of the soils. In-situ and remolded specimens were placed in contact with water before testing and were then sheared under normal loads ranging from 0.5 to 2.0 kips per square foot.
- Expansion index tests to evaluate the expansive nature of the soil. The samples were surcharged under 144 pounds per square foot at moisture content of near 50% saturation. Samples were then submerged in water for 24 hours and the amount of expansion was recorded with a dial indicator.
- Liquid and Plastic Limits tests to evaluate the plasticity and expansive nature of clayey soils.
- Chemical Analyses (Soluble Sulfates and Chlorides, pH, and Electrical Resistivity) to evaluate the potential adverse effects of the soil on concrete and steel.

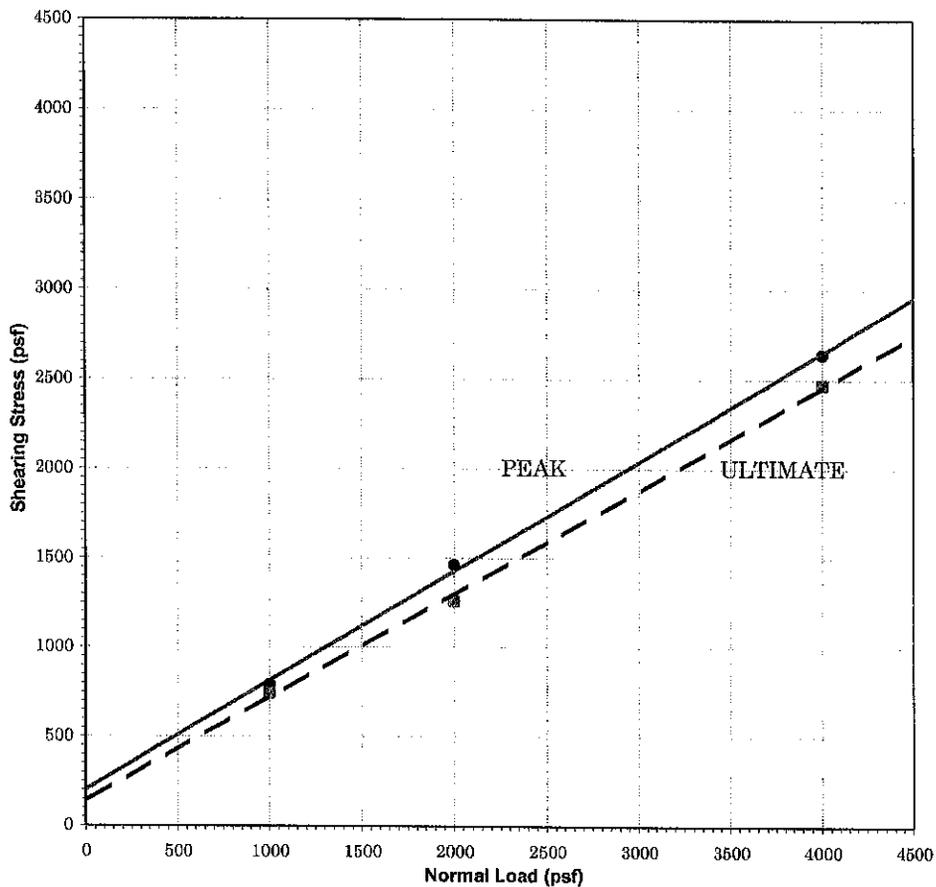
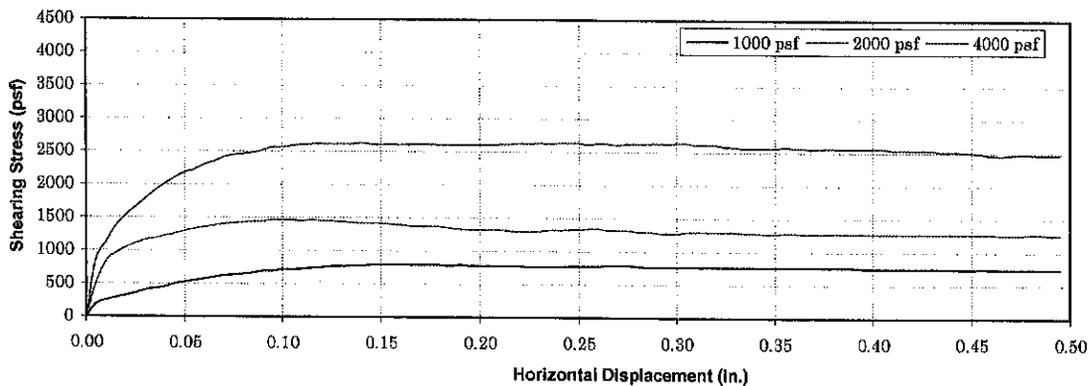
**DIRECT SHEAR DATA\***

Sample Location: B4 at 15 feet  
 Material: Sandy Silt (ML)  
 Dry Density (pcf): 103.1
