**GEOTECHNICAL ENGINEERING REPORT  
MULTI-FAMILY  
RESIDENTIAL DEVELOPMENT  
SOUTH OF VIA CANON AND  
CAMINO CAPISTRANO  
DANA POINT, CALIFORNIA**

Project: **Multi-Family Residential Development**  
South of Via Canon and Camino Capistrano  
Dana Point, California

Subject: **Geotechnical Engineering Report**

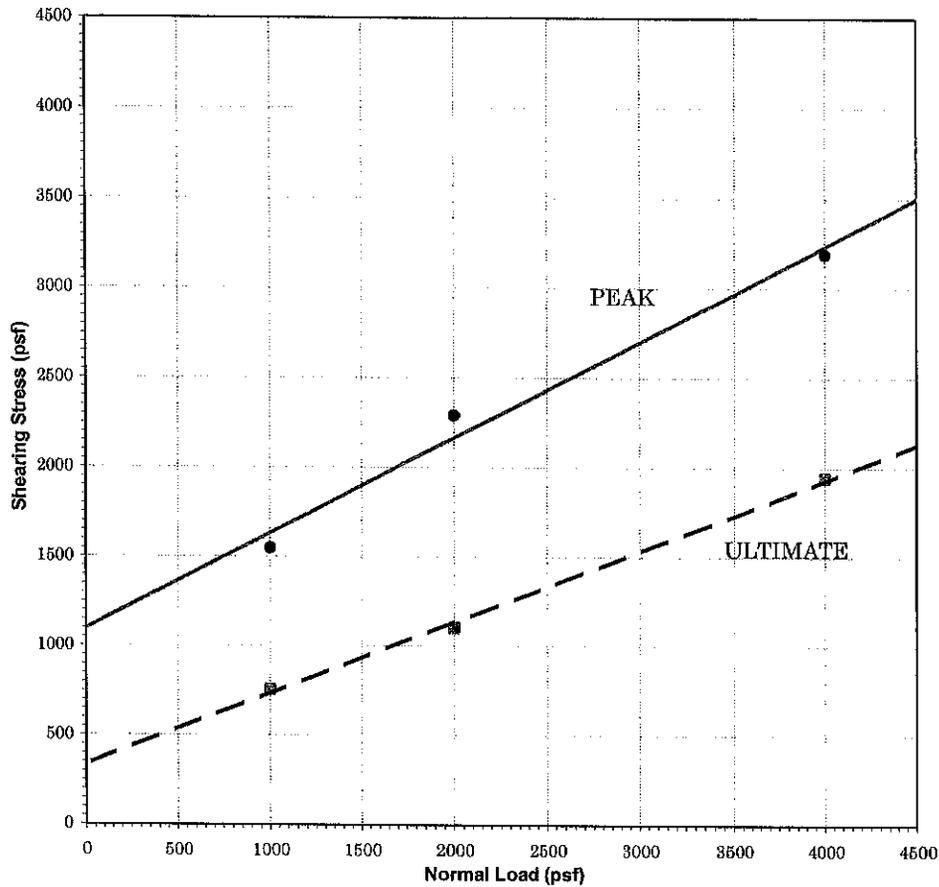
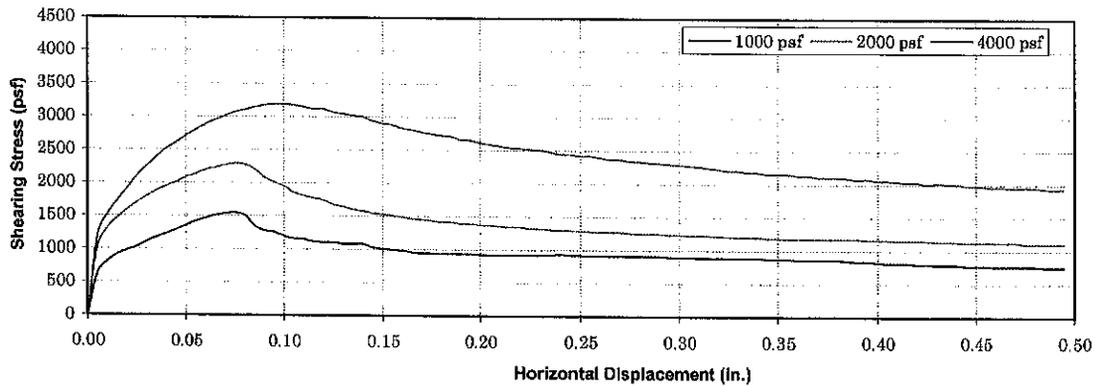
**DIRECT SHEAR DATA\***

Sample Location: B6 at 10 feet  
 Material: Claystone/Siltstone Bedrock  
 Dry Density (pcf): 93.2

- Direct Shear to evaluate the relative frictional strength of the soils. In-situ and remolded specimens were placed in contact with water before testing and were then sheared under normal loads ranging from 0.5 to 2.0 kips per square foot.
- Expansion index tests to evaluate the expansive nature of the soil. The samples were surcharged under 144 pounds per square foot at moisture content of near 50% saturation. Samples were then submerged in water for 24 hours and the amount of expansion was recorded with a dial indicator.
- Liquid and Plastic Limits tests to evaluate the plasticity and expansive nature of clayey soils.
- Chemical Analyses (Soluble Sulfates and Chlorides, pH, and Electrical Resistivity) to evaluate the potential adverse effects of the soil on concrete and steel.

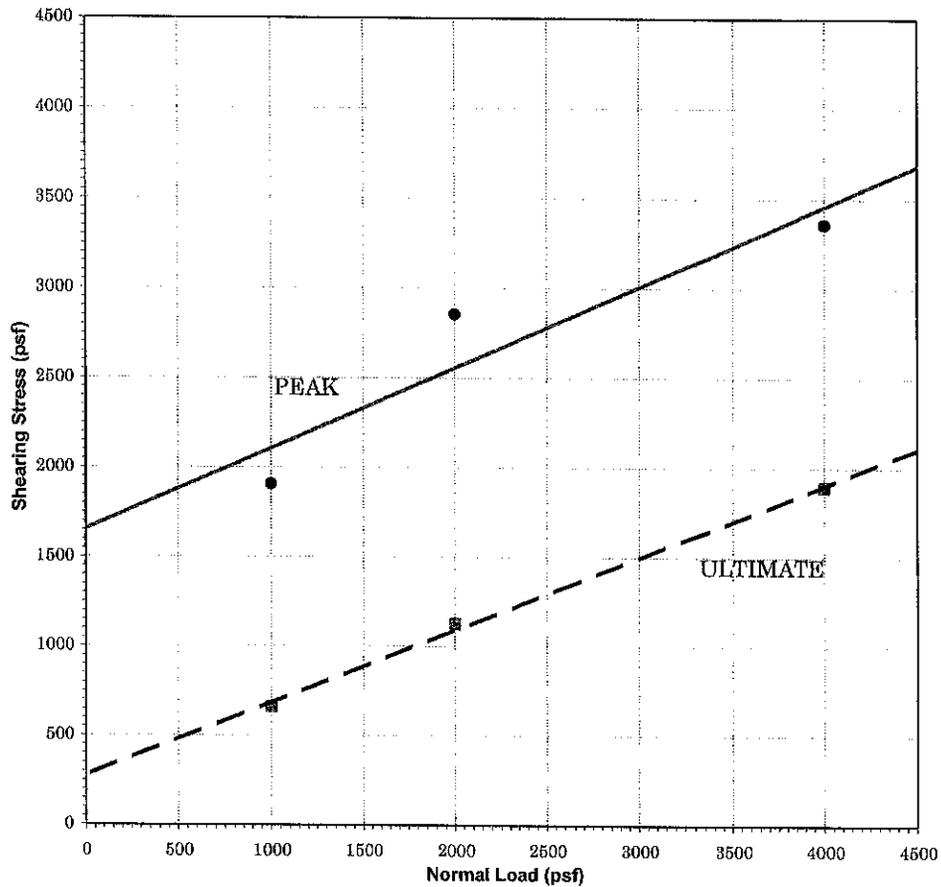
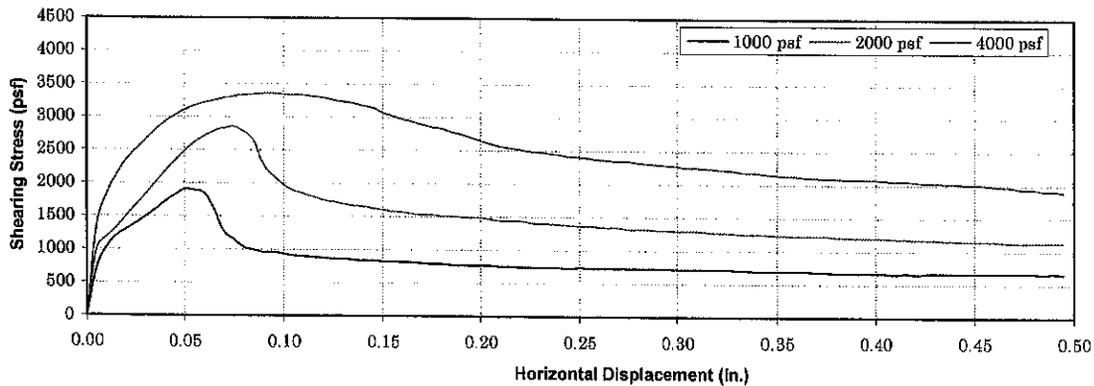
**DIRECT SHEAR DATA\***

Sample Location: B6 at 20 feet  
 Material: Claystone/Siltstone Bedrock  
 Dry Density (pcf): 85.8

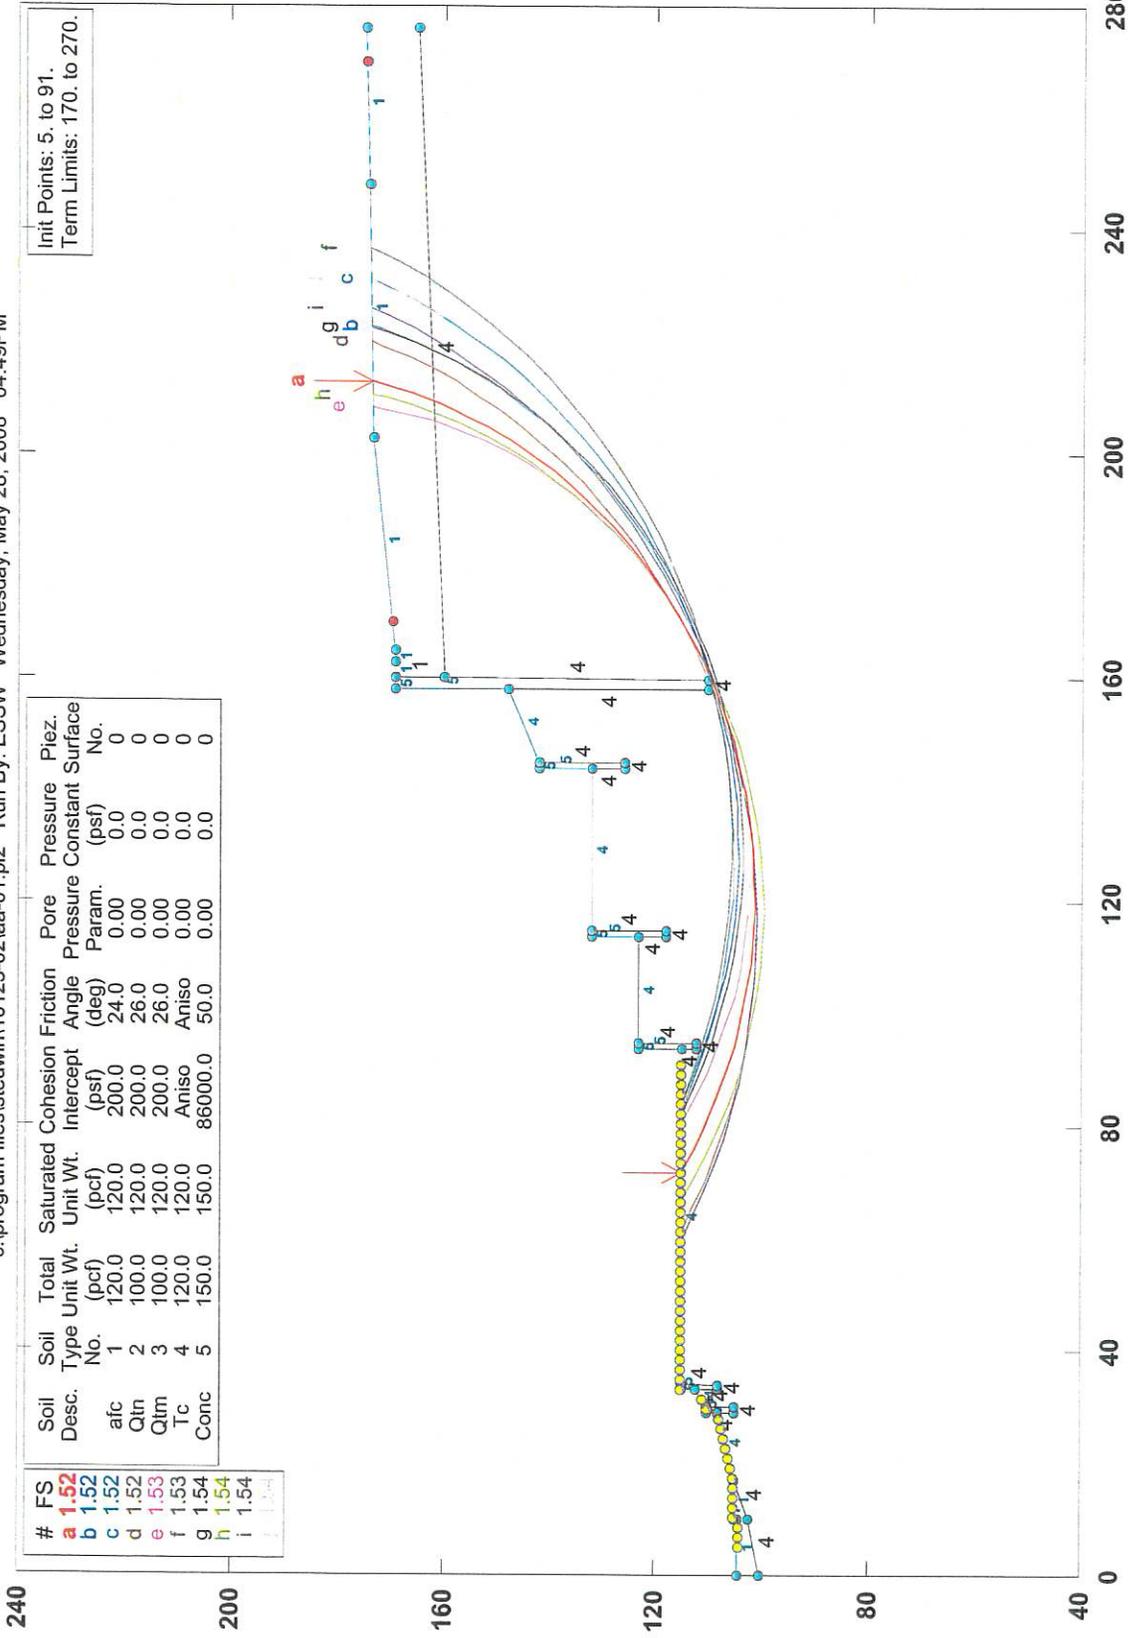
# 10123-02; Via Canon, Proposed Section AA'; Static

STABL6H FSmin=1.52  
Safety Factors Are Calculated By The Modified Bishop Method

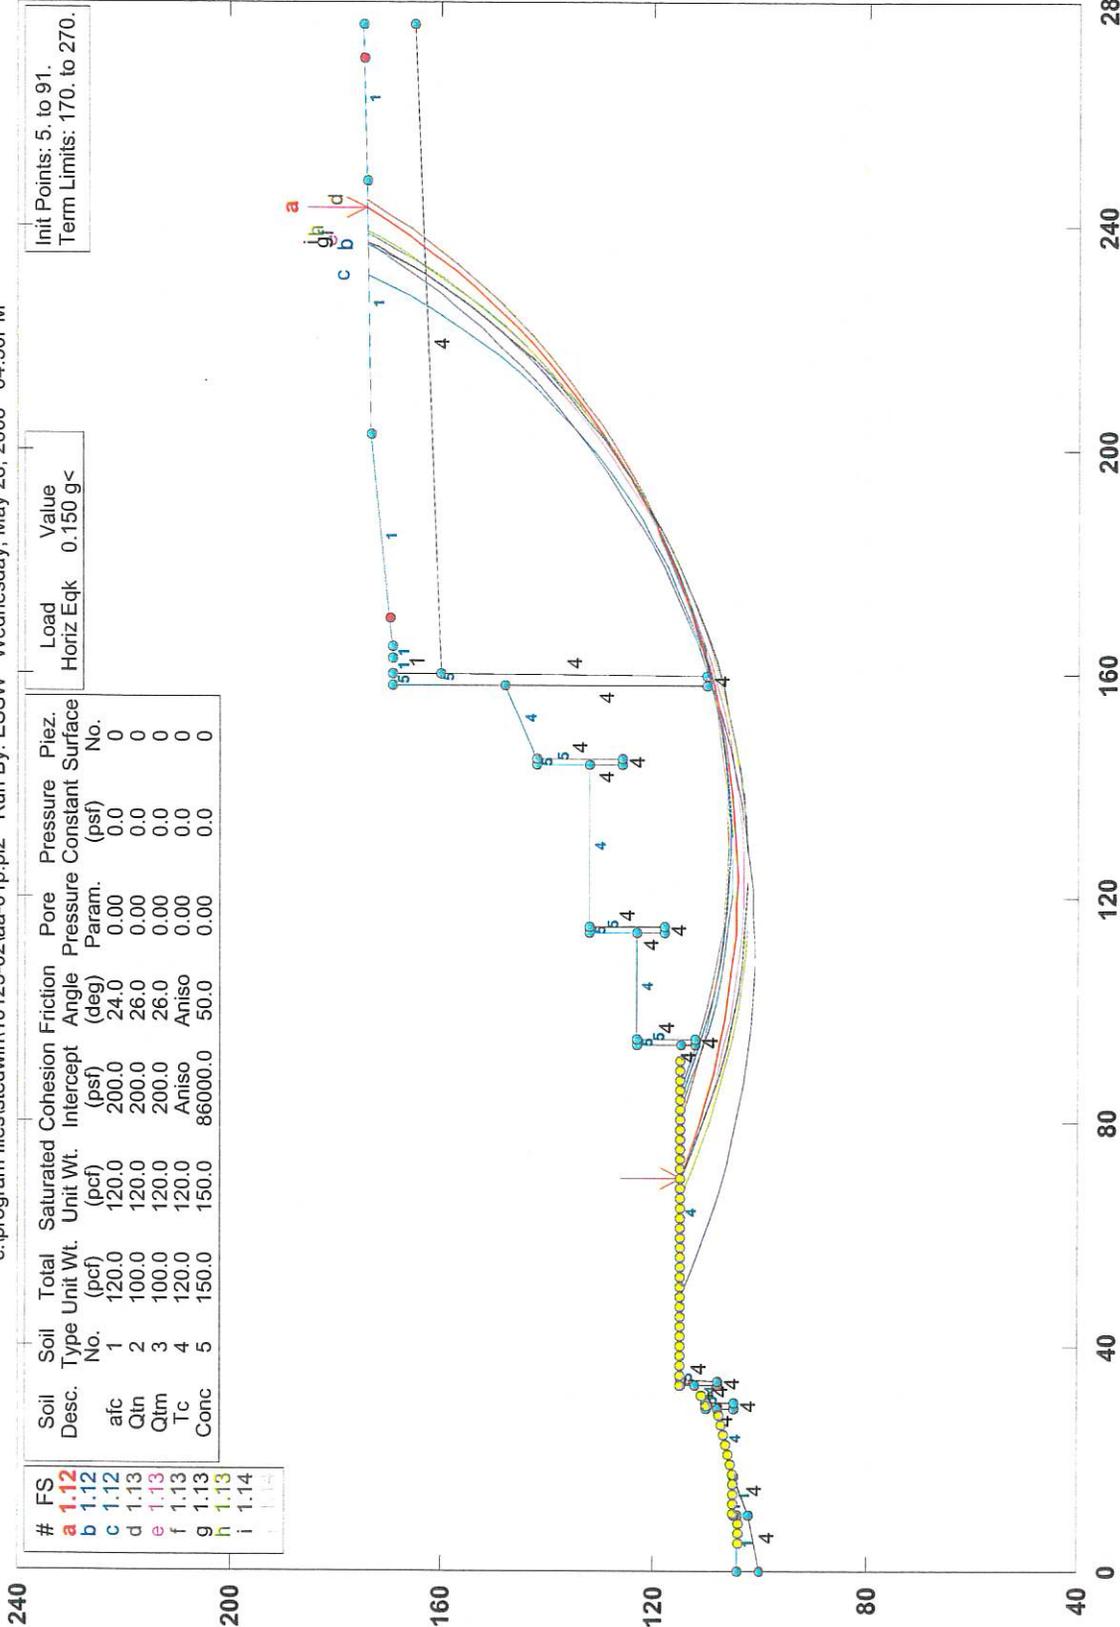
# 10123-02; Via Canon, Proposed Section AA'; Pseudostatic

Init Points: 5. to 91.  
Term Limits: 170. to 270.

Load Value  
Horiz Eqk 0.150 g<

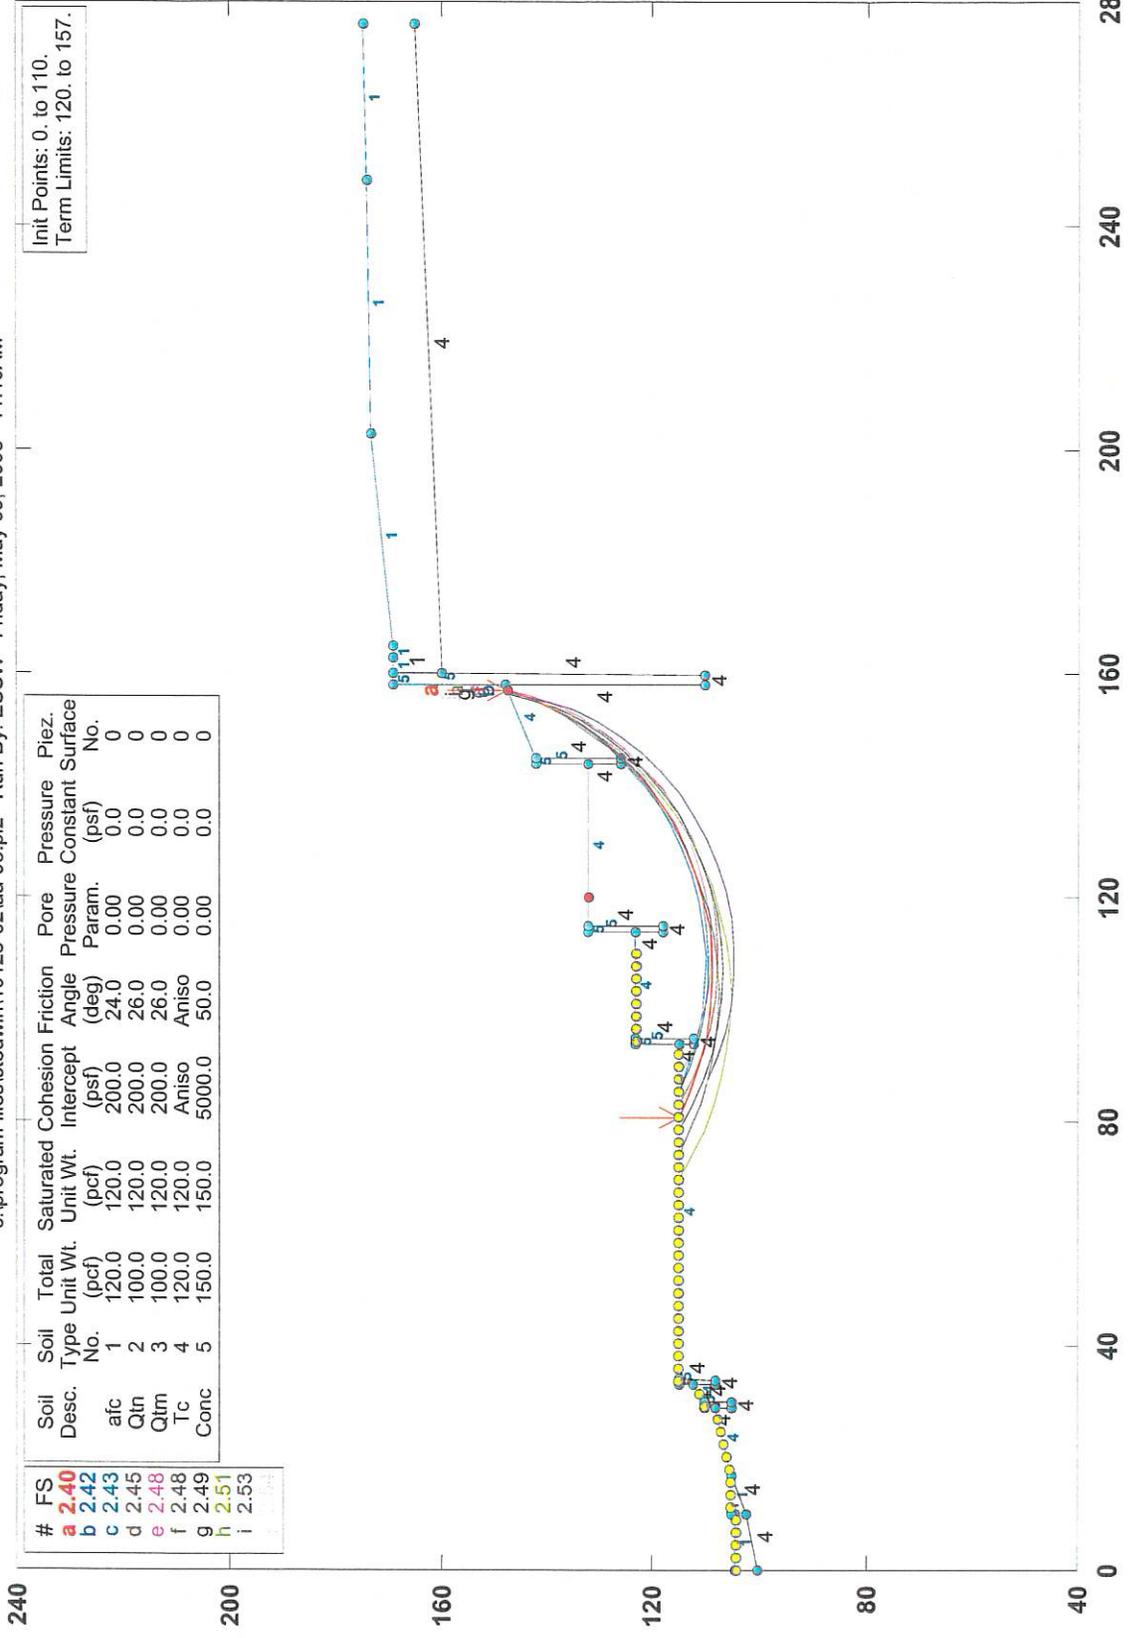
# 10123-02; Via Canon, Proposed Section AA'; Static

Init Points: 0. to 110.  
Term Limits: 120. to 157.

Soil Desc.	Soil Type No.	Total Unit Wt. (pcf)	Saturated Unit Wt. (pcf)	Intercept (psf)	Friction Angle (deg)	Pore Pressure Param. (psf)	Pressure Constant (psf)	Piez. Surface No.
a	1	120.0	120.0	200.0	24.0	0.00	0.00	0
b	2	100.0	120.0	200.0	26.0	0.00	0.00	0
c	3	100.0	120.0	200.0	26.0	0.00	0.00	0
d	4	120.0	120.0	5000.0	50.0	0.00	0.00	0
e	5	150.0	150.0	5000.0	50.0	0.00	0.00	0

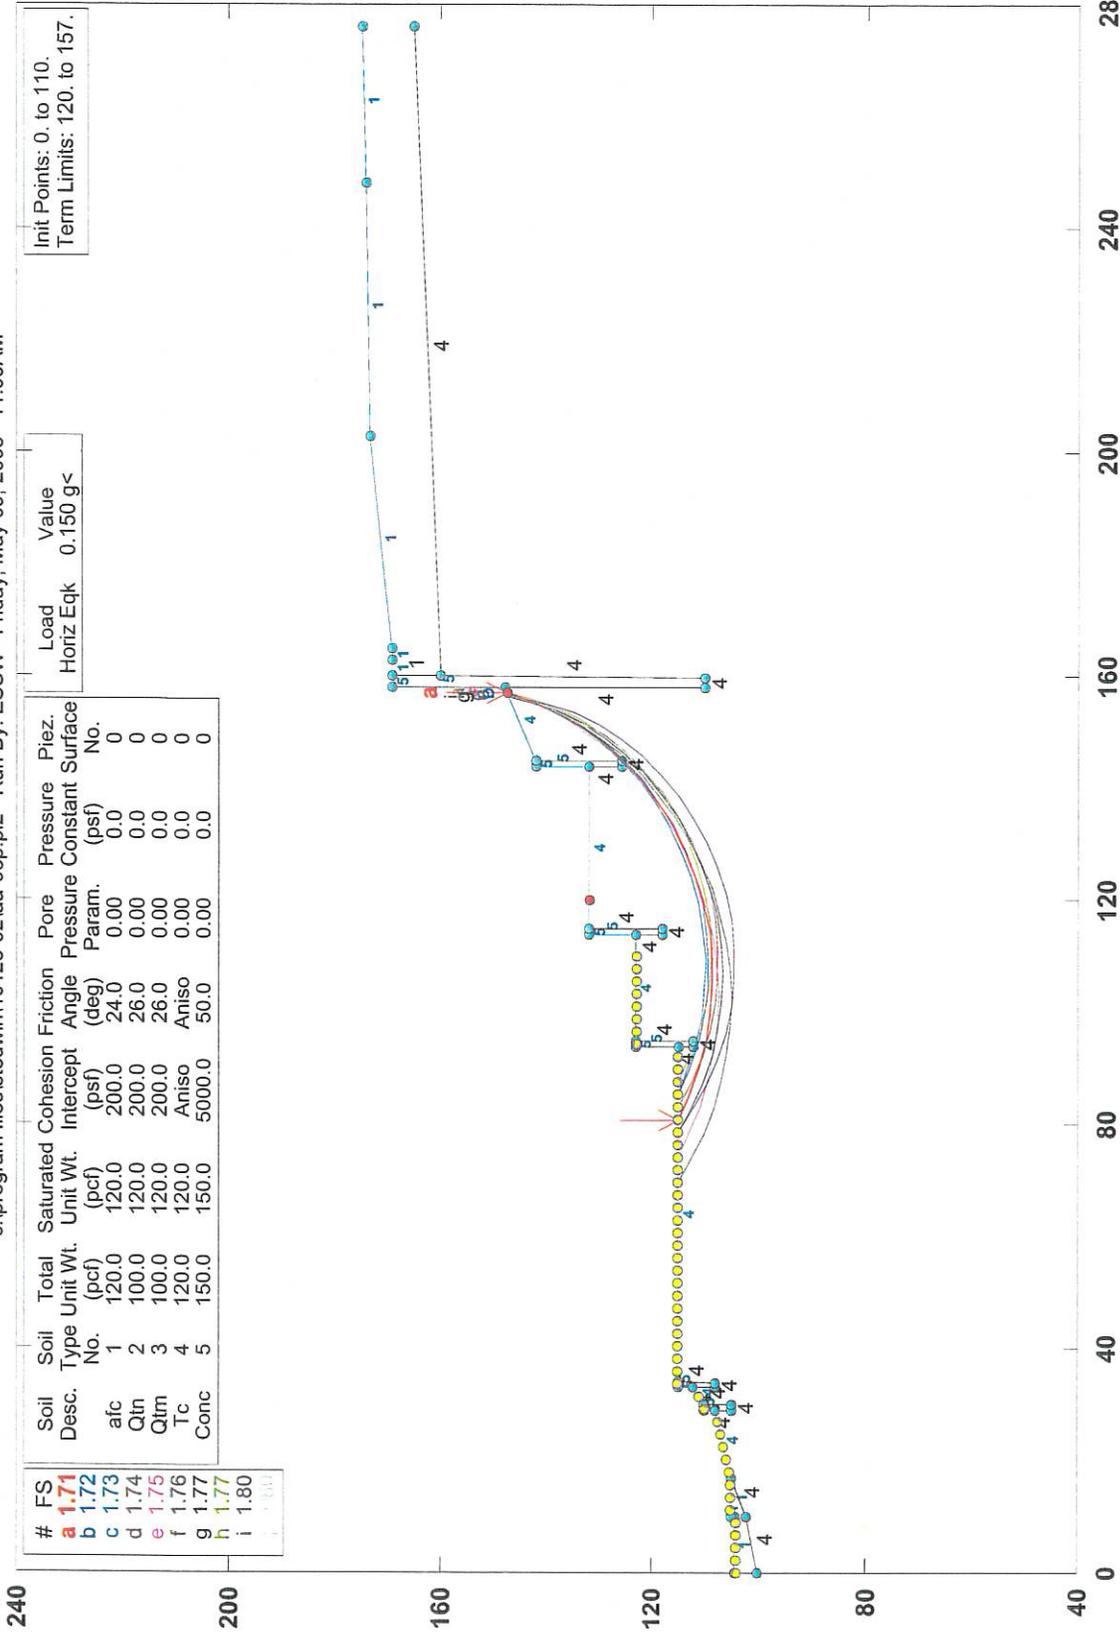
# 10123-02; Via Canon, Proposed Section AA'; Pseudostatic

Init Points: 0. to 110.  
Term Limits: 120. to 157.

Load Value  
Horiz Eqk 0.150 g<

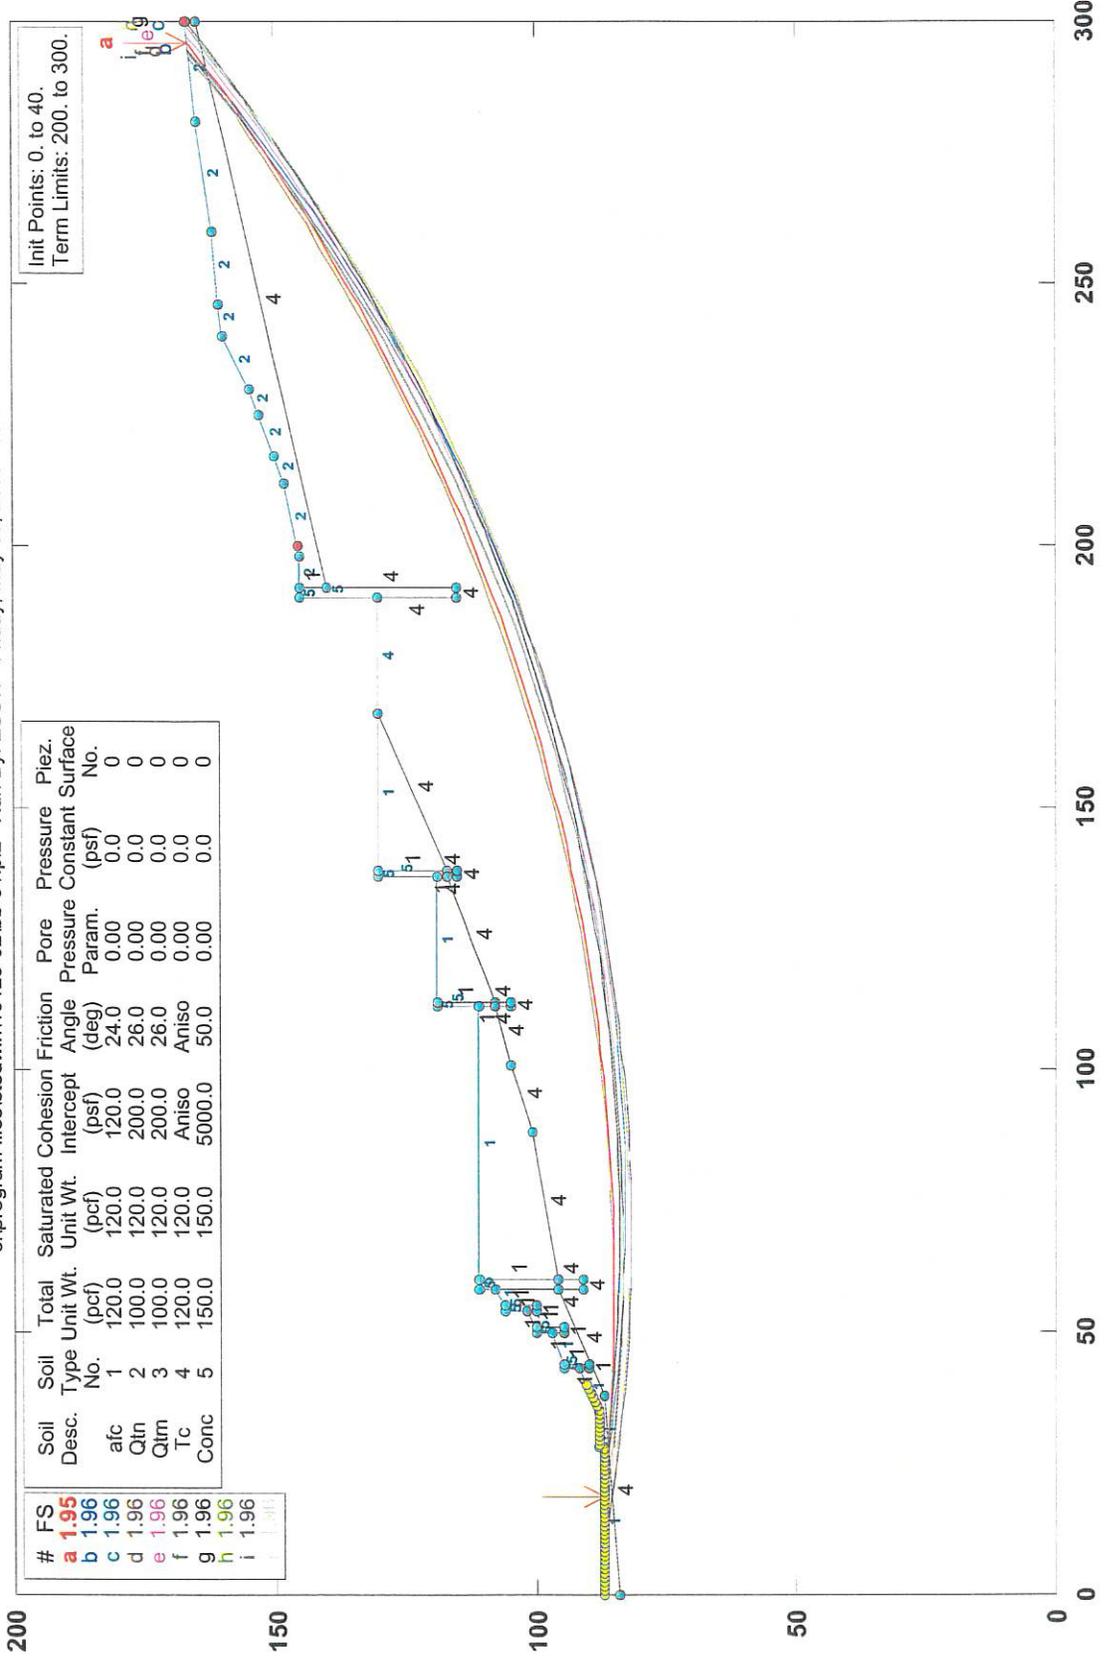
# 10123-02; Via Canon, Proposed Section BB; Static

Init Points: 0. to 40.  
Term Limits: 200. to 300.

#	FS	Soil Desc.	Total Unit Wt. (pcf)	Saturated Unit Wt. (pcf)	Cohesion Intercept (psf)	Friction Angle (deg)	Pore Pressure Param.	Pressure Constant	Piez. Surface No.
a	1.95	afc	120.0	120.0	120.0	24.0	0.00	0.00	0
b	1.96	Qtn	100.0	120.0	200.0	26.0	0.00	0.00	0
c	1.96	Qtrm	100.0	120.0	200.0	26.0	0.00	0.00	0
d	1.96	Tc	120.0	120.0	5000.0	50.0	0.00	0.00	0
e	1.96	Conc	150.0	150.0	5000.0	50.0	0.00	0.00	0
f	1.96								
g	1.96								
h	1.96								
i	1.96

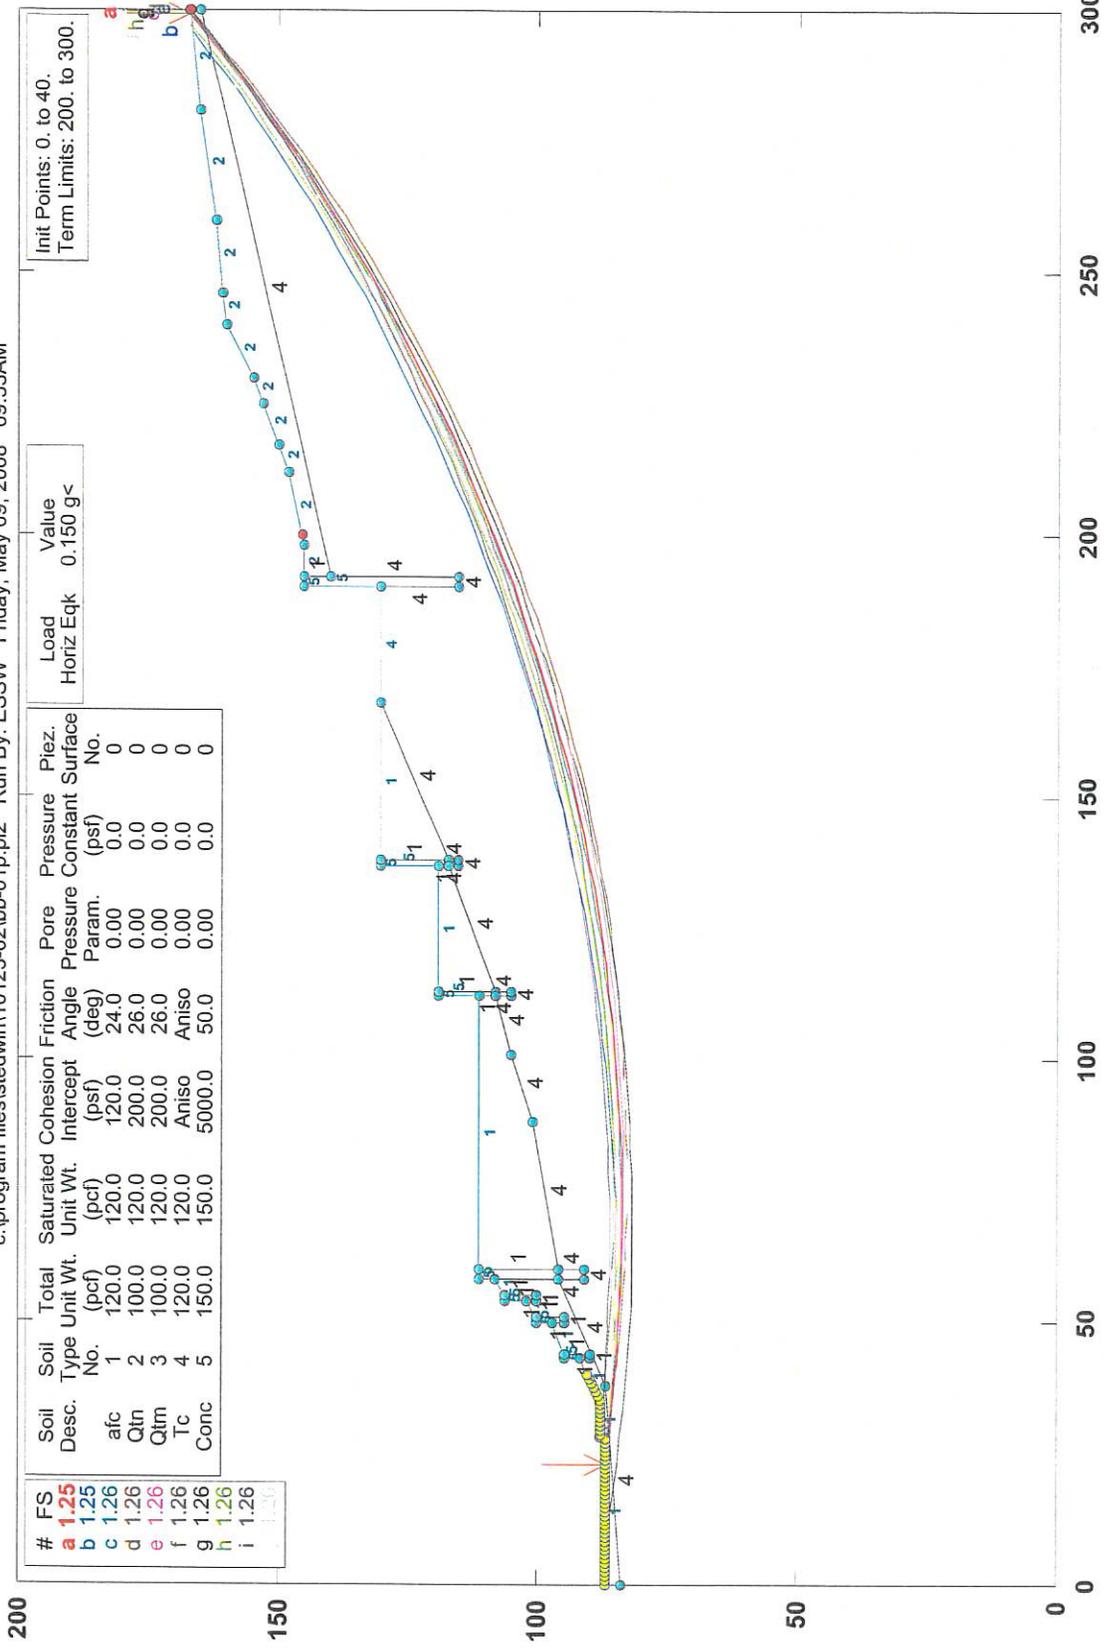
# 10123-02; Via Canon, Proposed Section BB; Pseudostatic

Init Points: 0. to 40.  
Term Limits: 200. to 300.

Load Value  
Horiz Eqk 0.150 g<

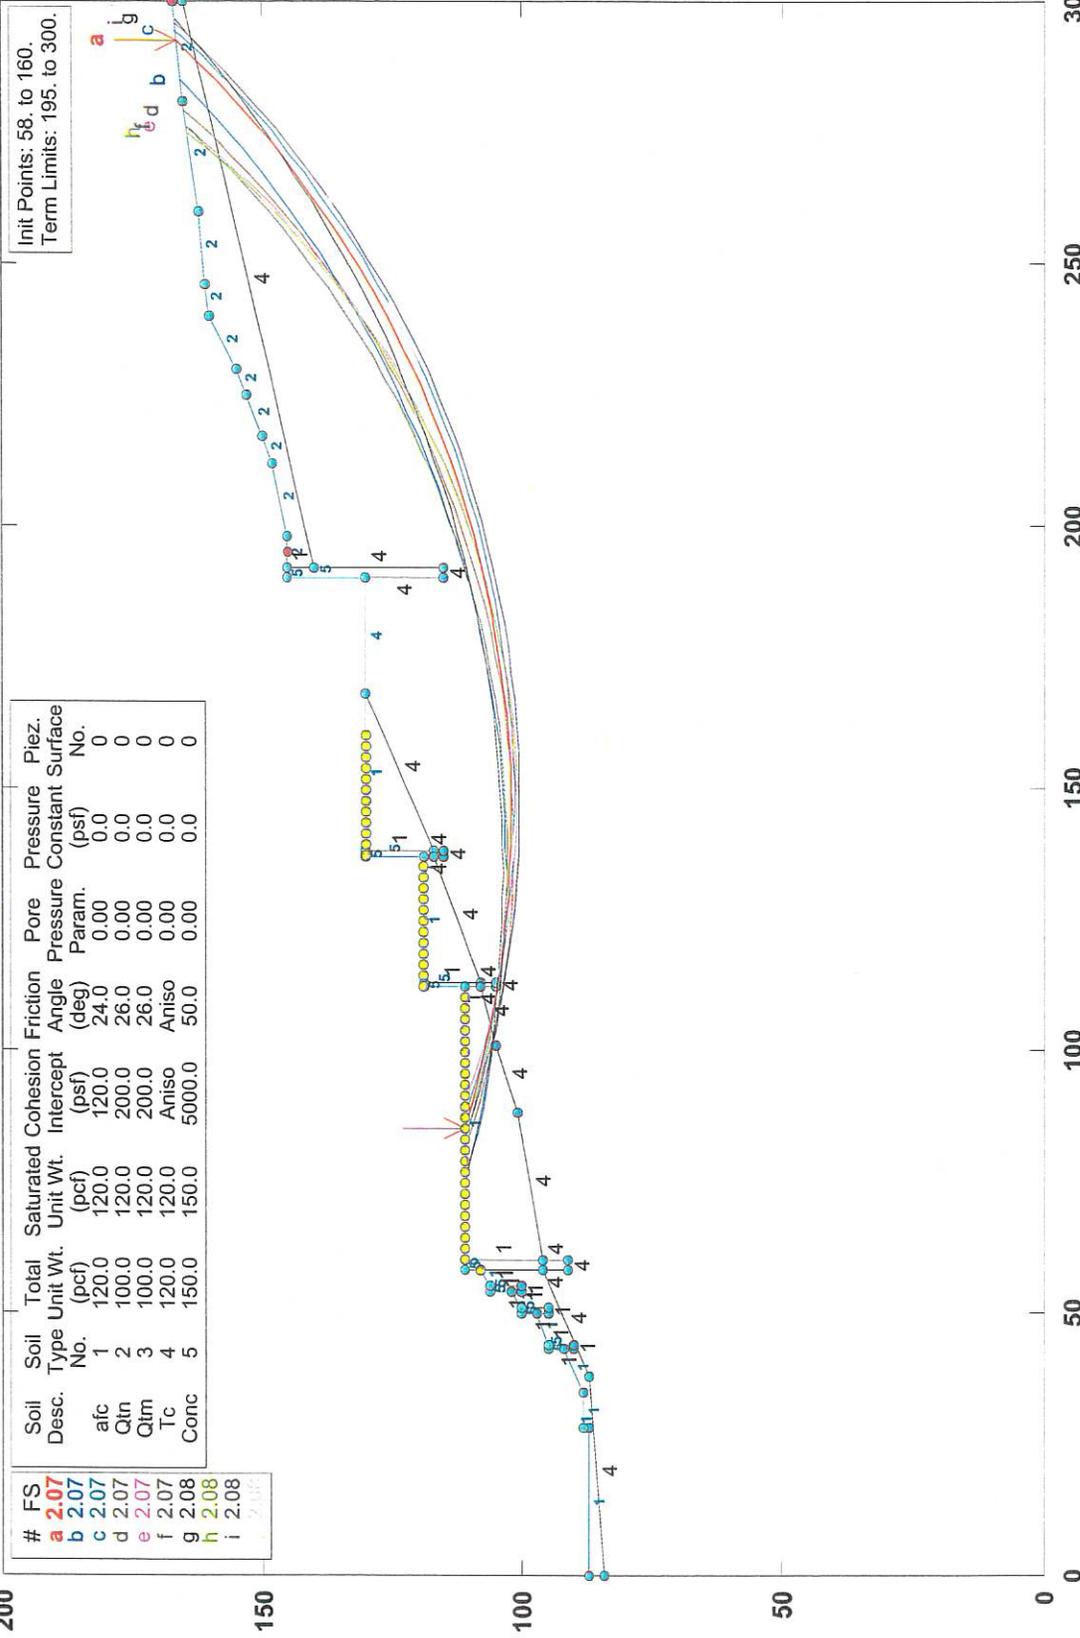
# 10123-02; Via Canon, Proposed Section BB; Static

Init Points: 58. to 160.  
Term Limits: 195. to 300.

#	Soil Desc.	Soil Type No.	Total Unit Wt. (pcf)	Saturated Unit Wt. (pcf)	Cohesion Intercept (psf)	Friction Angle (deg)	Pore Pressure Param.	Pressure Constant (psf)	Piez. No.
a	afc	1	120.0	120.0	120.0	24.0	0.00	0.0	0
b	Qtn	2	100.0	120.0	200.0	26.0	0.00	0.0	0
c	Qtm	3	100.0	120.0	200.0	26.0	0.00	0.0	0
d	Tc	4	120.0	120.0	Aniso	Aniso	0.00	0.0	0
e	Conc	5	150.0	150.0	5000.0	50.0	0.00	0.0	0

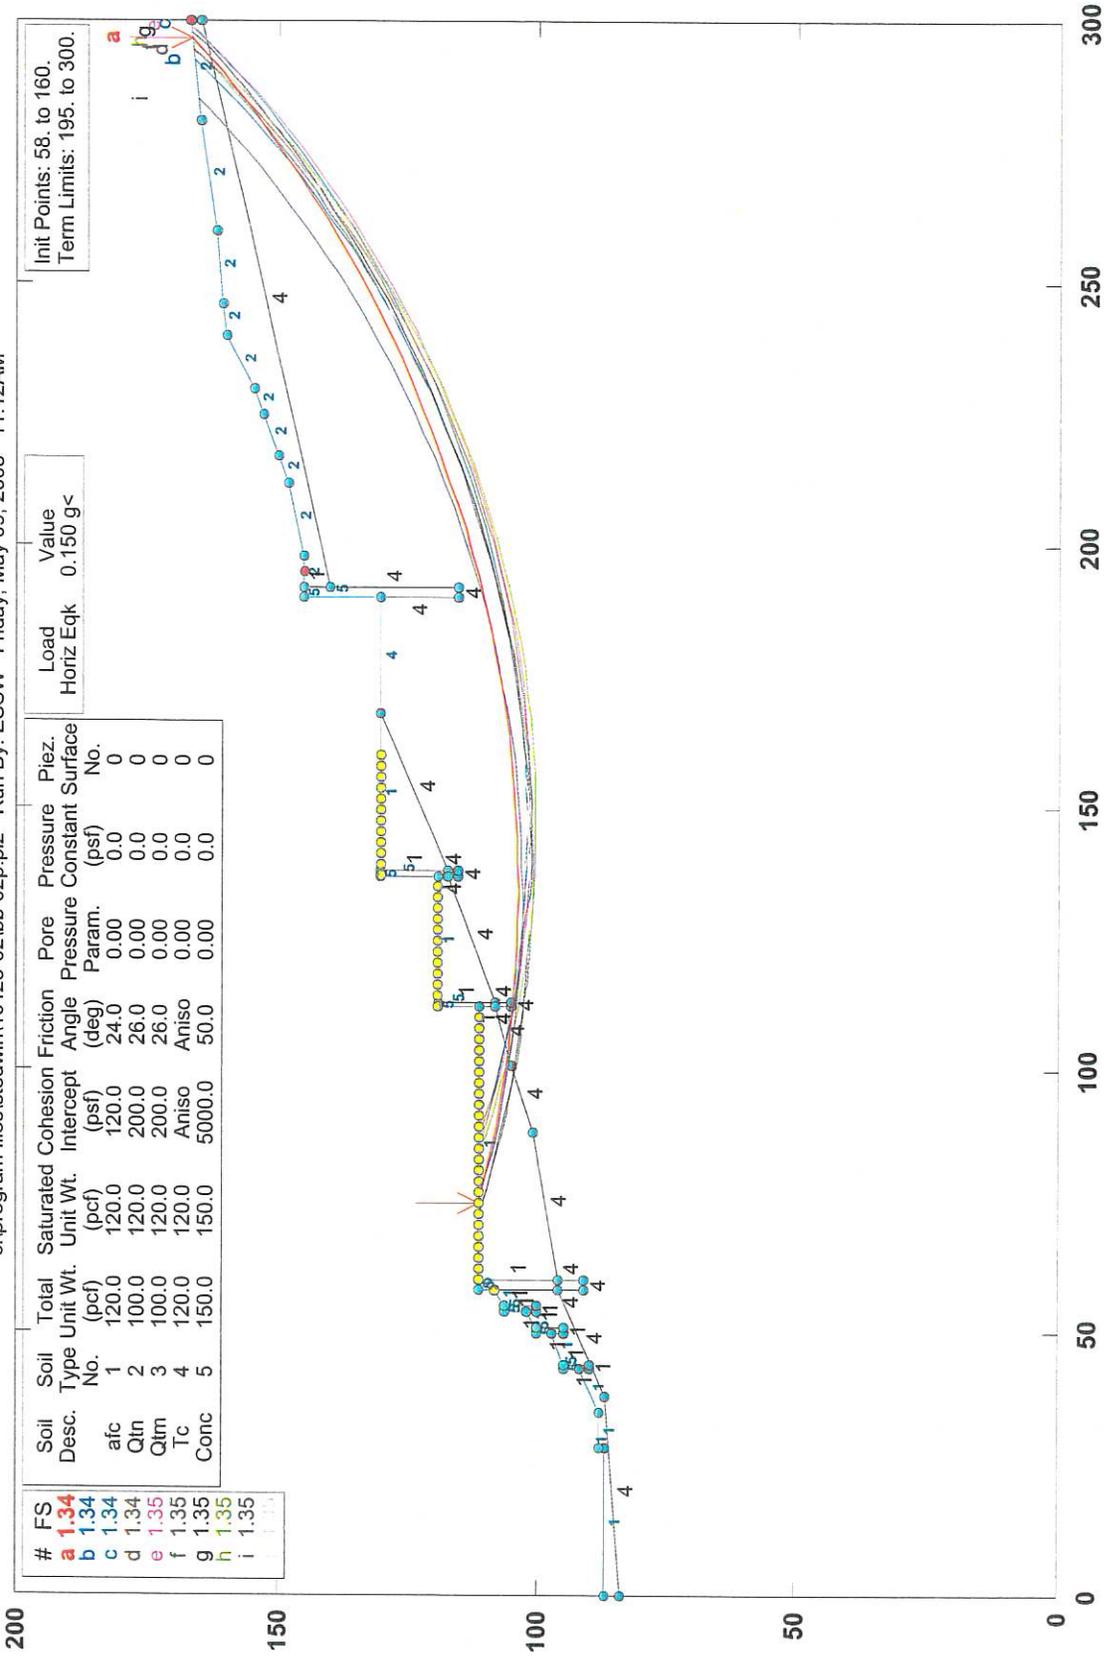
# 10123-02; Via Canon, Proposed Section BB; Pseudostatic

Init Points: 58. to 160.  
Term Limits: 195. to 300.

Load Value  
Horiz Eq 0.150 g<

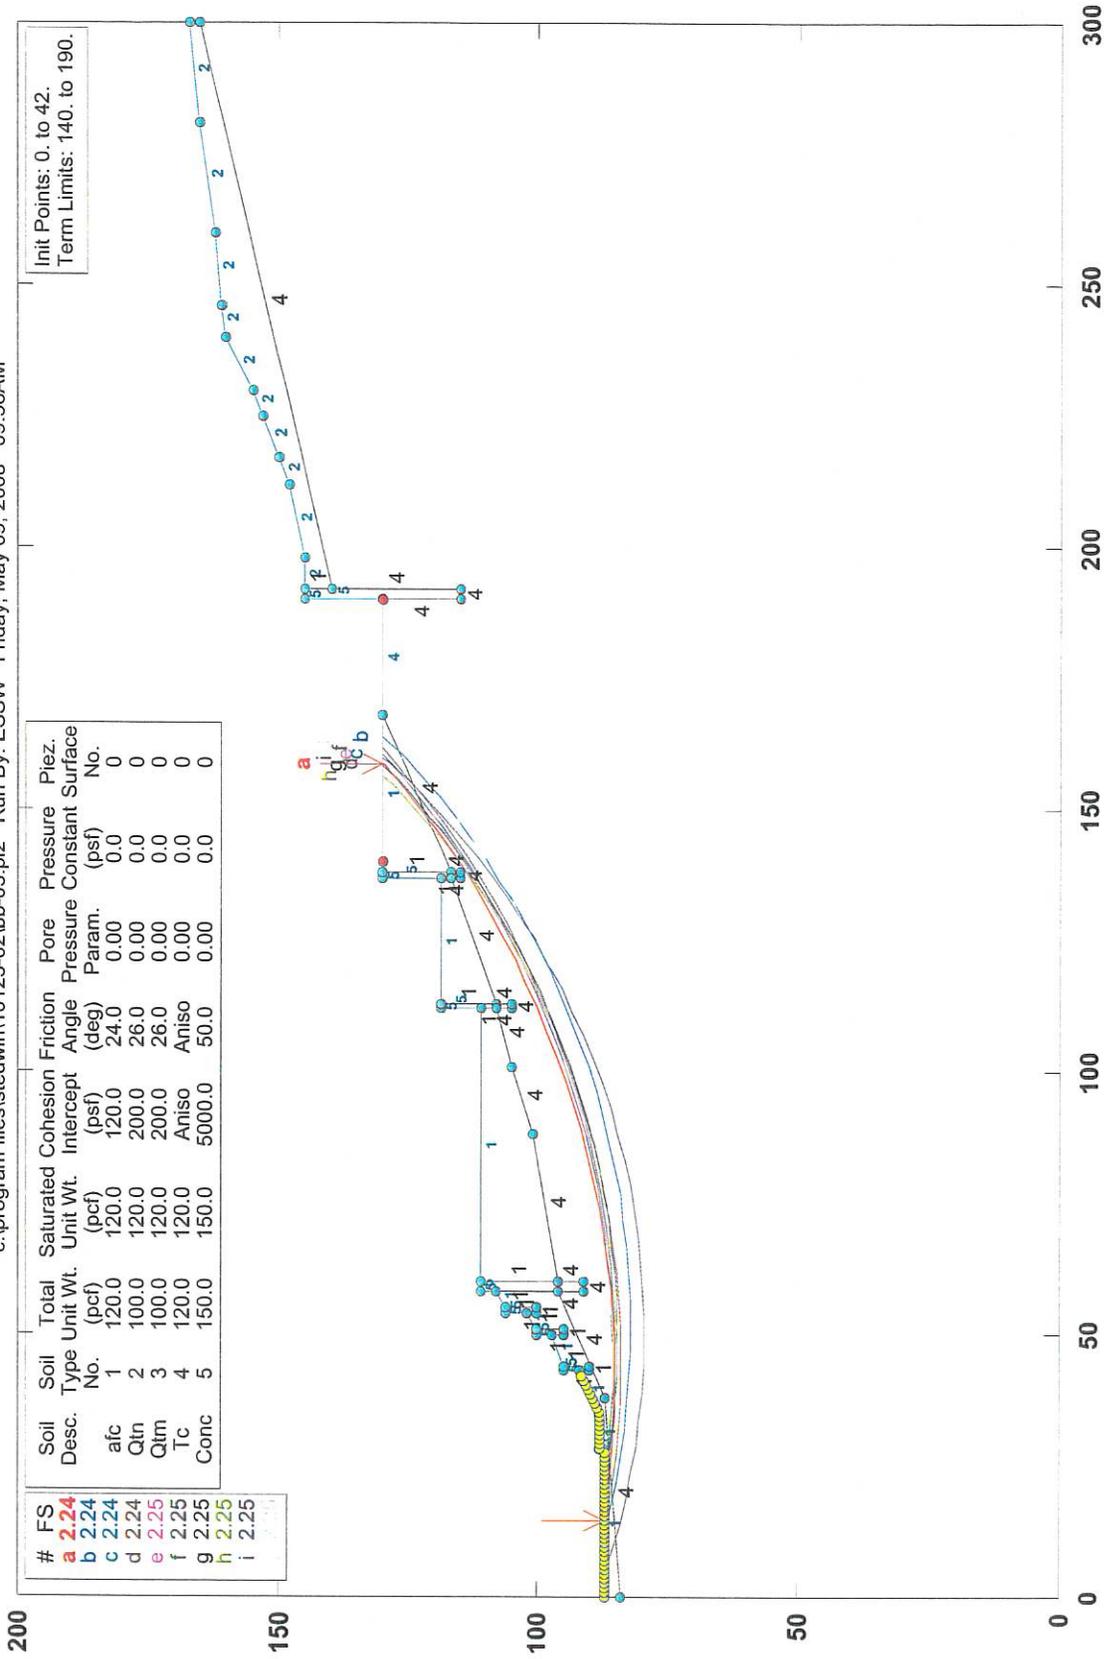
# 10123-02; Via Canon, Proposed Section BB; Static

Init Points: 0. to 42.  
Term Limits: 140. to 190.

#	FS
a	2.24
b	2.24
c	2.24
d	2.24
e	2.25
f	2.25
g	2.25
h	2.25
i	2.25

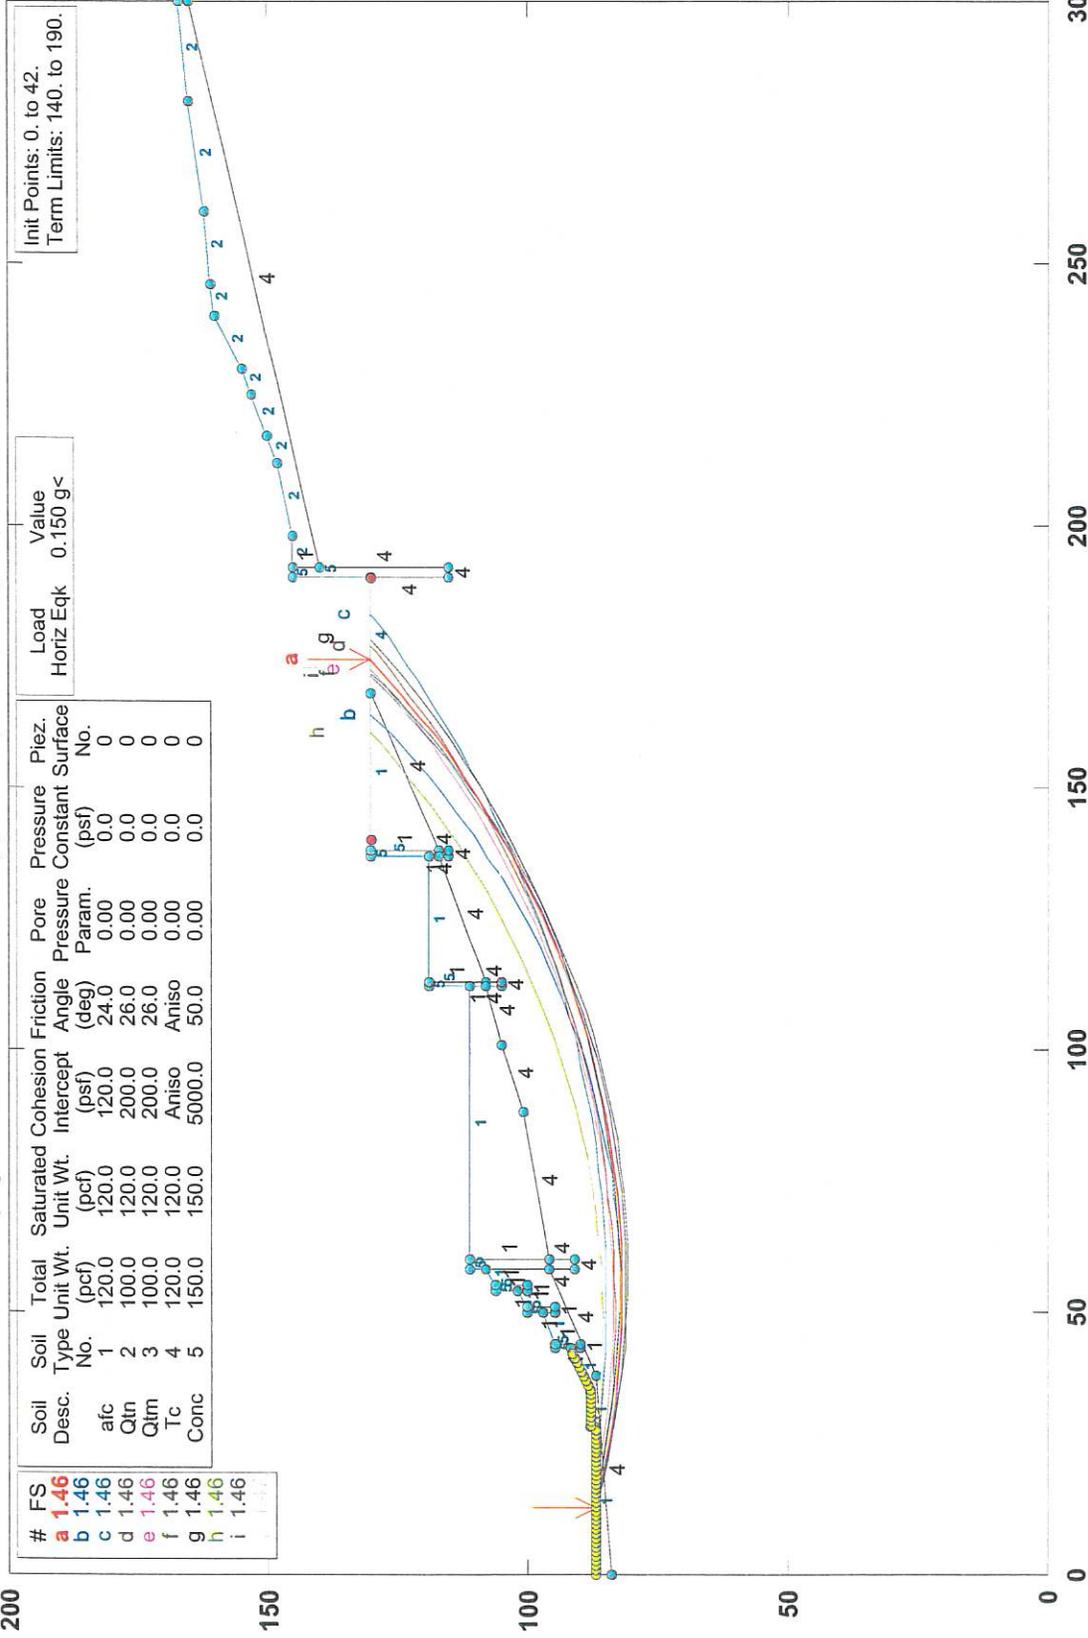
#	FS
a	1.46
b	1.46
c	1.46
d	1.46
e	1.46
f	1.46
g	1.46
h	1.46
i	1.46

Init Points: 0. to 42.  
Term Limits: 140. to 190.

STABL6H FSmin=1.46  
Safety Factors Are Calculated By The Modified Bishop Method
