**GEOTECHNICAL ENGINEERING REPORT  
MULTI-FAMILY  
RESIDENTIAL DEVELOPMENT  
SOUTH OF VIA CANON AND  
CAMINO CAPISTRANO  
DANA POINT, CALIFORNIA**

Project: **Multi-Family Residential Development**  
South of Via Canon and Camino Capistrano  
Dana Point, California

Subject: **Geotechnical Engineering Report**

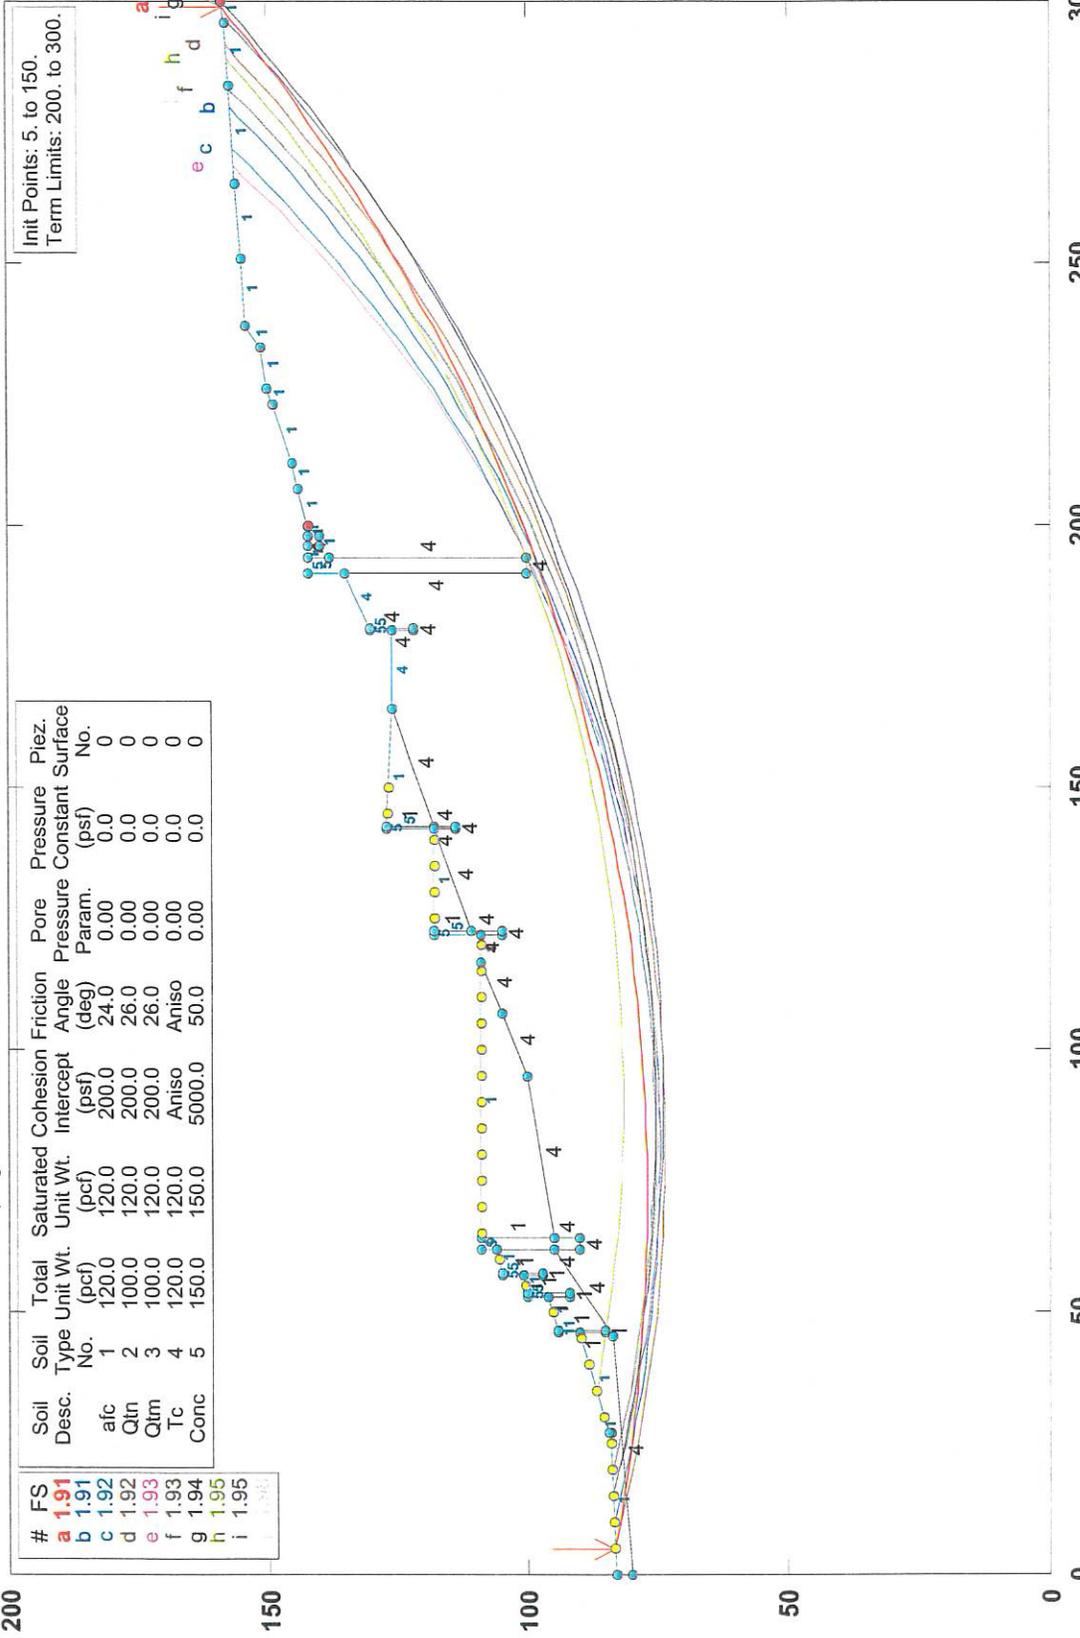
# 10123-02; Via Canon, Proposed Section CC'; Static

Init Points: 5. to 150.  
Term Limits: 200. to 300.

Soil Desc.	Soil Type No.	Total Unit Wt. (pcf)	Saturated Unit Wt. (pcf)	Cohesion Intercept (psf)	Friction Angle (deg)	Pore Pressure Param.	Piez. Pressure Constant (psf)	Piez. Surface No.
afc	1	120.0	120.0	200.0	24.0	0.00	0.00	0
Qtn	2	100.0	120.0	200.0	26.0	0.00	0.00	0
Qtm	3	100.0	120.0	200.0	26.0	0.00	0.00	0
Tc	4	120.0	120.0	Aniso	Aniso	0.00	0.00	0
Conc	5	150.0	150.0	5000.0	50.0	0.00	0.00	0

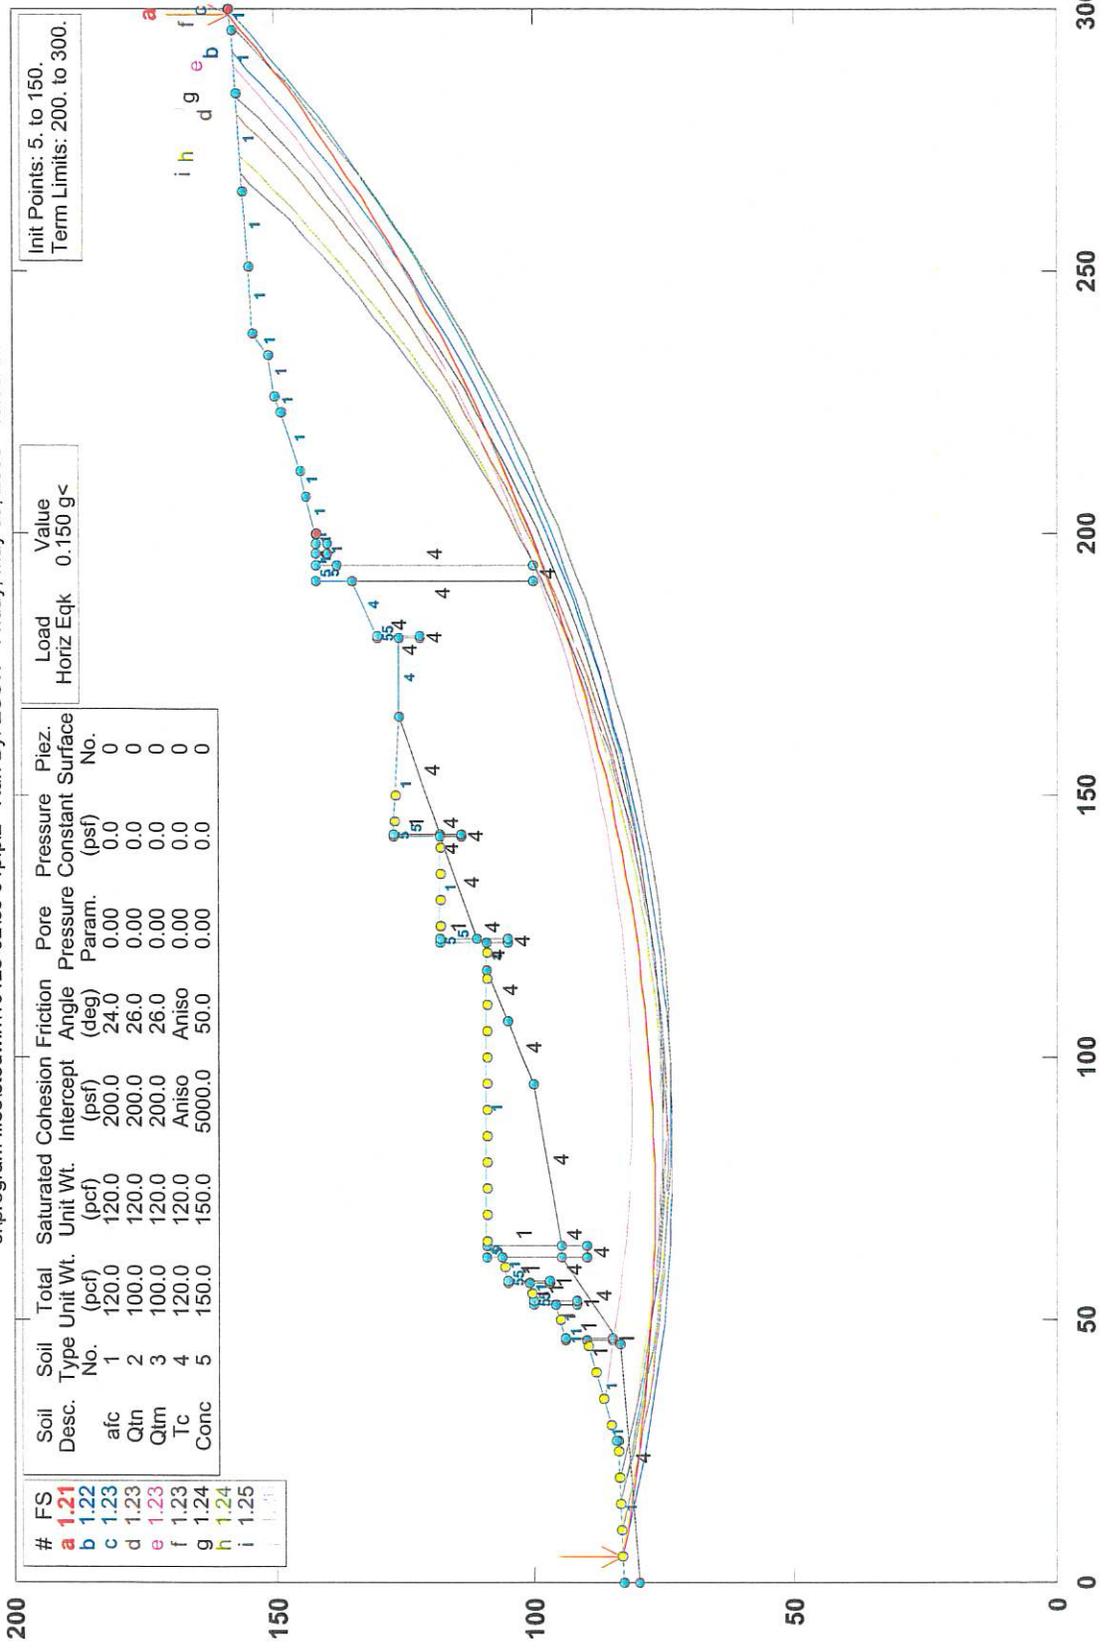
# 10123-02; Via Canon, Proposed Section CC'; Pseudostatic

STABL6H FSmin=1.21  
Safety Factors Are Calculated By The Modified Bishop Method

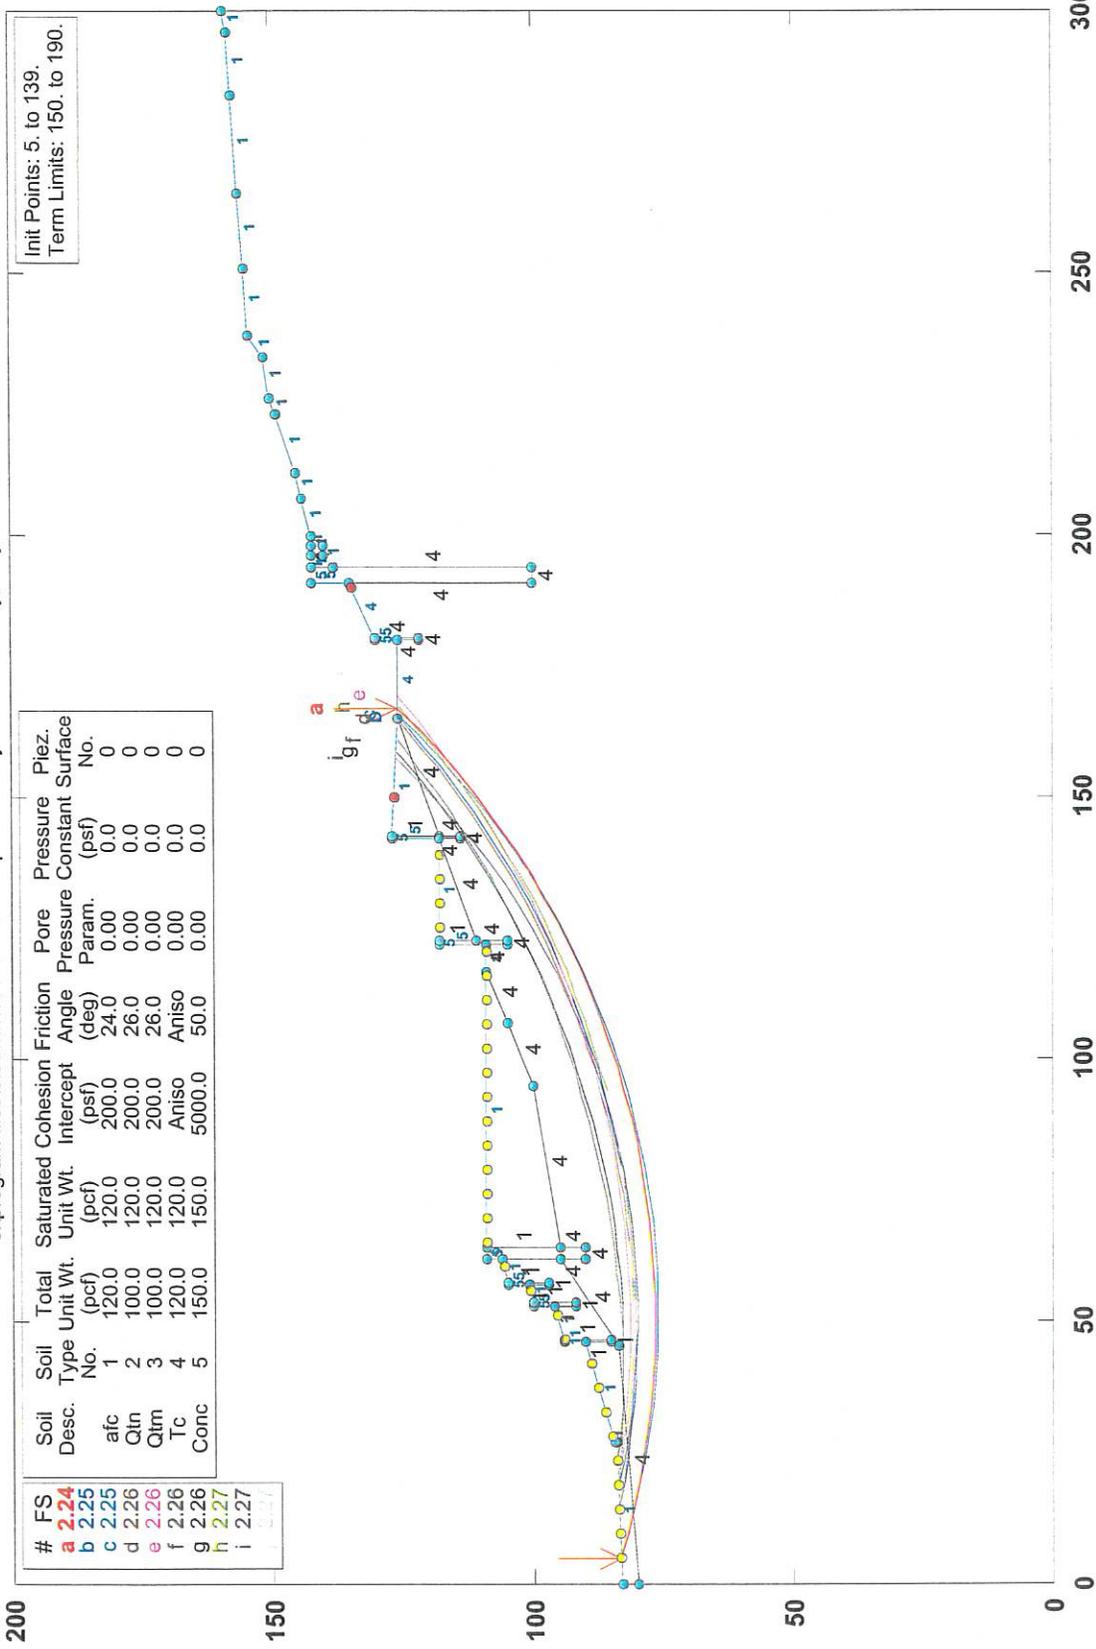
# 10123-02; Via Canon, Proposed Section CC; Static

Init Points: 5. to 139.  
Term Limits: 150. to 190.

Soil Desc.	Soil Type No.	Total Unit Wt. (pcf)	Saturated Unit Wt. (pcf)	Cohesion Intercept (psf)	Friction Angle (deg)	Pore Pressure Param.	Piez. No.
afc	1	120.0	120.0	200.0	24.0	0.00	0
Qtn	2	100.0	120.0	200.0	26.0	0.00	0
Qtm	3	100.0	120.0	200.0	26.0	0.00	0
Tc	4	120.0	120.0	Aniso	Aniso	0.00	0
Conc	5	150.0	150.0	5000.0	50.0	0.00	0

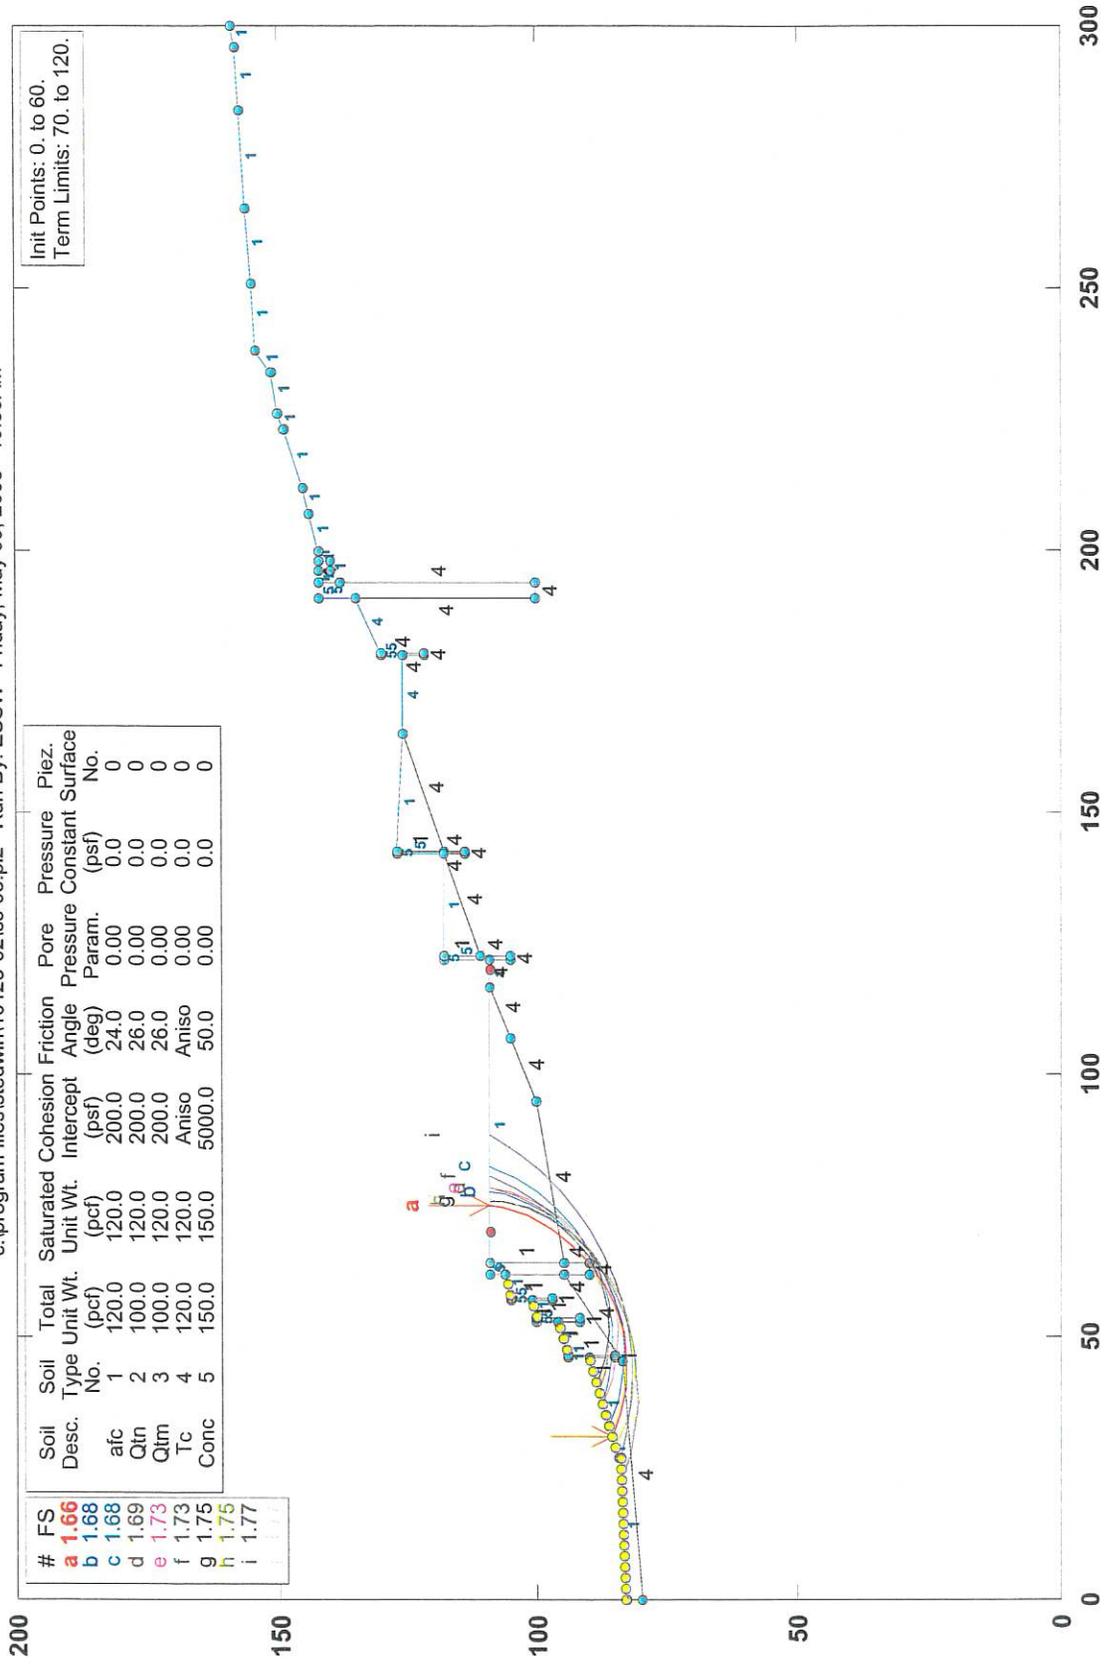
Soil Desc.	Soil Type No.	Total Unit Wt. (pcf)	Saturated Unit Wt. (pcf)	Intercept (psf)	Friction Angle (deg)	Pore Pressure Param.	Pressure Constant (psf)	Piez. Surface No.
afc	1	120.0	120.0	200.0	24.0	0.00	0.0	0
Qtn	2	100.0	120.0	200.0	26.0	0.00	0.0	0
Qtrm	3	100.0	120.0	200.0	26.0	0.00	0.0	0
Tc	4	120.0	120.0	Aniso	Aniso	0.00	0.0	0
Conc	5	150.0	150.0	5000.0	50.0	0.00	0.0	0

#	FS
a	1.66
b	1.68
c	1.68
d	1.69
e	1.73
f	1.73
g	1.75
h	1.75
i	1.77

STABL6H FSmin=1.66  
Safety Factors Are Calculated By The Modified Bishop Method

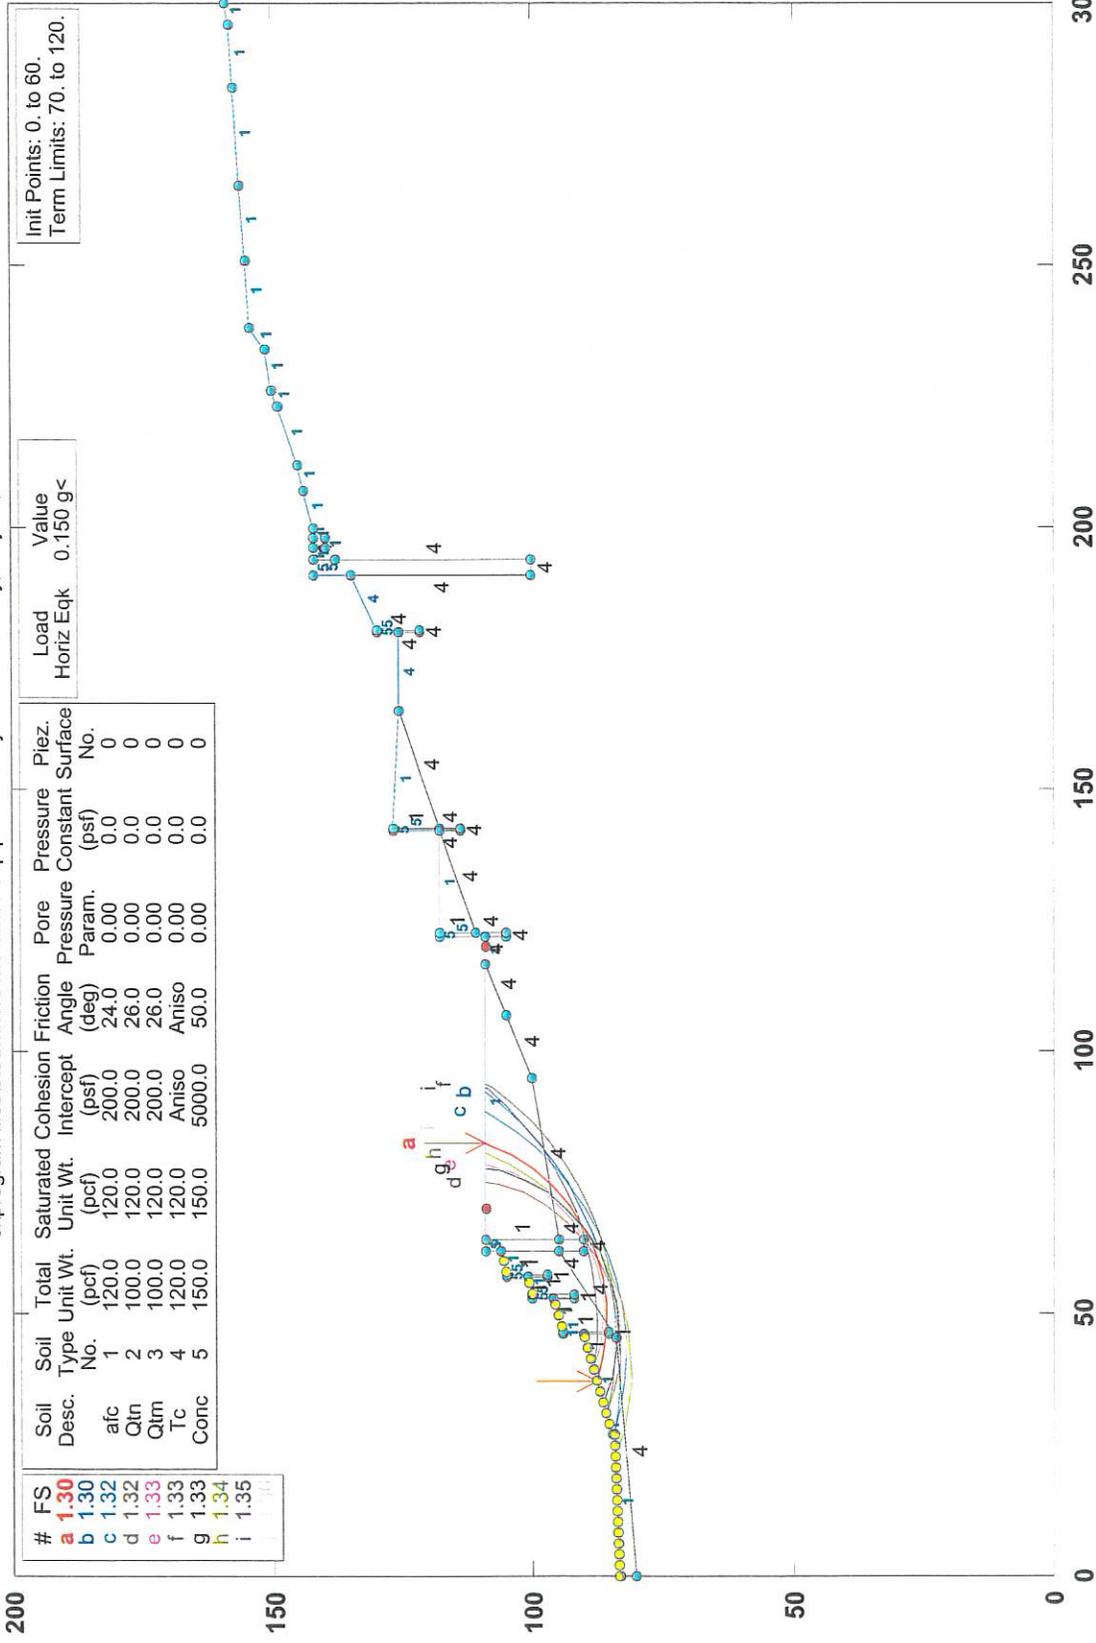
# 10123-02; Via Canon, Proposed Section CC; Pseudostatic

Safety Factors Are Calculated By The Modified Bishop Method

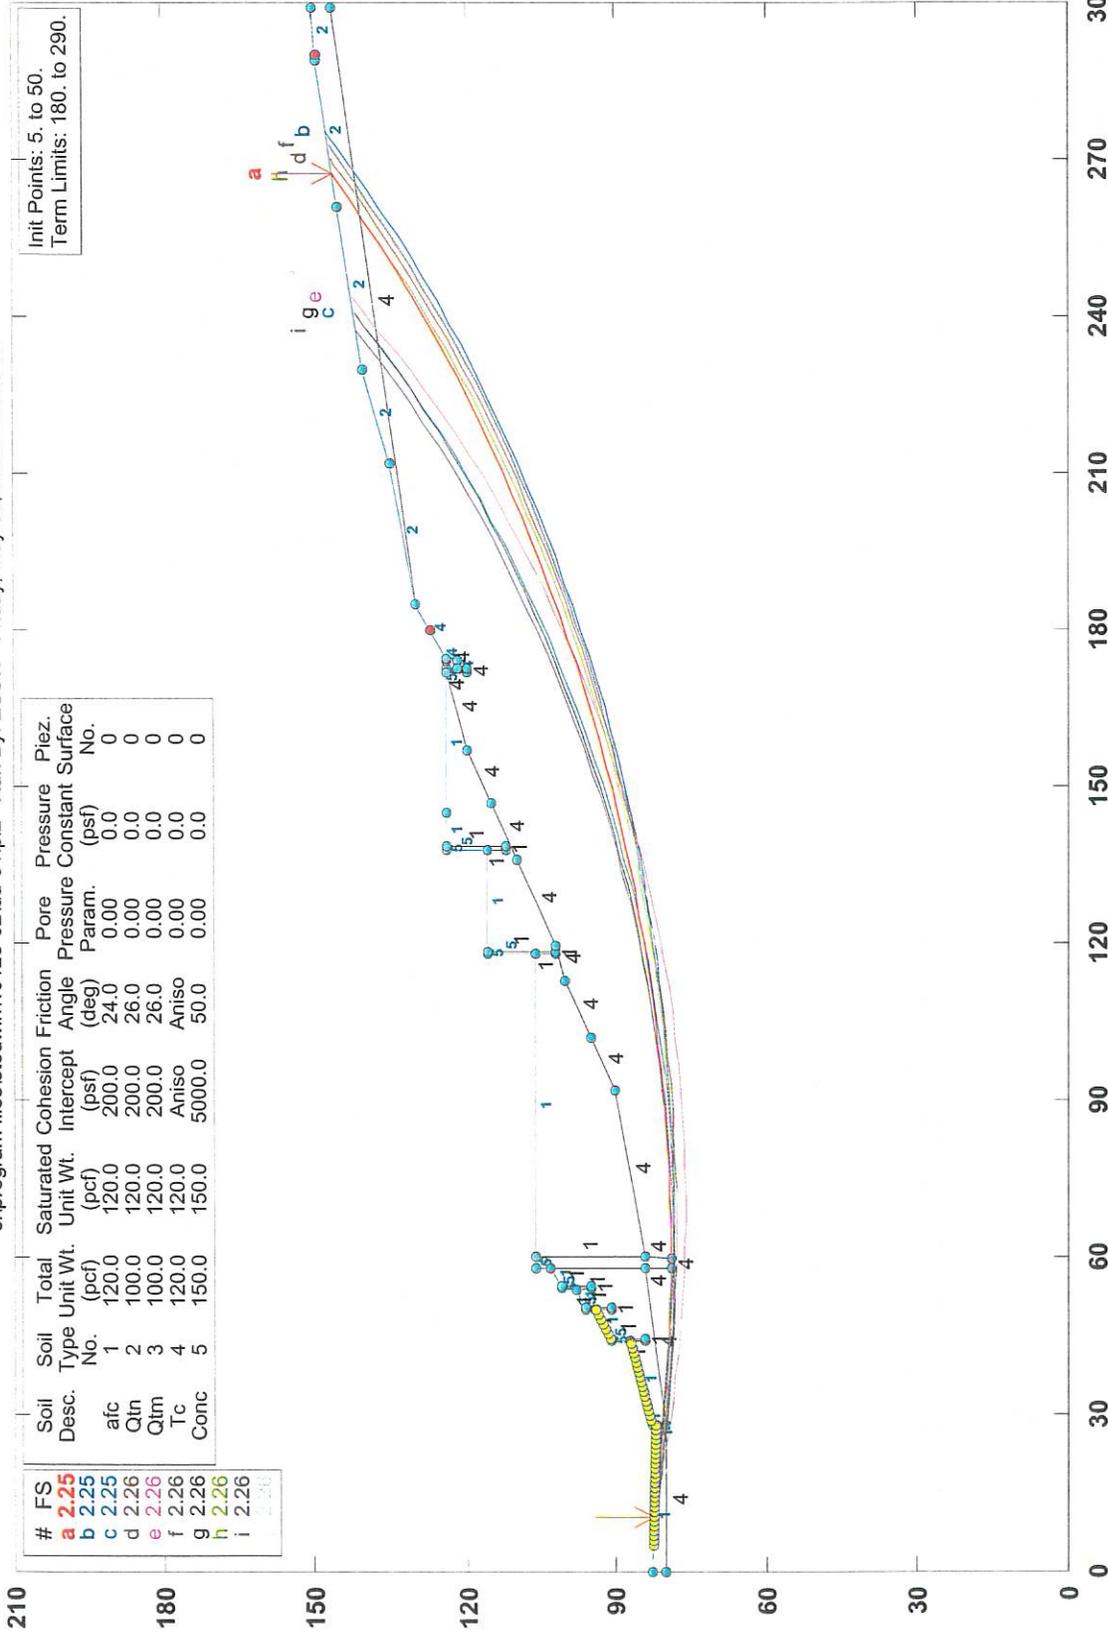
# 10123-02; Via Canon, Proposed Section DD; Static

Init Points: 5. to 50.  
Term Limits: 180. to 290.

STABL6H FSmin=2.25  
Safety Factors Are Calculated By The Modified Bishop Method

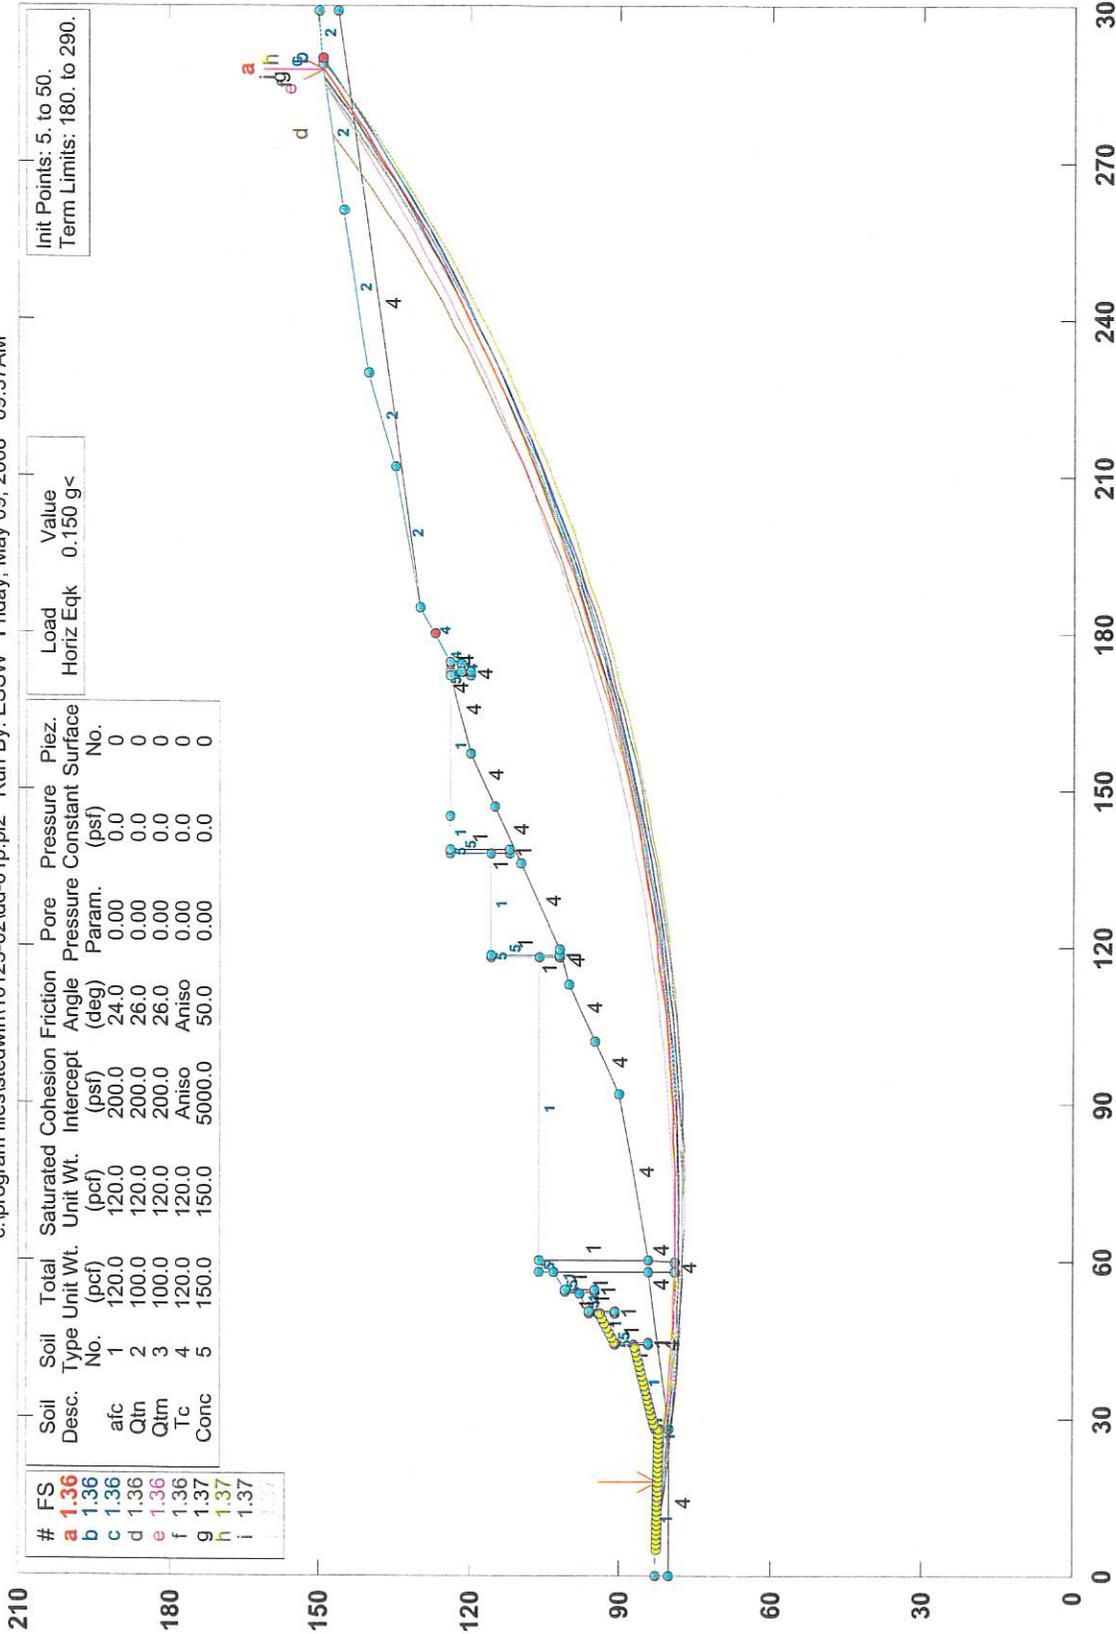
# 10123-02; Via Canon, Proposed Section DD; Pseudostatic

Init Points: 5. to 50.  
Term Limits: 180. to 290.

Load Value  
Horiz Eqk 0.150 g<

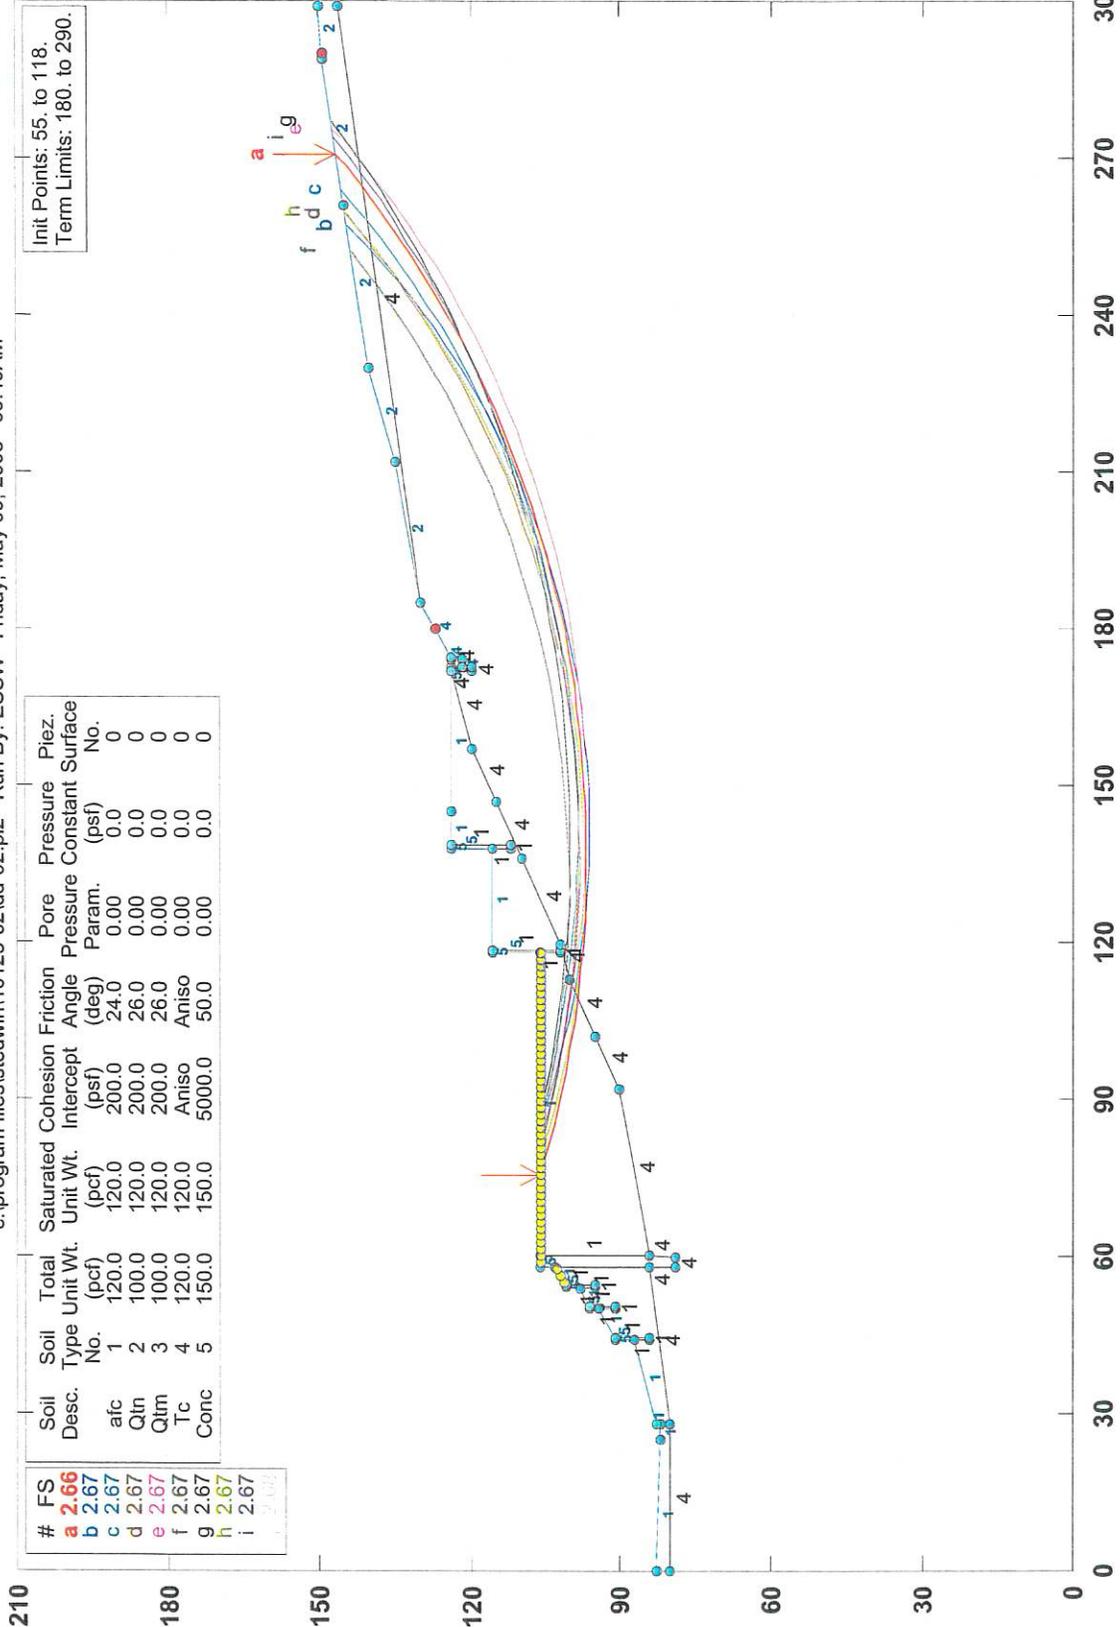
# 10123-02; Via Canon, Proposed Section DD; Static

Init Points: 55. to 118.  
Term Limits: 180. to 290.

Soil Desc.	Soil Type No.	Total Unit Wt. (pcf)	Saturated Unit Wt. (pcf)	Intercept (psf)	Friction Angle (deg)	Pore Pressure Param.	Pressure Constant (psf)	Piez. Surface No.
atc	1	120.0	120.0	200.0	24.0	0.00	0.0	0
Qtm	2	100.0	120.0	200.0	26.0	0.00	0.0	0
Qtm	3	100.0	120.0	200.0	26.0	0.00	0.0	0
Tc	4	120.0	120.0	Aniso	Aniso	0.00	0.0	0
Conc	5	150.0	150.0	5000.0	50.0	0.00	0.0	0

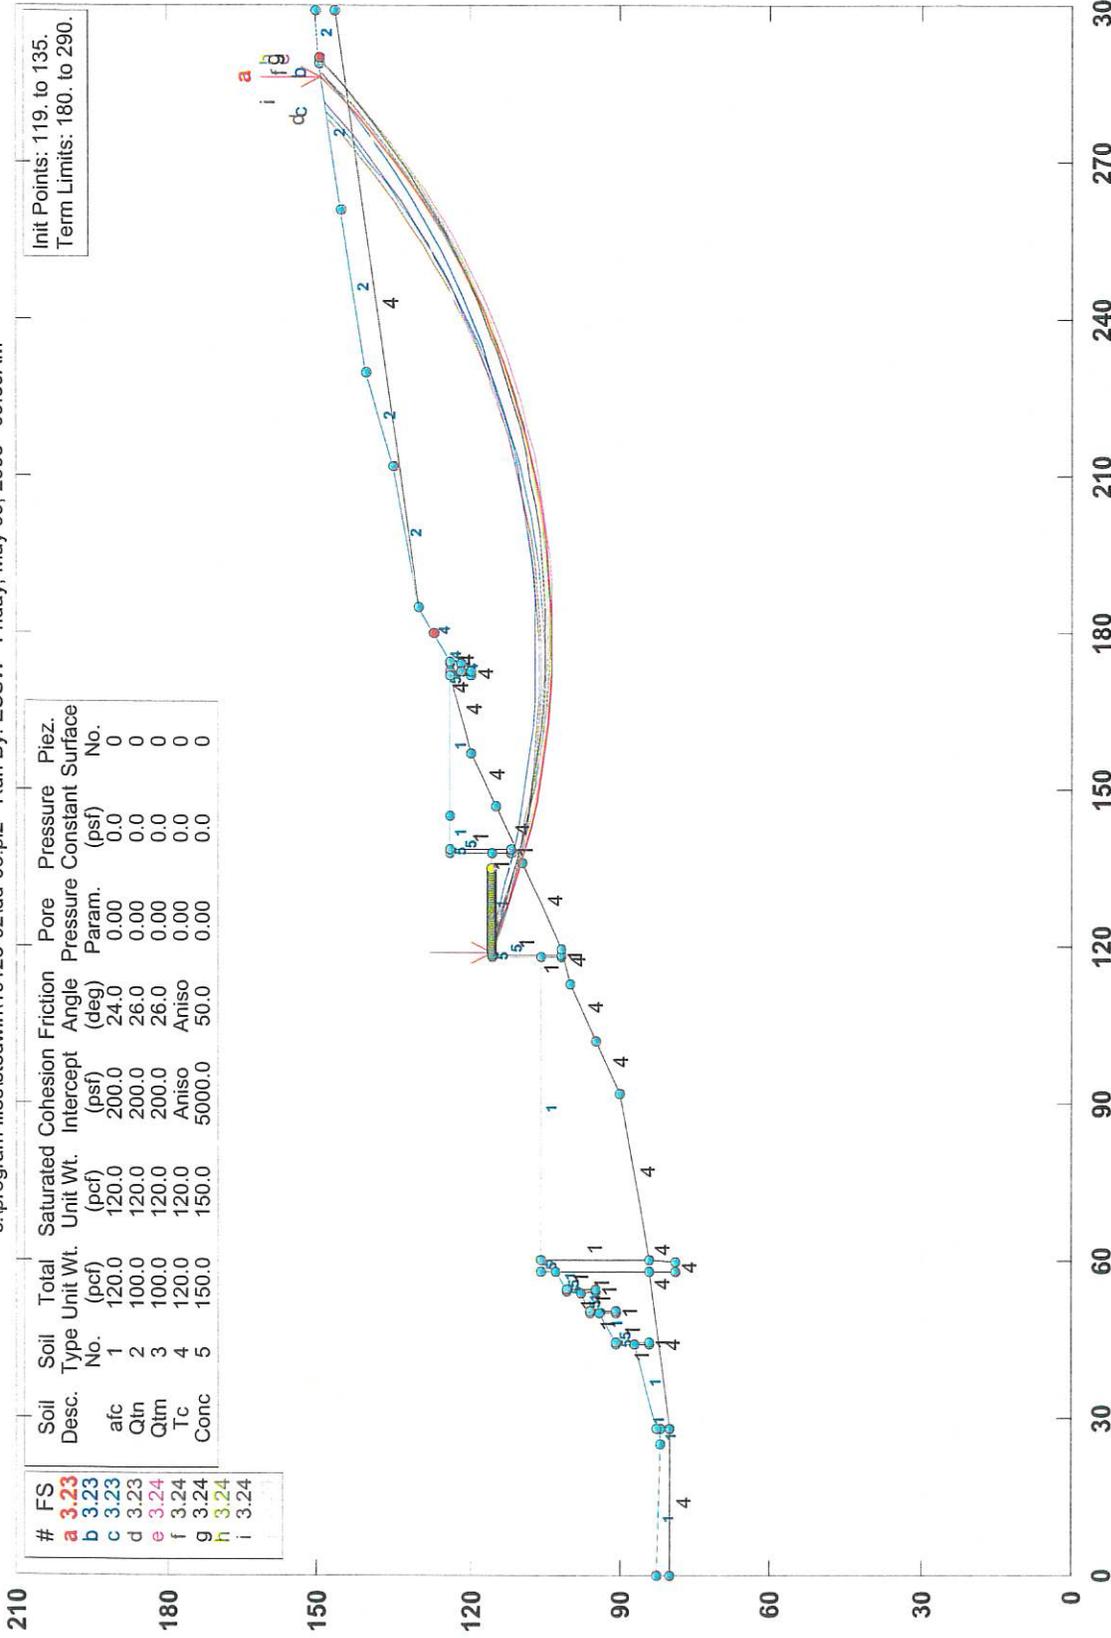
# 10123-02; Via Canon, Proposed Section DD; Static

Init Points: 119. to 135.  
Term Limits: 180. to 290.

Soil Desc.	Soil Type No.	Total Unit Wt. (pcf)	Saturated Unit Wt. (pcf)	Cohesion (psf)	Friction Angle (deg)	Pore Pressure Param.	Pressure Constant (psf)	Piez. No.
afc	1	120.0	120.0	200.0	24.0	0.00	0.0	0
Qtn	2	100.0	120.0	200.0	26.0	0.00	0.0	0
Qtm	3	100.0	120.0	200.0	26.0	0.00	0.0	0
Tc	4	120.0	120.0	Aniso	Aniso	0.00	0.0	0
Conc	5	150.0	150.0	5000.0	50.0	0.00	0.0	0

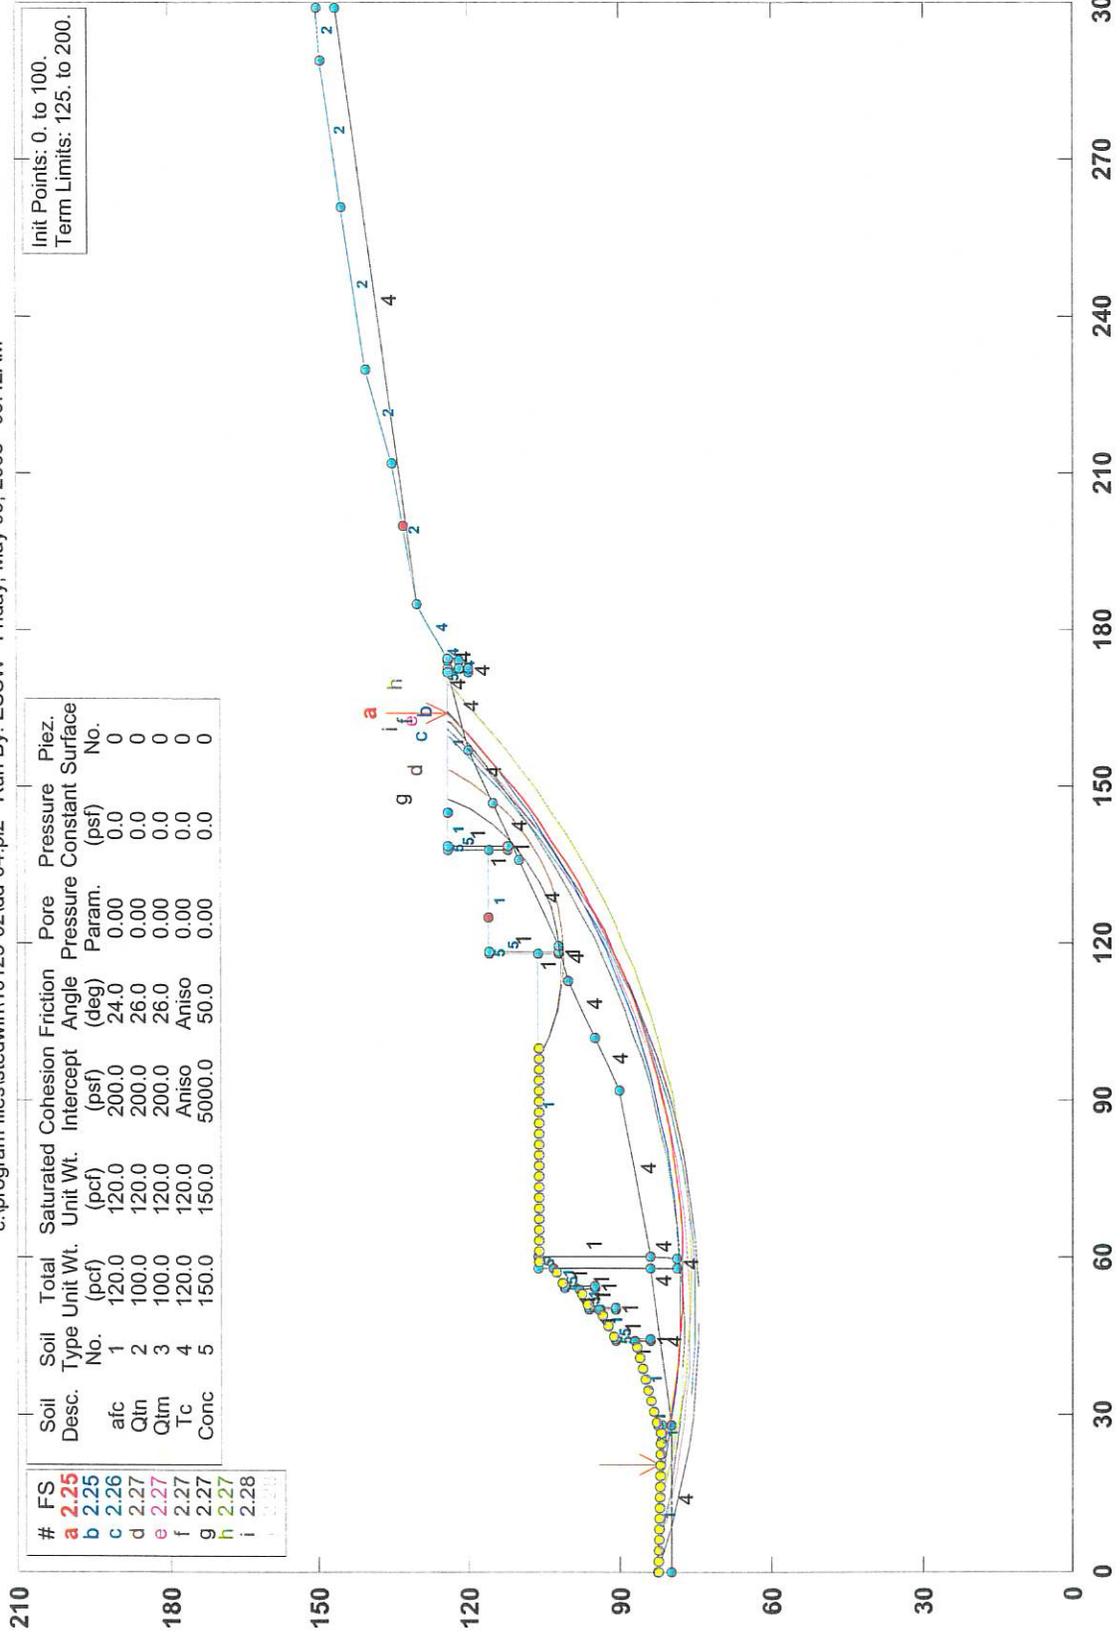
# 10123-02; Via Canon, Proposed Section DD; Static

Init Points: 0. to 100.  
Term Limits: 125. to 200.

Soil Desc.	Soil Type No.	Total Unit Wt. (pcf)	Saturated Unit Wt. (pcf)	Intercept (psf)	Friction Angle (deg)	Pore Pressure Param.	Pressure Constant (psf)	Piez. No.
afc	1	120.0	120.0	200.0	24.0	0.00	0.0	0
d	2	100.0	120.0	200.0	26.0	0.00	0.0	0
Qtm	3	100.0	120.0	200.0	26.0	0.00	0.0	0
Tc	4	120.0	120.0	Aniso	Aniso	0.00	0.0	0
Conc	5	150.0	150.0	5000.0	50.0	0.00	0.0	0

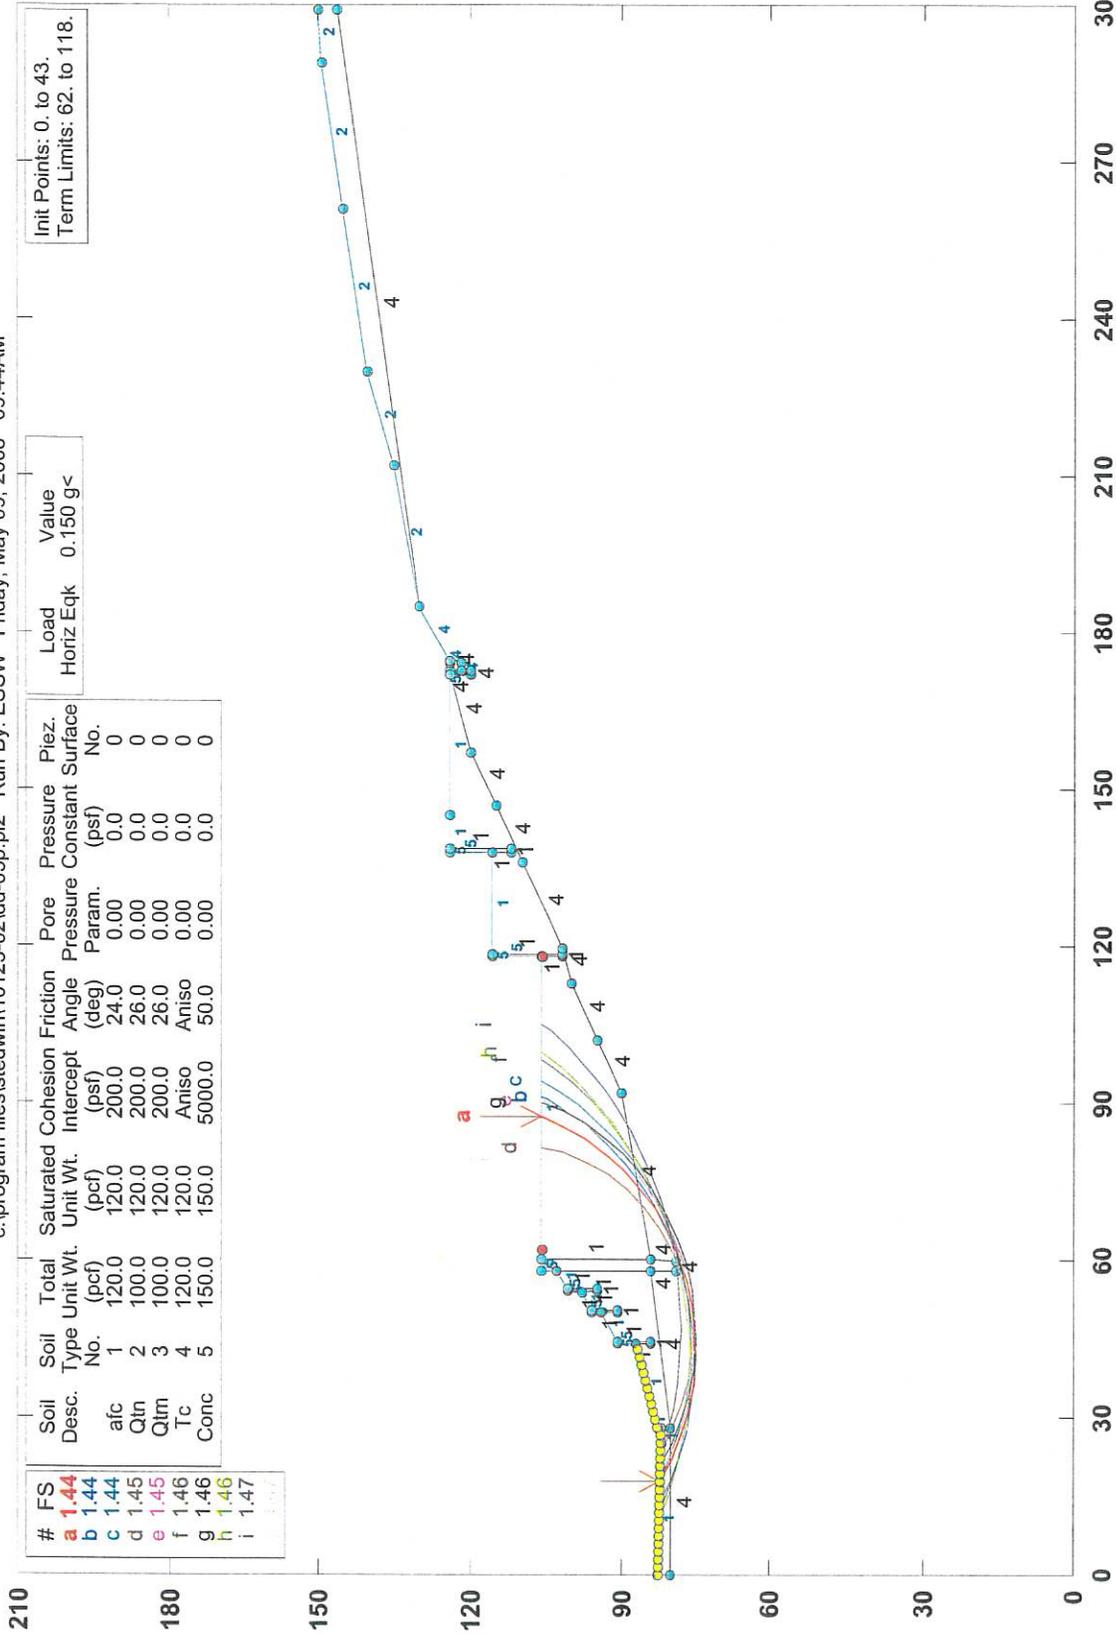
# 10123-02; Via Canon, Proposed Section DD; Pseudostatic

STABL6H FSmin=1.44  
Safety Factors Are Calculated By The Modified Bishop Method

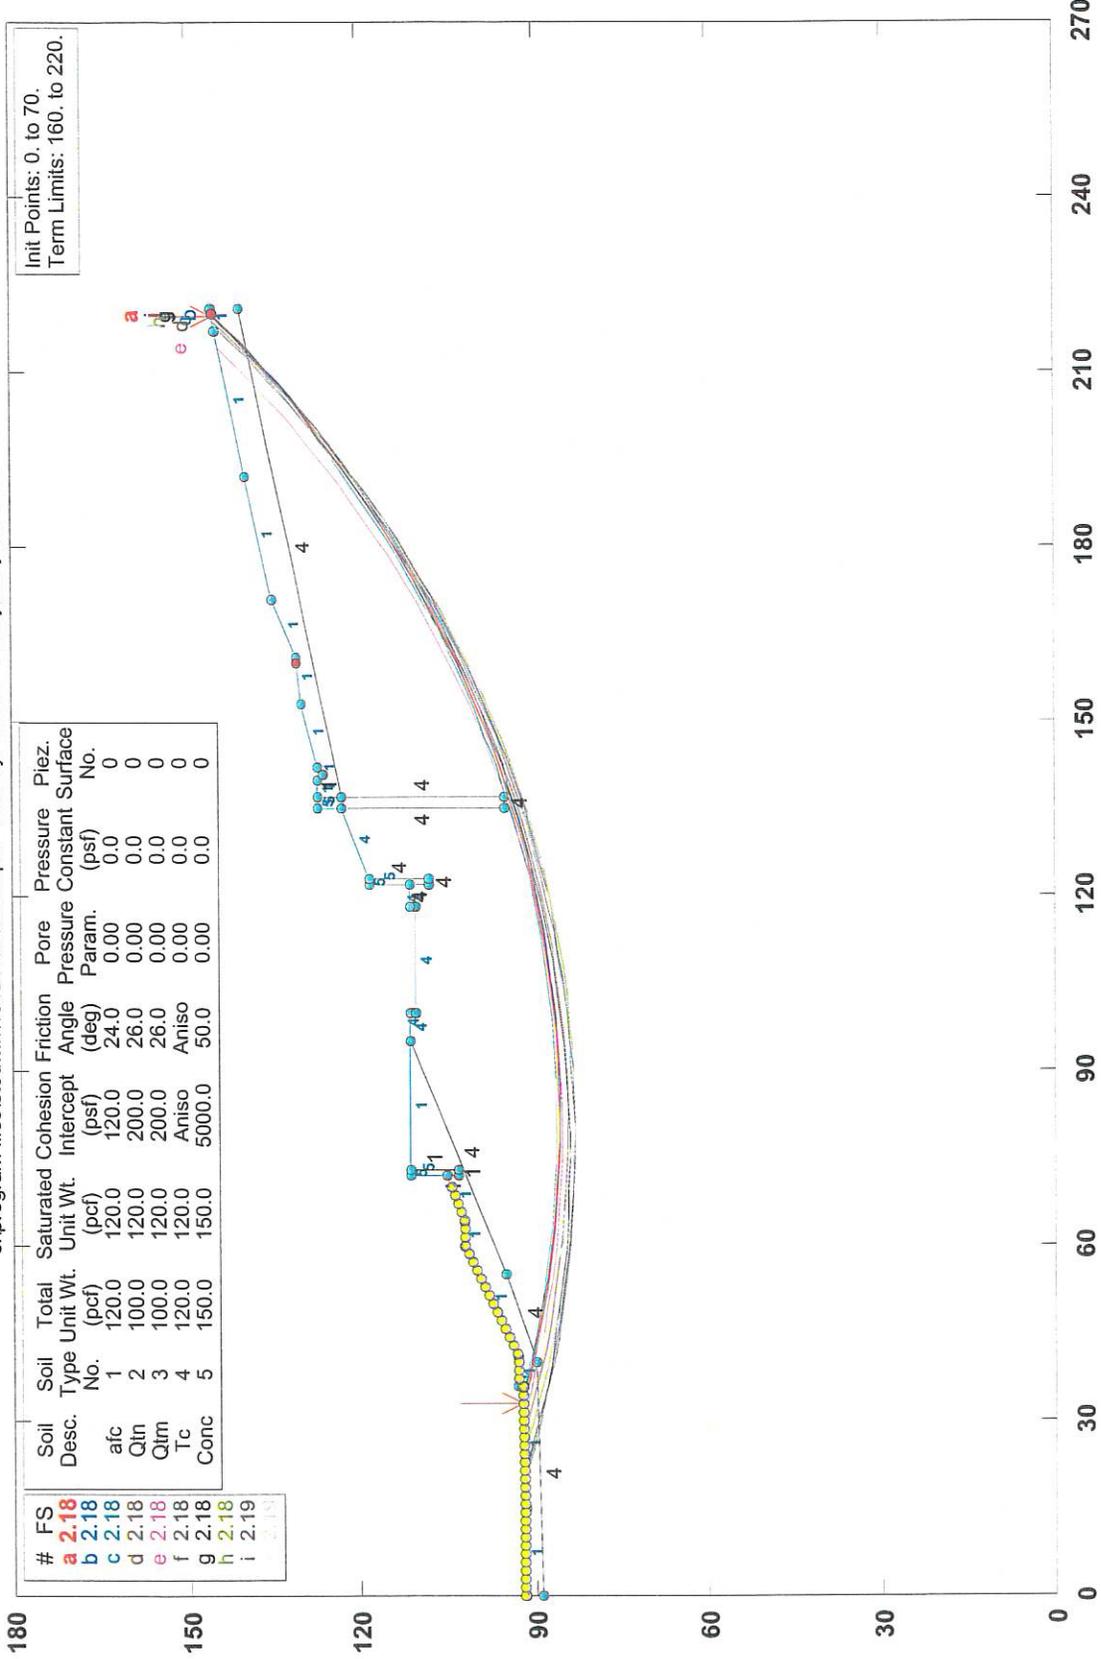
# 10123-02; Via Canon, Proposed Section EE'; Static

STABL6H FSmin=2.18  
Safety Factors Are Calculated By The Modified Bishop Method
