**GEOTECHNICAL ENGINEERING REPORT  
MULTI-FAMILY  
RESIDENTIAL DEVELOPMENT  
SOUTH OF VIA CANON AND  
CAMINO CAPISTRANO  
DANA POINT, CALIFORNIA**

Project: **Multi-Family Residential Development**  
South of Via Canon and Camino Capistrano  
Dana Point, California

Subject: **Geotechnical Engineering Report**

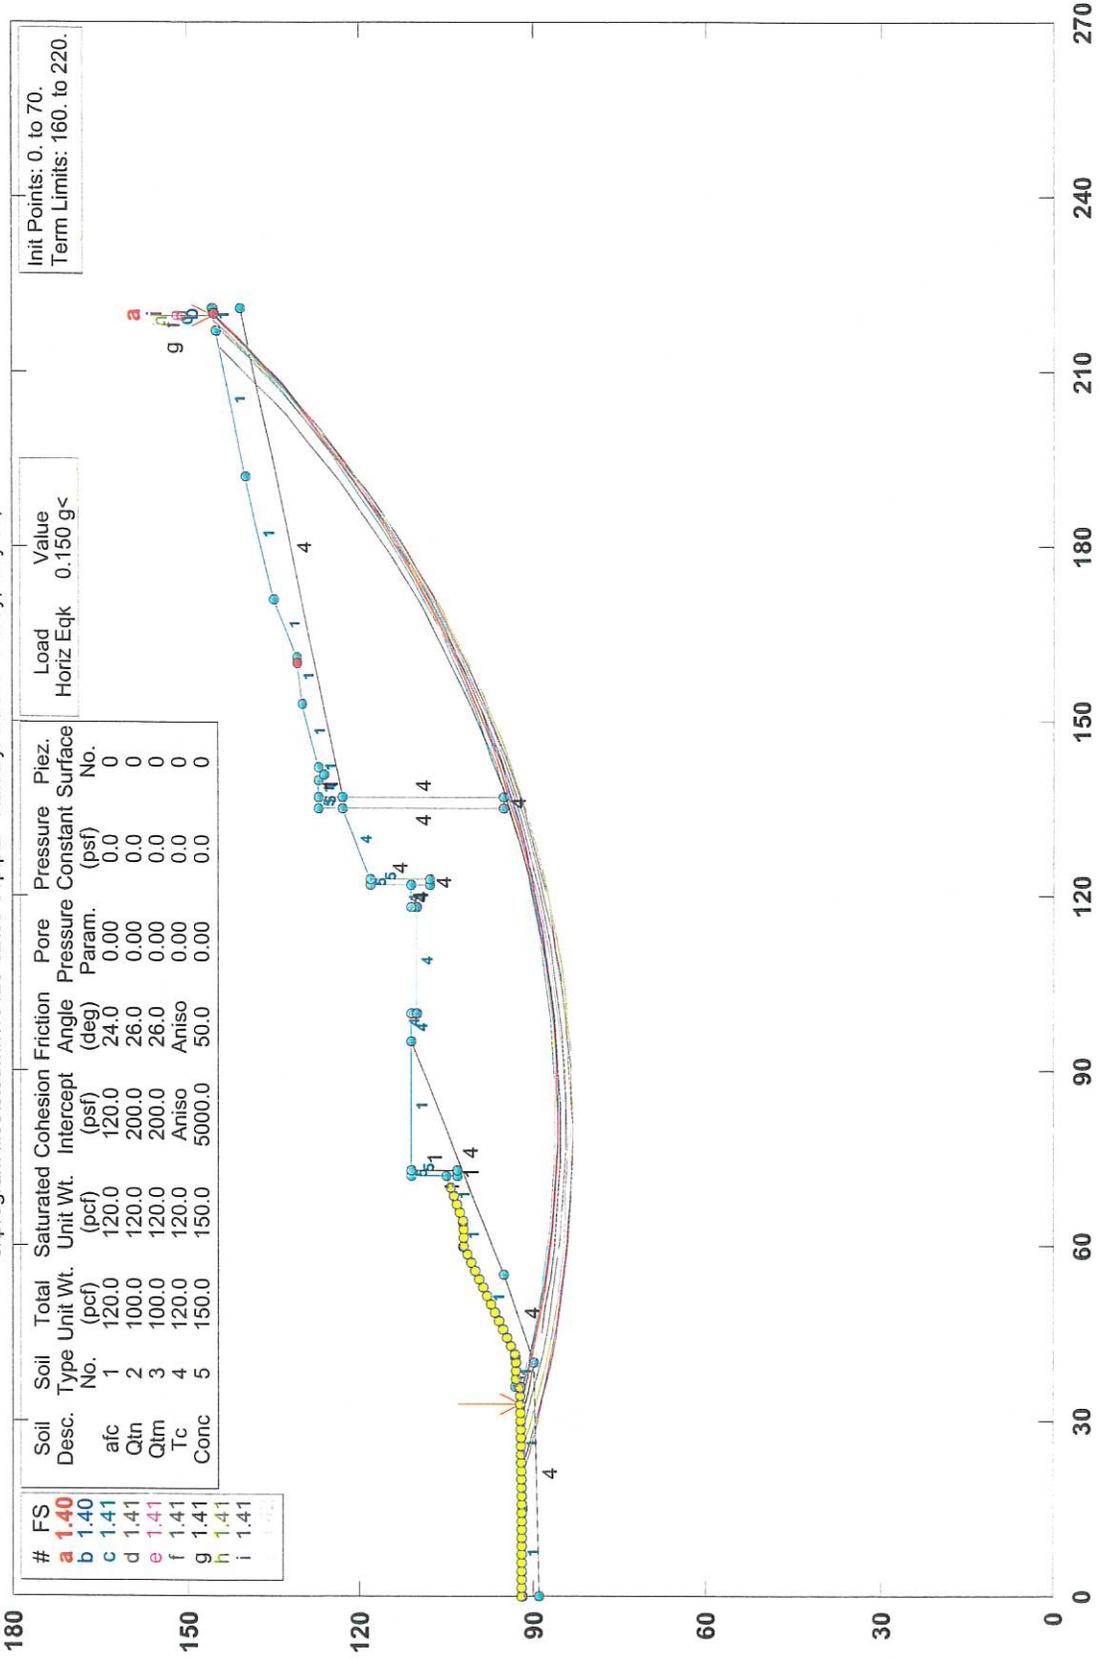
# 10123-02; Via Canon, Proposed Section EE'; Pseudostatic

STABL6H FSmin=1.40  
Safety Factors Are Calculated By The Modified Bishop Method

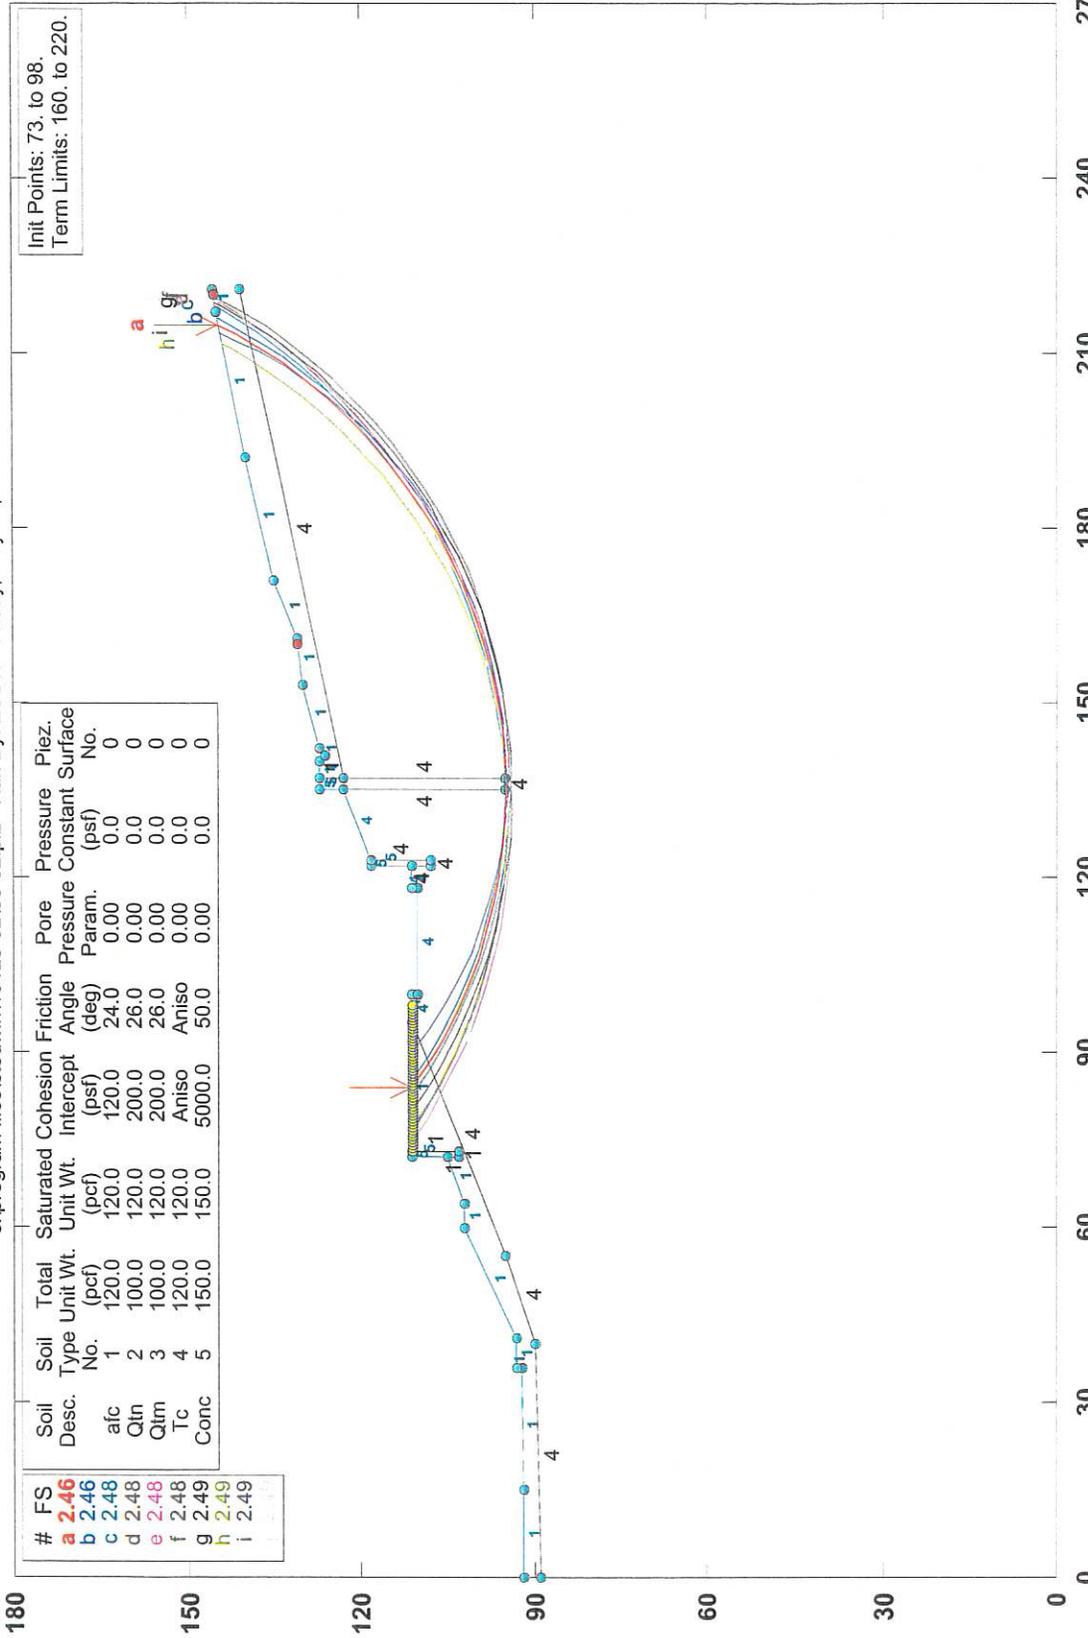
# 10123-02; Via Canon, Proposed Section EE'; Static

Init Points: 73. to 98.  
Term Limits: 160. to 220.

Soil Desc.	Soil Type No.	Total Unit Wt. (pcf)	Saturated Unit Wt. (pcf)	Cohesion (psf)	Friction Angle (deg)	Pore Pressure Param.	Pressure Constant (psf)	Piez. No.
afc	1	120.0	120.0	120.0	24.0	0.00	0.0	0
Qtn	2	100.0	120.0	200.0	26.0	0.00	0.0	0
Qtm	3	100.0	120.0	200.0	26.0	0.00	0.0	0
Tc	4	120.0	120.0	Aniso	Aniso	0.00	0.0	0
Conc	5	150.0	150.0	5000.0	50.0	0.00	0.0	0

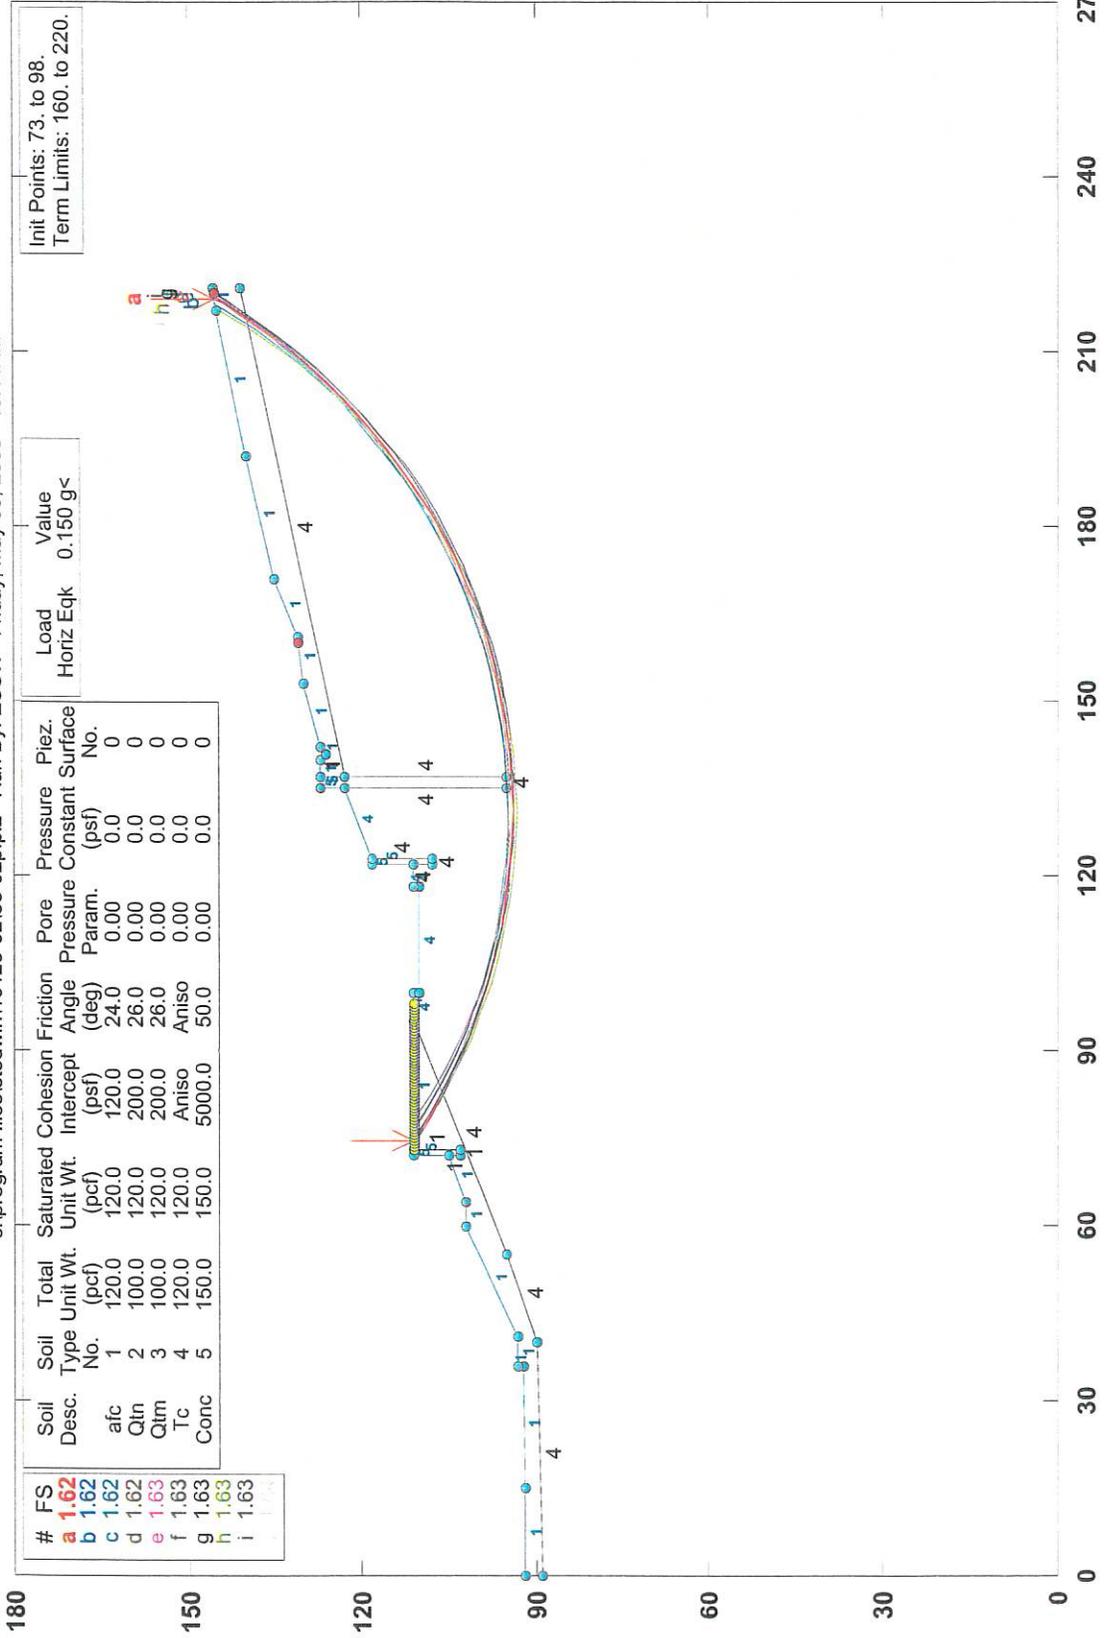
# 10123-02; Via Canon, Proposed Section EE'; Pseudostatic

Init Points: 73. to 98.  
Term Limits: 160. to 220.

STABL6H FSmin=1.62  
Safety Factors Are Calculated By The Modified Bishop Method

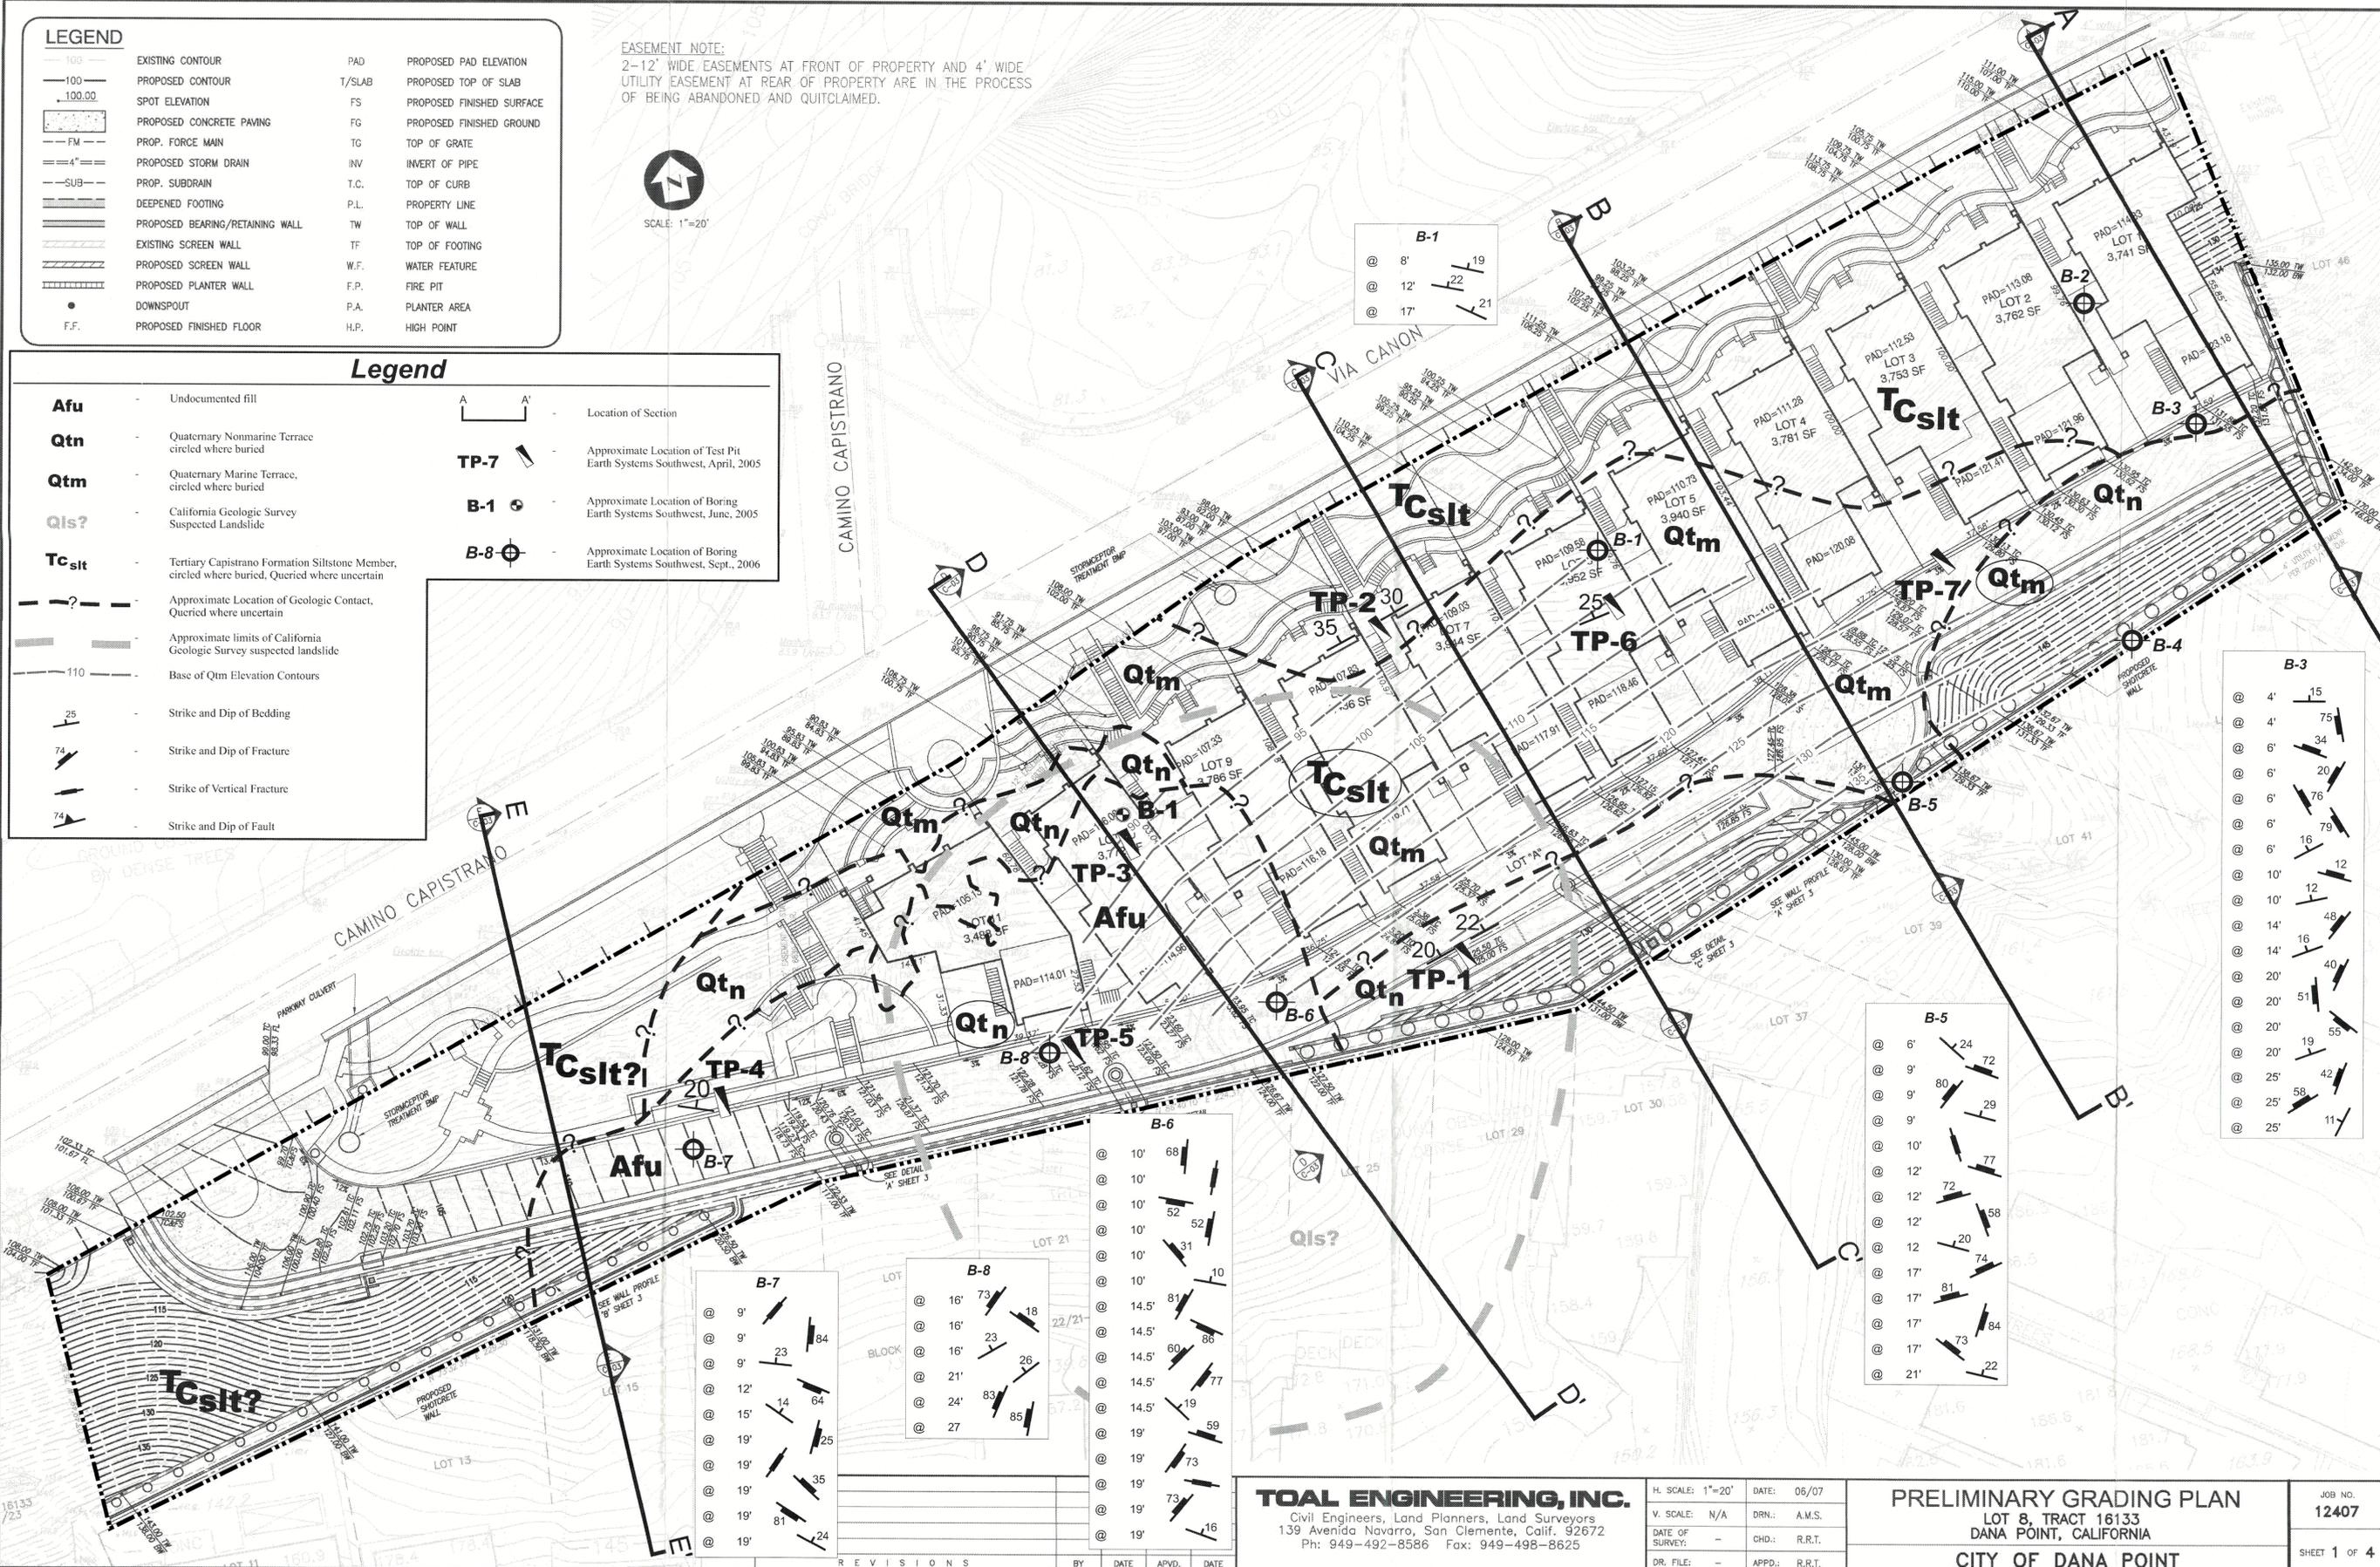
Legend		Location of Section	
<b>Afu</b>	Undocumented fill		Location of Section
<b>Qtn</b>	Quaternary Nonmarine Terrace circled where buried		Approximate Location of Test Pit Earth Systems Southwest, April, 2005
<b>Qtm</b>	Quaternary Marine Terrace, circled where buried		Approximate Location of Boring Earth Systems Southwest, June, 2005
<b>Qls?</b>	California Geologic Survey Suspected Landslide		Approximate Location of Boring Earth Systems Southwest, Sept., 2006
<b>Tcslit</b>	Tertiary Capistrano Formation Siltstone Member, circled where buried, Queried where uncertain		
	Approximate Location of Geologic Contact, Queried where uncertain		
	Approximate limits of California Geologic Survey suspected landslide		
	Base of Qtm Elevation Contours		
	Strike and Dip of Bedding		
	Strike and Dip of Fracture		
	Strike of Vertical Fracture		
	Strike and Dip of Fault

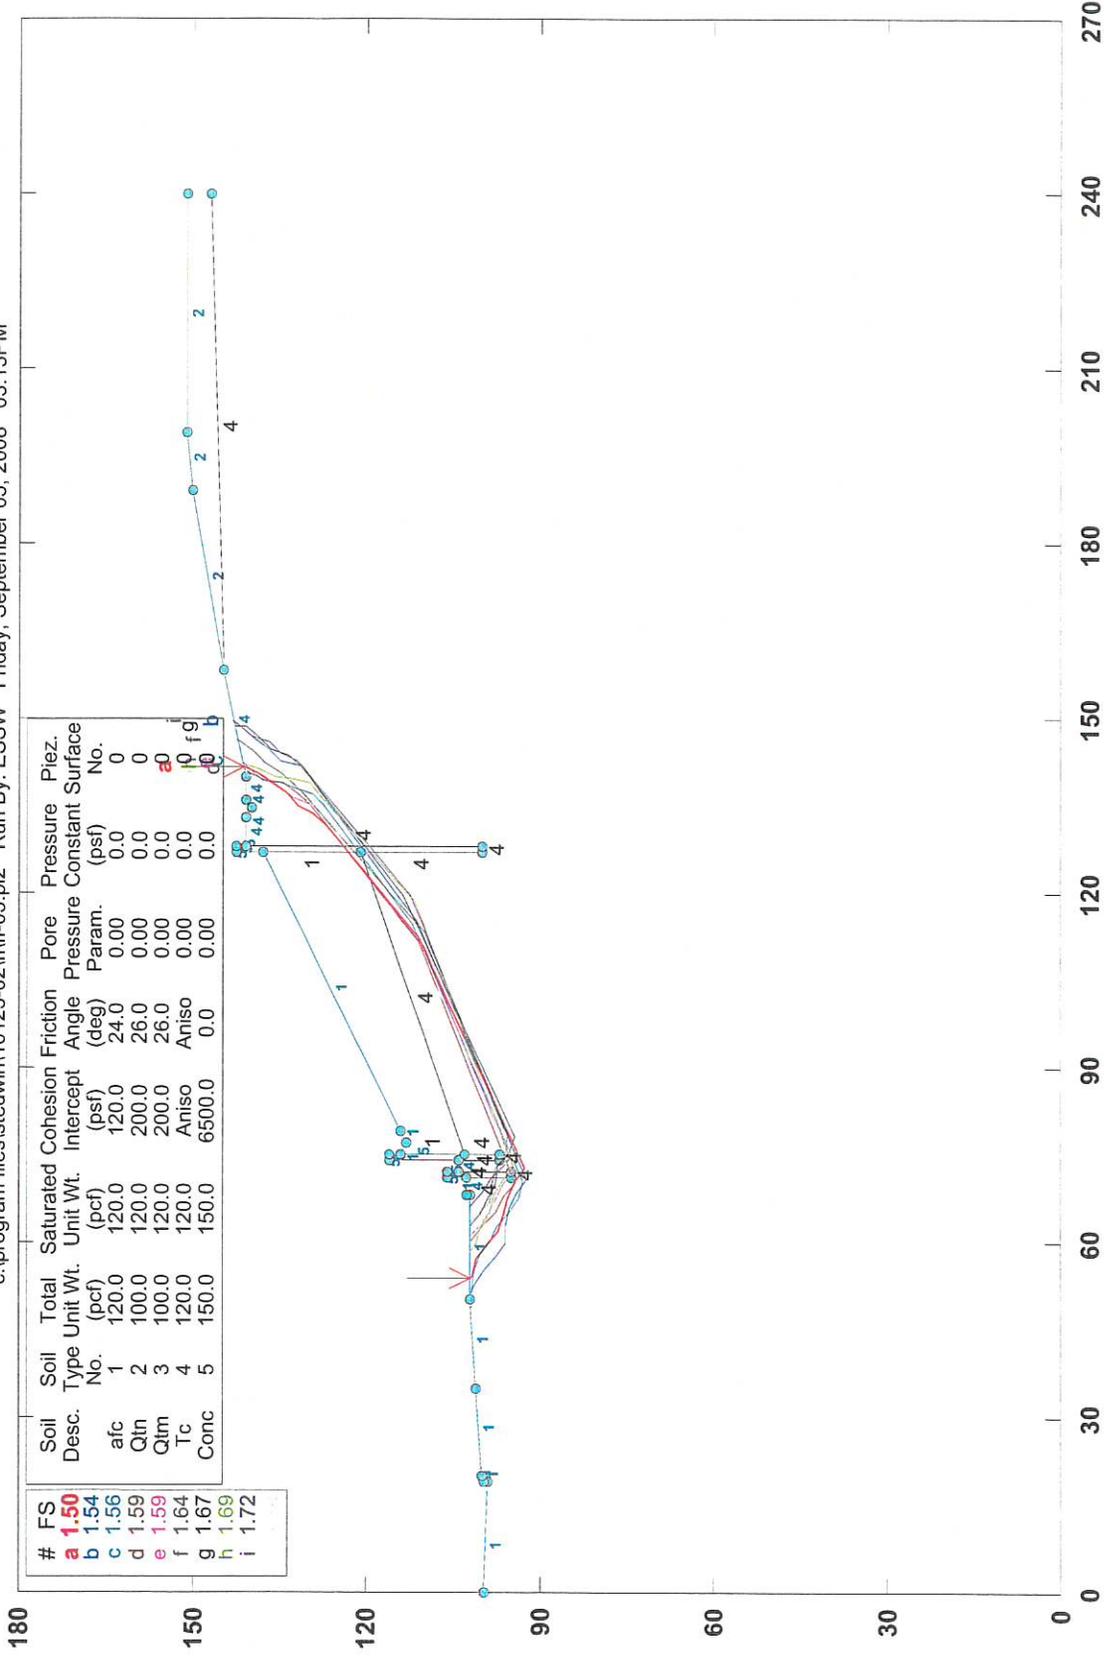
# 10123-02; Via Canon, Proposed Section FF'; Static

Soil Desc.	Soil Type No.	Total Unit Wt. (pcf)	Saturated Unit Wt. (pcf)	Cohesion (psf)	Friction Angle (deg)	Pore Pressure Param.	Piez. Constant Surface No.
a fc	1	120.0	120.0	120.0	24.0	0.00	0
b Qtn	2	100.0	120.0	200.0	26.0	0.00	0
c Qtn	3	100.0	120.0	200.0	26.0	0.00	0
d Tc	4	120.0	120.0	Aniso	Aniso	0.00	0
e Conc	5	150.0	150.0	6500.0	0.0	0.00	0

#	FS
a	1.50
b	1.54
c	1.56
d	1.59
e	1.59
f	1.64
g	1.67
h	1.69
i	1.72

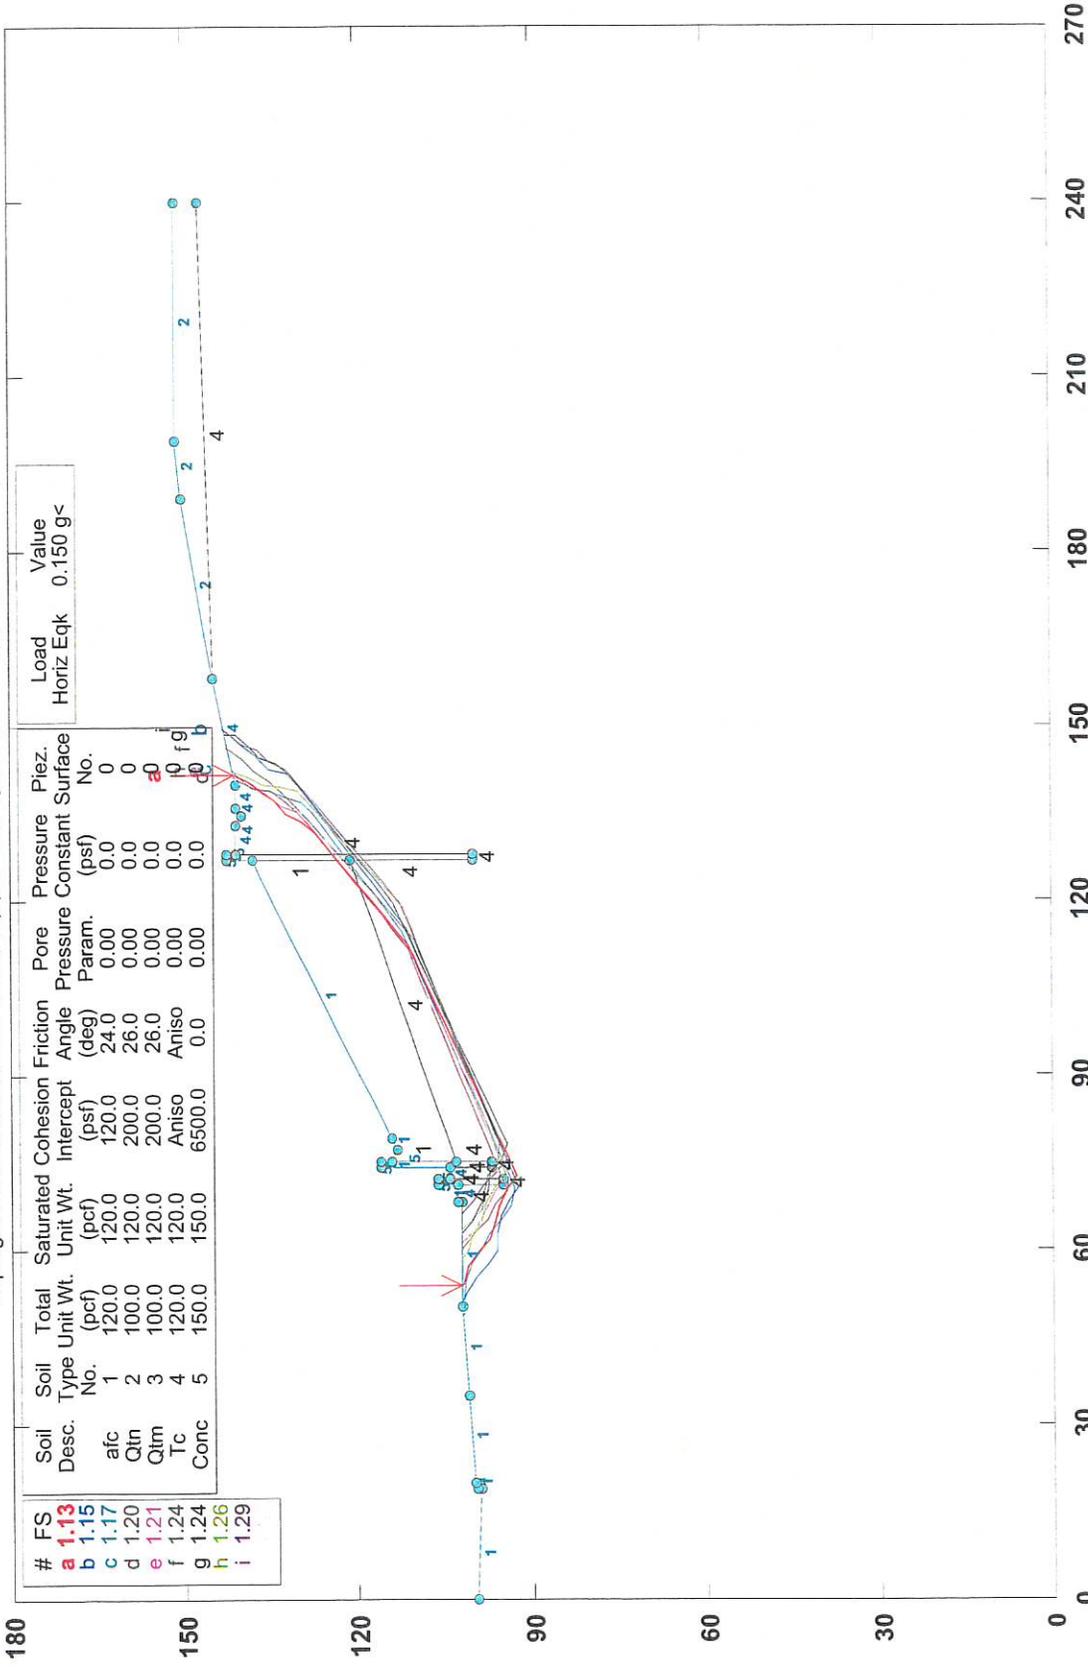
# 10123-02; Via Canon, Proposed Section FF'; Pseudostatic

#	FS
a	1.13
b	1.15
c	1.17
d	1.20
e	1.21
f	1.24
g	1.24
h	1.26
i	1.29

Soil Desc.	Soil Type No.	Total Unit Wt. (pcf)	Saturated Unit Wt. (pcf)	Cohesion (psf)	Friction Angle (deg)	Pore Pressure Param.	Pressure Constant (psf)	Piez. No.	Load Horiz Eqk	Value
afc	1	120.0	120.0	120.0	24.0	0.00	0.0	0	0.150	g<
Qtn	2	100.0	120.0	200.0	26.0	0.00	0.0	0		
Qtm	3	100.0	120.0	200.0	26.0	0.00	0.0	0		
Tc	4	120.0	120.0	Aniso	Aniso	0.00	0.0	0		
Conc	5	150.0	150.0	6500.0	0.0	0.00	0.0	0

STABL6H FSmin=1.13  
Safety Factors Are Calculated By The Modified Janbu Method

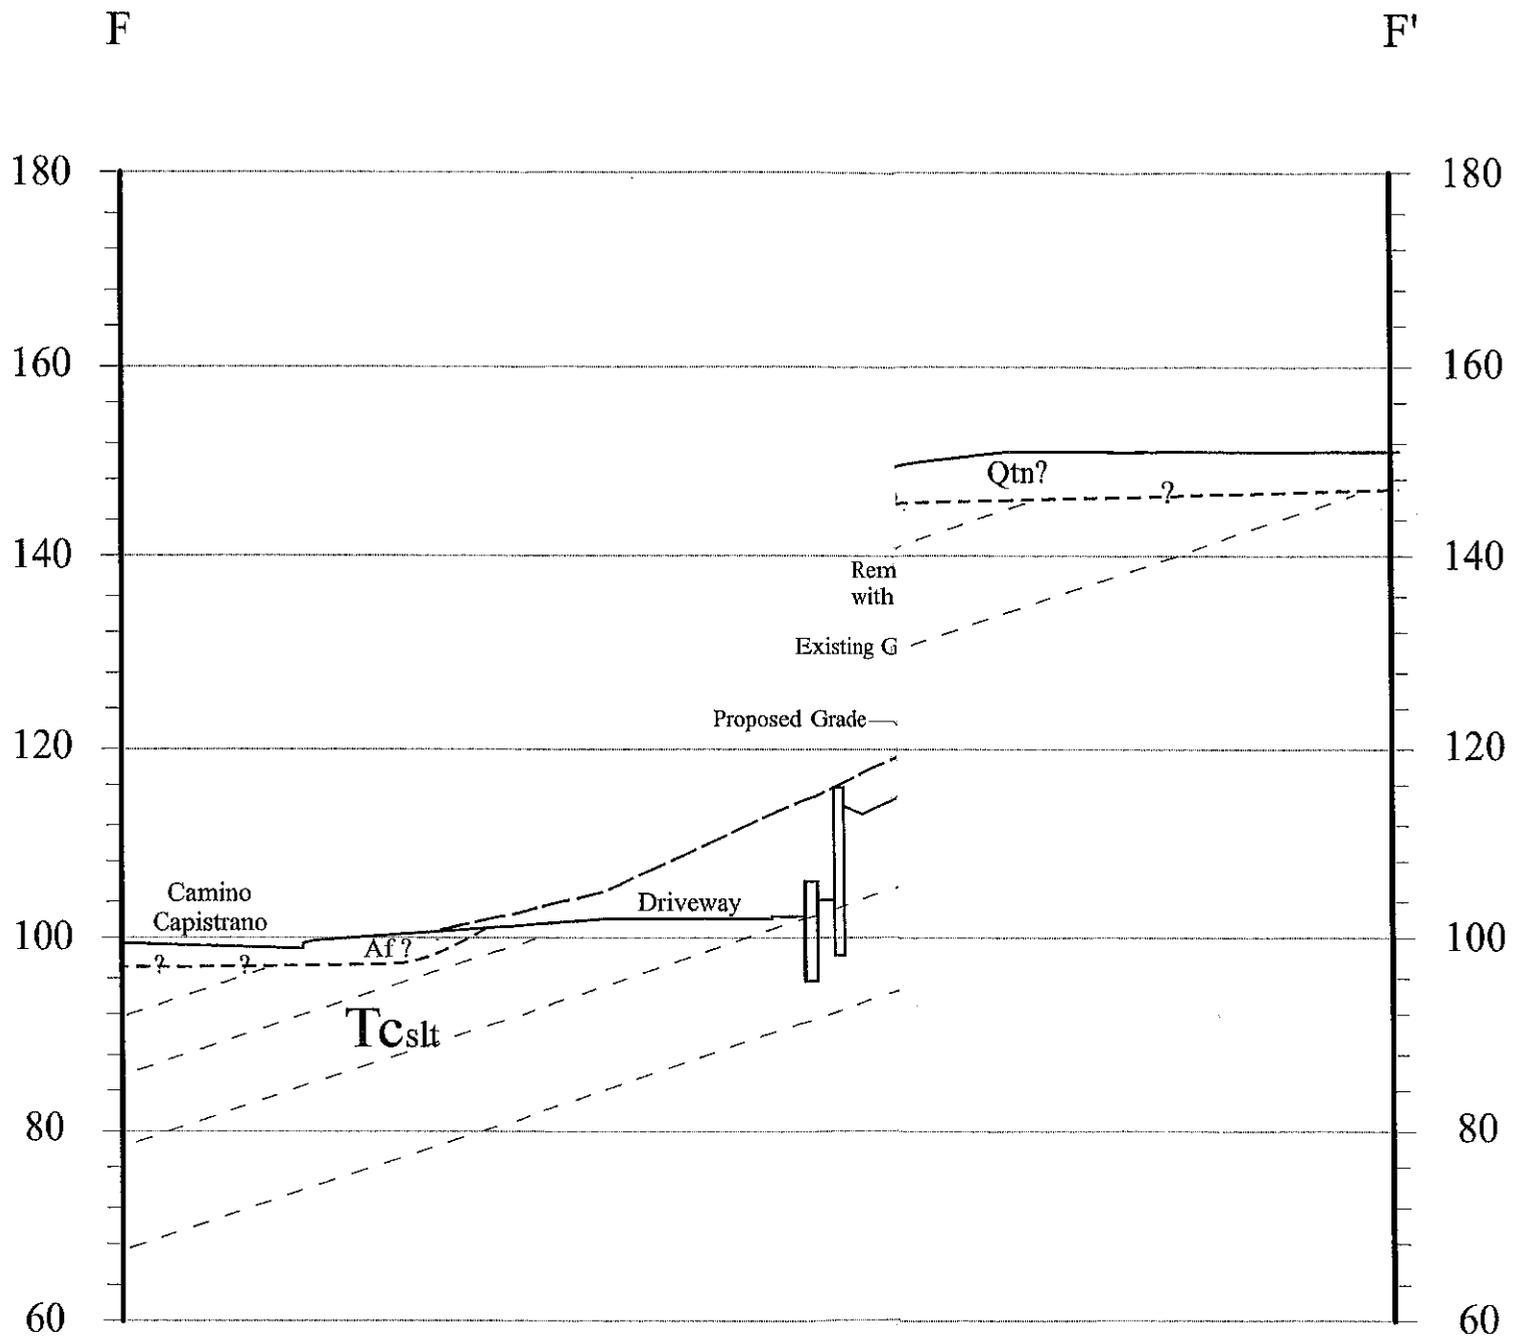
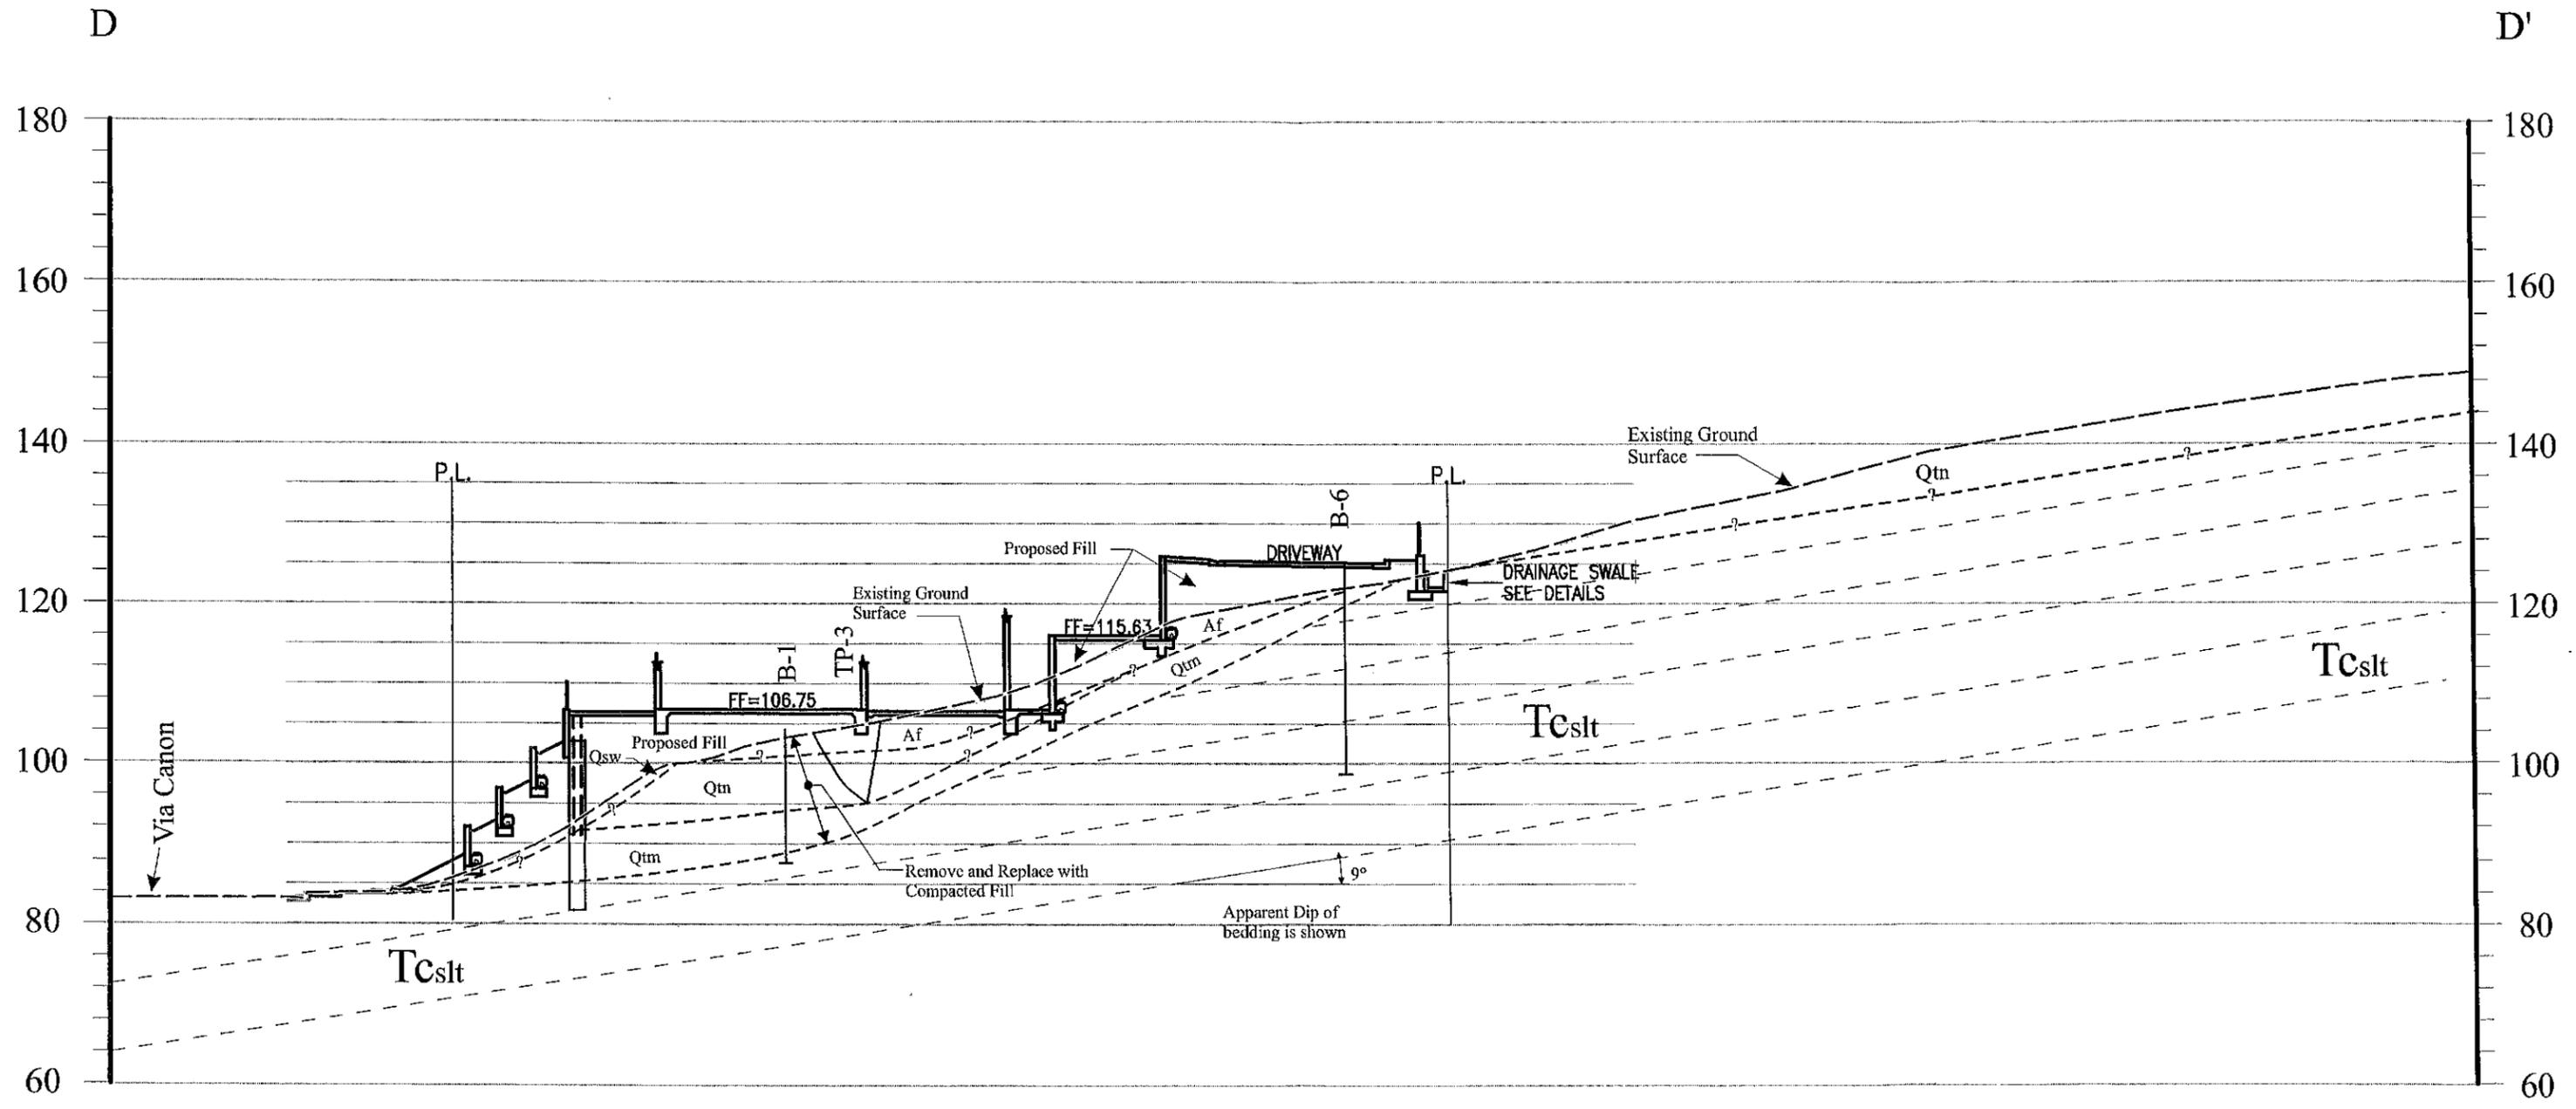
**Figure 3F**  
**Geologic Section F-F'**

- Af Documented fill
- Afu Undocumented fill
- Qtn Quaternary Nonmarine Terrace
- Qtm Quaternary Marine Terrace
- Qsw Slopewash

As shown on Geologic Section F-F', the cut-slope will be over-excavated to "exposed" bedding planes will be removed and recompacted as engineered fill; thereby eliminating surcharge bedding plane loads along the lower most driveway wall. The upper proposed shotcrete wall under the temporary cut condition would retain up to about 20 feet of soil. This shotcrete wall should be designed to retain this earth load. Moreover, our stability analysis indicates that the shotcrete wall needs to exert up to about 6,500 lbs/lineal feet lateral thrust to maintain a permanent safety factor of 1.5. Assuming an 8-foot soldier pile spacing and effective moment arm at about 7 feet above to potential failure plane, this computes to a moment demand of 364 feet kips. The soldier pile beam should be sized to resist this potential demand. Specifications for recompaction are given below.
